Visual Contrast Rating Data Sheet

Devers-Palo Verde 2 Transmission Line Project

Key Viewpoint <div style="text-align: center; font-size: 1.2em; font-weight: bold;">9</div>

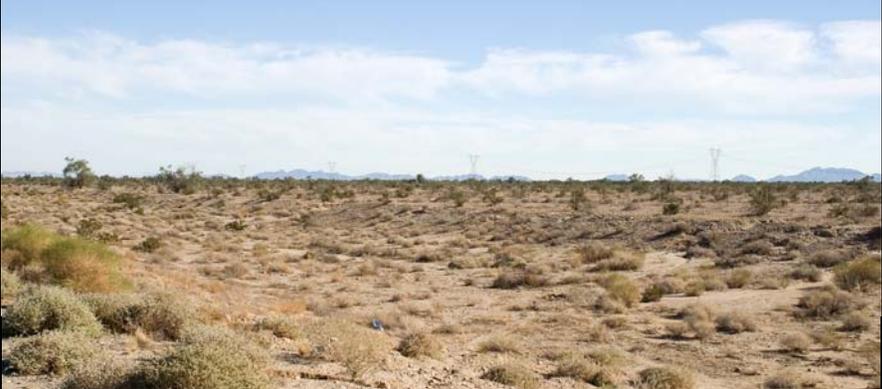
Location Interstate 10 at the end of the Corn Springs Road on-ramp in Chuckwalla Valley, viewing east-southeast.	
VRM Class <div style="text-align: center; font-size: 1.2em; font-weight: bold;">III</div>	
Analyst Michael Clayton	
Date October 22, 2005

LANDFORM / WATER	VEGETATION	STRUCTURES
Form	Same	Same	Geometric and complex to simple linear
Line	Same	Same	Vertical and diagonal for structures, to curvilinear for conductors
Color	Same	Same	Light gray to lavender at distance
Texture	Same	Same	Smooth

LANDFORM / WATER				VEGETATION				STRUCTURES			
	NONE	WEAK	MODERATE	STRONG	NONE	WEAK	MODERATE	STRONG	NONE	WEAK	MODERATE	STRONG
Form	4				4					4		
Line	4				4					4	4	
Color	4				4					4		
Texture	4				4					4

Term: <input type="checkbox"/> Short <input checked="" type="checkbox"/> Long	Level of Change: <input type="checkbox"/> Very Low <input checked="" type="checkbox"/> Low <input type="checkbox"/> Moderate <input type="checkbox"/> High
Does the Project Design Meet VRM Objectives? <input checked="" type="checkbox"/> Yes <input type="checkbox"/> No
