ELDORADO-LUGO-MOHAVE (ELM) SERIES CAPACITATOR PROJECT

Date: July 13, 2021
To: Eric Chiang, Project Manager, CPUC
From: Vida Strong, Aspen Project Manager
Subject: Monitoring Report #5: May 1 to June 30, 2021

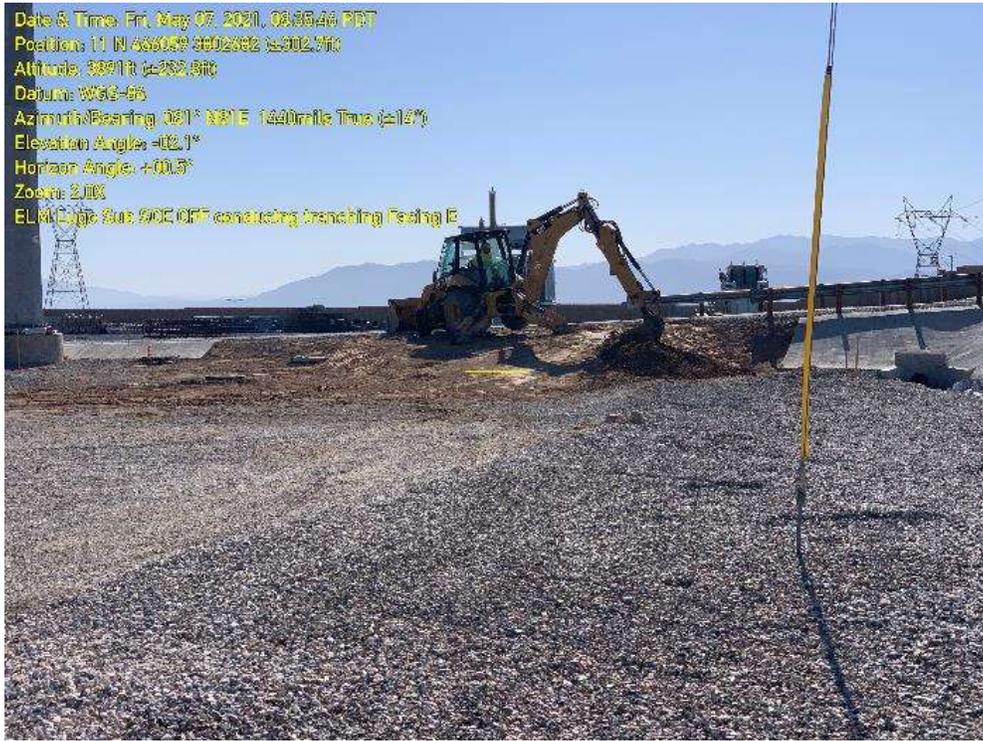
Photo 1: Trenching work at Lugo Substation. May 7, 2021. Photo courtesy of SCE.

2. Construction activities that occurred at the Lugo Substation during the reporting period included staging equipment, trenching and backfilling, pouring concrete, installing conduit, installing ground and conductor wire, and installing bus supports and circuit breaker pedestals (see Photos 1 and 2).

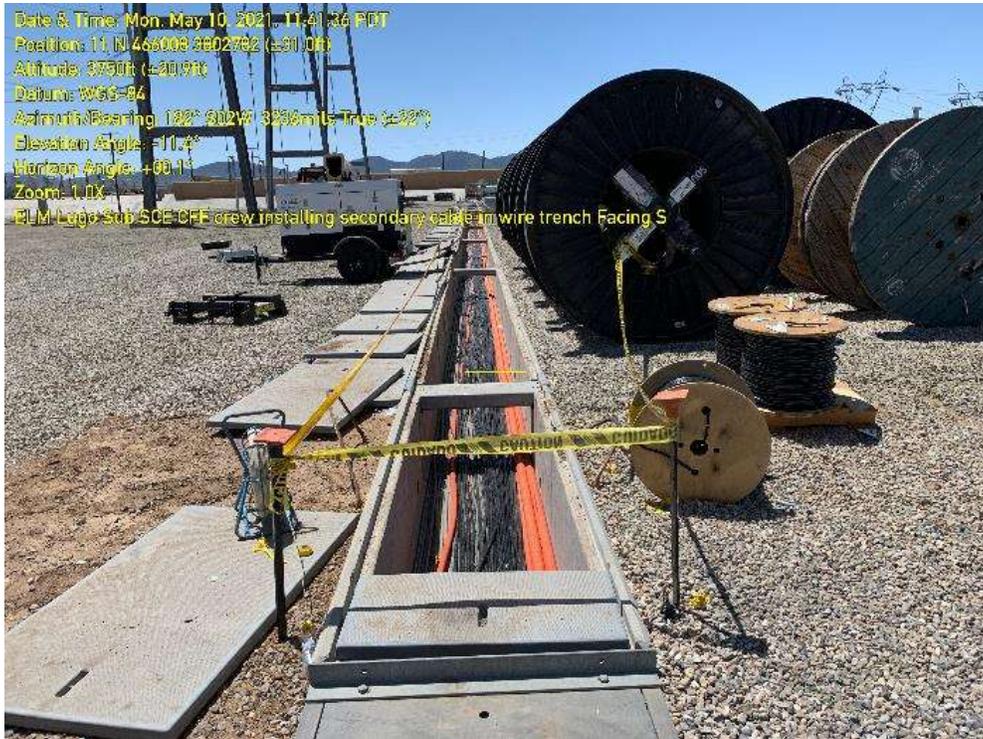
Photo 2: Conduit and wire installation at Lugo Substation. May 10, 2021. Photo courtesy of SCE.

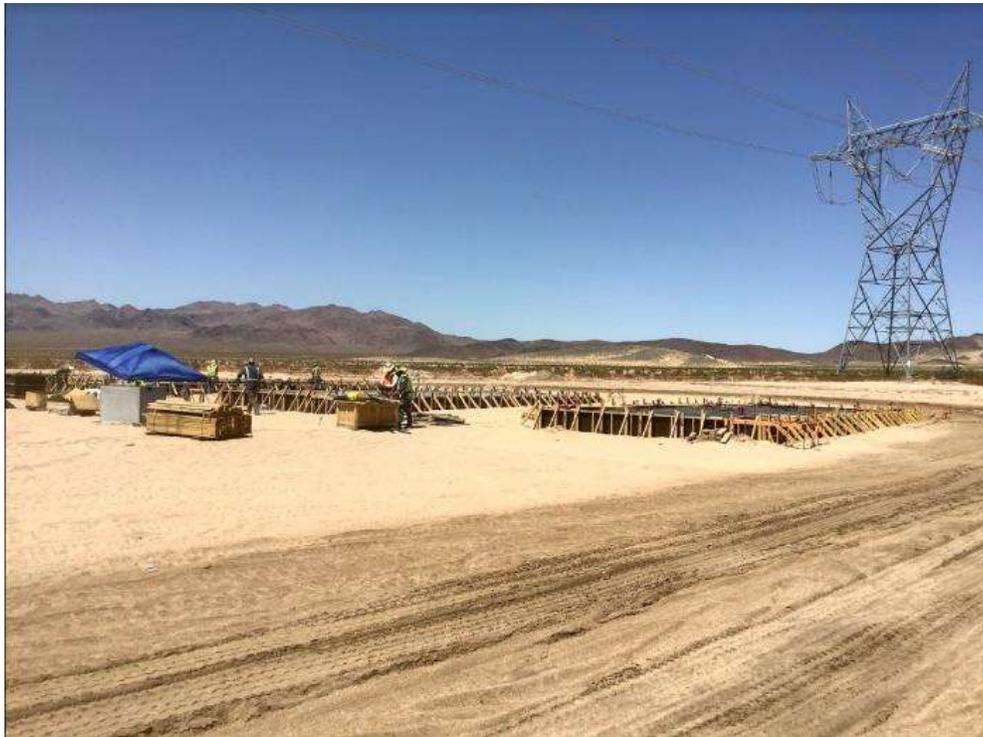
Photo 3: Forming concrete pads at the Ludlow Series Capacitor. May 18, 2021.

3. Construction activities that occurred at the Ludlow Series Capacitor during the reporting period included material deliveries, maintaining BMPs and desert tortoise fencing, grading, soil compaction, riprap installation, pit excavation, drilling foundations, constructing and removing concrete forms, and pouring concrete (see Photo 3).

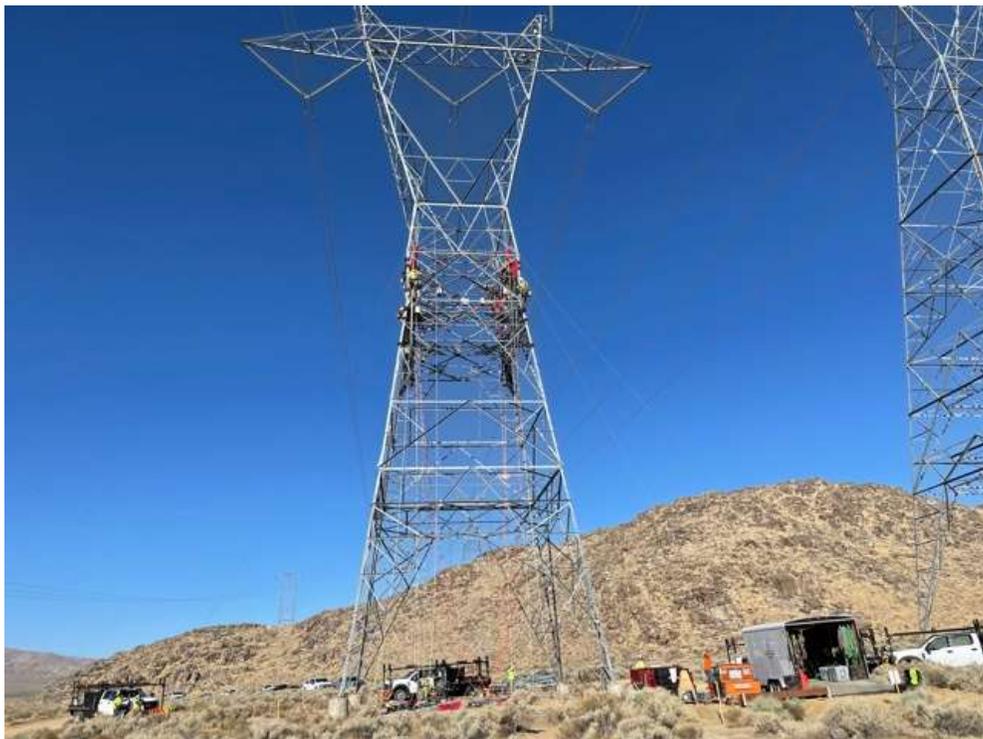
Photo 4: Modifications at Structure M22-T4. June 10, 2021. Photo courtesy of SCE.

1. The currently approved tower modifications are being performed by AMPJACK crews.
2. Construction activities that occurred along the Lugo-Mohave transmission line included tower modifications at Structure M22-T4 (see Photo 4).

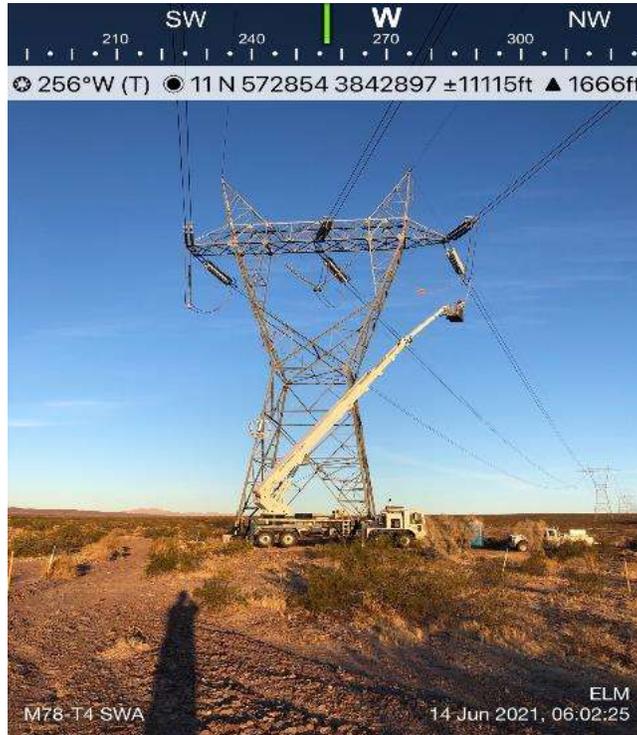
Photo 5: OPGW installation work at Structure M78-T4. June 14, 2021. Photo courtesy of SCE.

1. For the currently approved structure modifications and OPGW installation, construction activities are being performed by American Power crews.
2. Construction activities that occurred along the Lugo-Mohave transmission line included elevation and sag surveying, mobilizing materials and equipment, BMP installations at Structures M68-T4 and M78-T4, tower modifications at Structure M68-T4, and OPGW installation at Structures M69-T1 through M69-T3 and M78-T4 (see Photo 5).

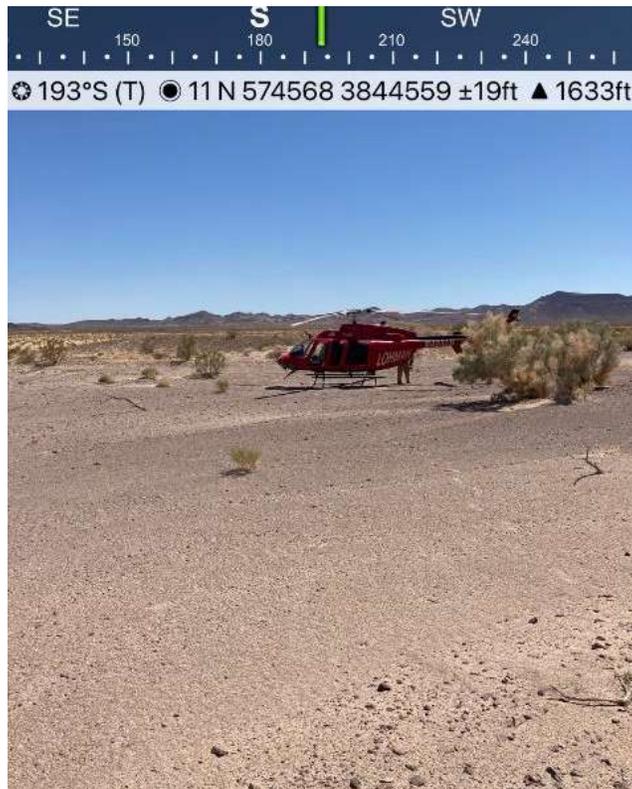
- On June 4, 2021, the SCE Biological Monitor documented a Level 1 Incident when a project helicopter made a precautionary landing within a large, open ephemeral wash approximately 2,060 feet south of Structure M79-T1 (see Photo 6). The landing area was outside of approved project limits. After the helicopter was approved for takeoff again, the SCE Biological Monitor inspected the area and reported no observed impacts to biological resources, no spills, or no other contamination. The CPUC Project Manager was immediately notified of this event by SCE.

Photo 6: Precautionary helicopter landing near Structure M79-T1. June 4, 2021. Photo courtesy of SCE.
