PROJECT MEMORANDUM SDG&E – MIGUEL-MISSION 230 KV #2 PROJECT

Subject: Weekly Report #5: August 29, 2004 – September 4, 2004

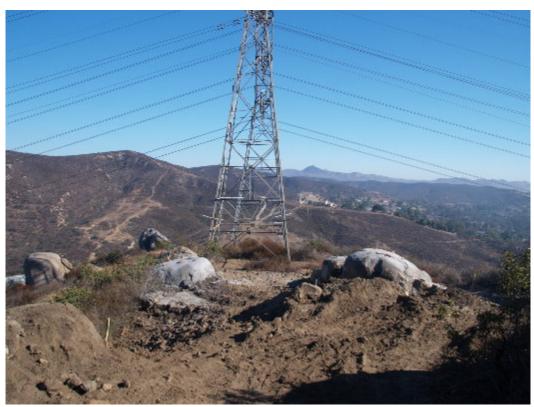
The CPUC EM conducted a site visit on August 31. The pad at the north end of Magnolia Road had been completed and crews had moved to Site 1300 to prepare the site for blasting. The large boulders and bedrock have been drilled for blasting and the blasting plan is under review with SDG&E (see Figure 1).

Figure 1 – Site 1300 cleared and holes drilled to prepared for blasting.

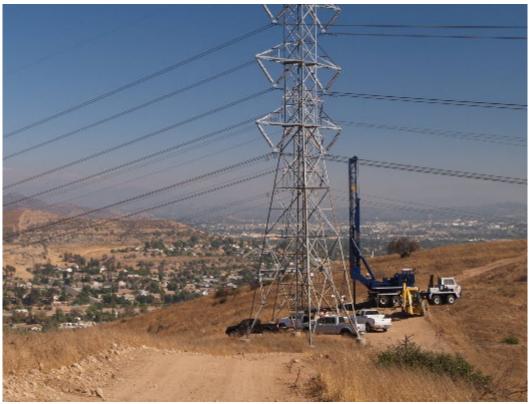
The transmission line contractor, PAR, started work during the subject week. A boring crew started excavation of the bore hole for the tower foundation at Site 1400 (see Figure 2). The crew encountered a great deal of cobble in the upper layers of the bore hole.

Figure 2 – PAR started boring work for transmission tower foundations at Site 1400.

Both an environmental monitor and paleontologist were on-site for the boring work at Site 1400. No significant environmental compliance issues were noted at the site. The crew took care to minimize fugitive dust despite the fact that the site is on a ridge far from sensitive receptors.

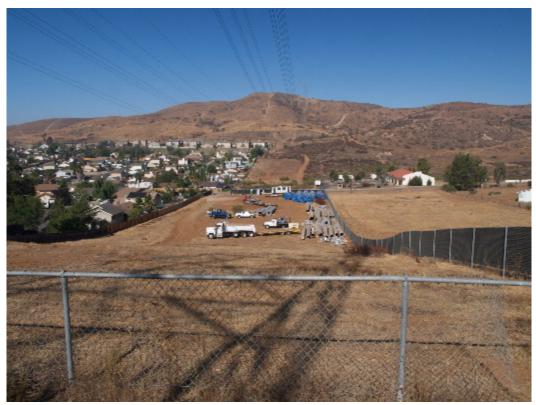
The Summit laydown area is being used for staging and storage. The area has been fenced with screening material and no environmental compliance issues were noted at the site (see Figure 3).

Figure 3 – Laydown site at Summit being used for material storage.

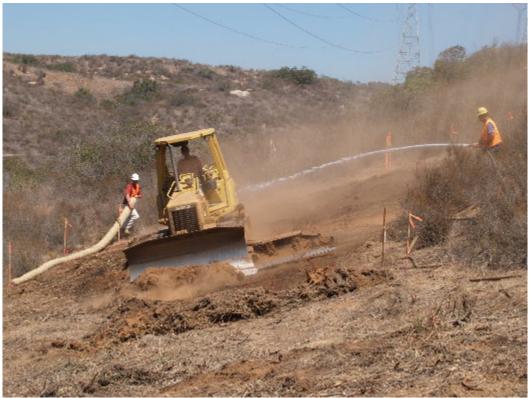
The clearing crew worked on Site 321 early in the week to prepare for grading activities. The grading crews moved to the site on Tuesday afternoon and started removing the root layer (see Figure 4). Work continued as crews created a transition from the pad to the access road (see Figure 5). Changes to the grade of the access road from maintenance have placed the access road lower than shown on plans. The transition from the pad site to the access road may have to be reviewed by SDG&E engineers.

Figure 4 – Grading work started at Site 321 above Steele Canyon High School. The Essex EI worked with the water truck operator to improve dust control.

The clearing crew is aware that the access roads need to be watered if fugitive dust is observed leaving the right-of-way. A water truck was on-site at Site 321 to control fugitive dust during the grading activities. An Essex EI was on-site for both the clearing and grading work at Site 321.

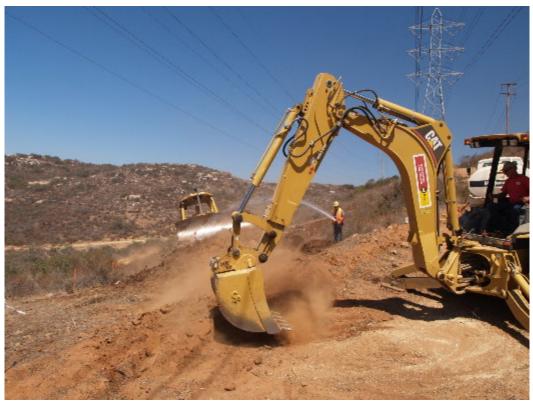
Figure 5 – An operator cut a transition from pad to access road at Site 321.
