#### PROJECT MEMORANDUM SDG&E – MIGUEL-MISSION 230 KV #2 PROJECT

**Subject:** Weekly Report #7: September 12, 2004 – September 18, 2004

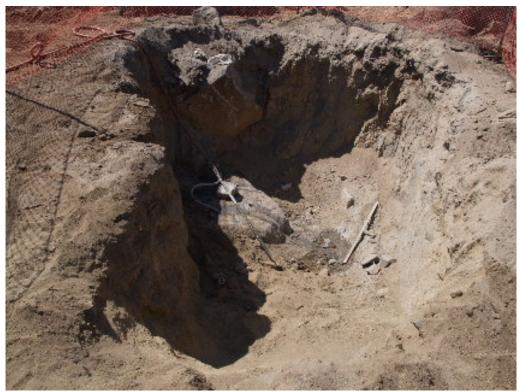
The large boulders and bedrock at Site 1300 have been removed using a rock hammer instead of blasting. In addition, the contractor is currently using a chemical expansion agent to fracture the bedrock at the site (see Figure 1).

**Figure 1** – The PAR crew at Tower Site 1300 used a chemically expansive material to fracture the bedrock in the foundation hole.

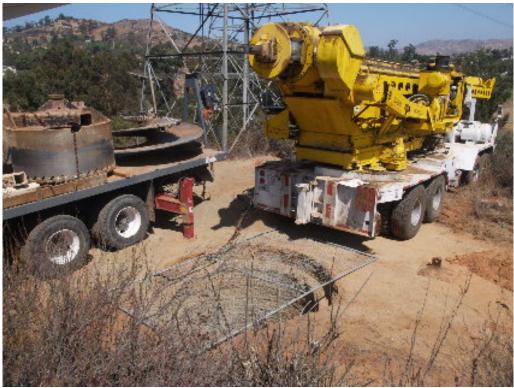
The transmission line contractor, PAR, continued working on foundations during the subject week. A boring crew completed excavation of the bore hole for the tower foundation at Site 1290 and was preparing to move to the next location to reset (see Figure 2). Another PAR crew worked on drilling the foundation at Site 1320. An Essex EI was on-site with the PAR crew.

**Figure 2** – The PAR boring crew finished at Tower Site 1290 and is preparing to move to the next location.

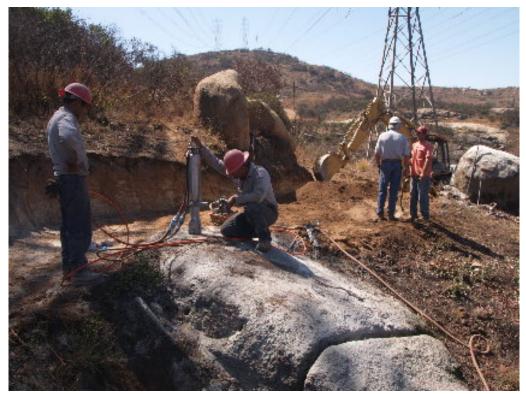
The clearing crew worked on Site 92, near Sweetwater Reservoir to prepare for grading activities. The grading crews completed work at Site 873 and moved to Site 912 to start splitting the large boulders on the site (see Figure 3). Due to the rocks and side slope, SDG&E made minor changes to the pad width and the major work at Site 912 was completed. The Union crew then moved to Site 932 and worked on the steep side slope (see Figure 4).

**Figure 3** – A special crew worked at hydraulically splitting the boulders at Site 912.

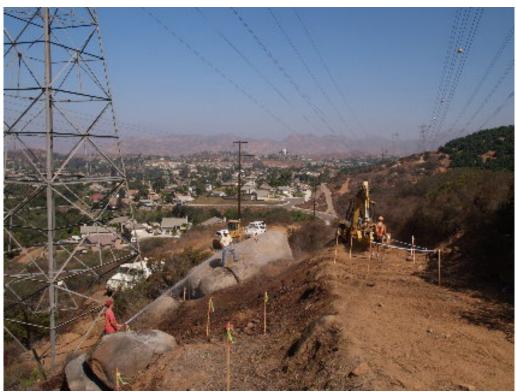
**Figure 4** – The Union crew at Site 932 worked on removing loose boulders and soil from the side slope.

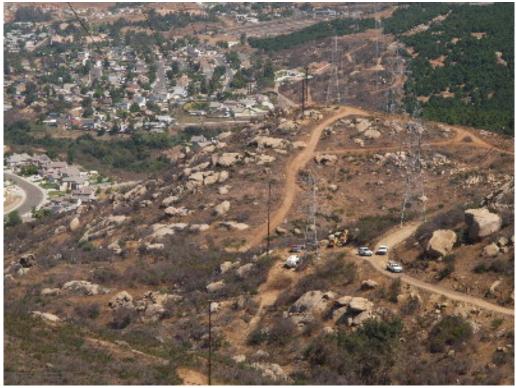
The clearing crew is aware that the access roads need to be watered if fugitive dust is observed leaving the right-of-way. A water truck was on-site to control fugitive dust during the grading activities. An Essex EI was on-site for both the clearing and grading work. The CPUC EM walked the right-of-way from the western access gate to Tower Site 912 and did not observe any environmental compliance issues (see Figure 5).

**Figure 5** – The CPUC EM walked the right-of-way west of Site 912 to review environmental compliance.

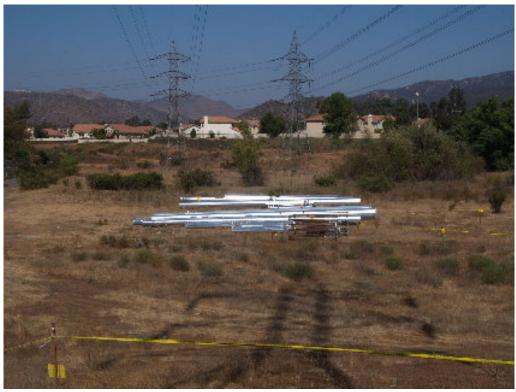
A staging and storage area is located adjacent to a residential school for children and SDG&E followed up on a request by school staff to not install screening and allow the children to view the construction activity. SDG&E had obtained Director approval not to install the screening and has forwarded the approval to the CPUC EM. The sensitive plant resources in the area have been marked with yellow exclusion tape; however, a crane operator unloaded two tower sections that encroached on the ambrosia buffer area (see Figure 6). The CPUC EM was notified of the issue by SDG&E and they were already in the process of getting the tower sections moved away from the buffer zone. No impacts to the sensitive species occurred due to the operator error. SDG&E will work to avoid this problem on the delivery of materials in the future.

**Figure 6** – Tower sections were placed within the buffer of the ambrosia exclusion area by an operator error. The poles were moved back from the exclusion area.
