## Aspen Environmental Group

#### PROJECT MEMORANDUM SDG&E – MIGUEL-MISSION 230 KV #2 PROJECT

**Subject:** Weekly Report #14: October 31, 2004 – November 6, 2004

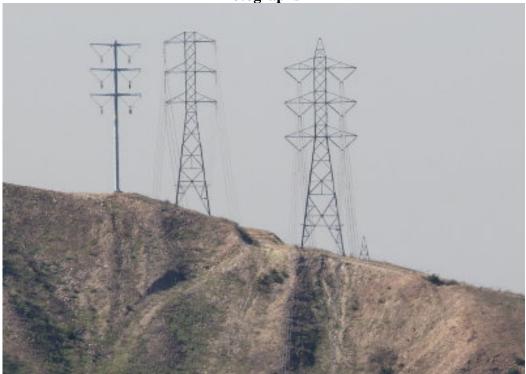
**Figure 1** – The newly erected pole with the top installed can be seen on the left side of the photograph (taken looking west from Summit Road yard).

A crew worked to place the tops on the tower bases that had previously been erected (see Figure 1). The work was delayed on November 2 due to mechanical problems with the crane working east of Santee Lakes. Crews continued to work out of the Summit Road yard with no complaints received from the local residents (see Figure 2).

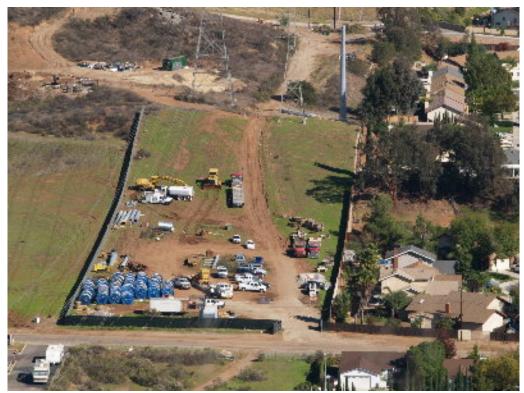
Figure 2 – Overview of the Summit Road yard looking east.

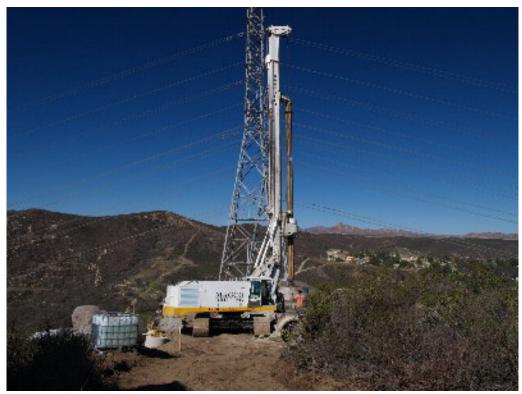
**Figure 3** – The drilling crew continued working at Tower Site 1300.

A drilling crew continued work on the hard bedrock at Site 1300 (see Figure 3). Several different drilling machines and crews have worked on the exceptionally hard material at this site.

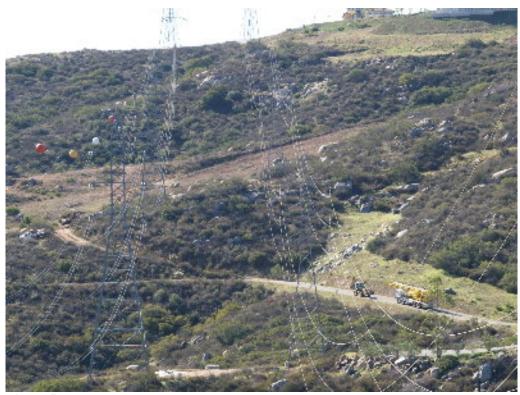
A drilling machine attempted to access sites west of Tower Site 661, but could not make it up the road due to damage and moisture from the past week's rainfall (see Figure 5). The crew will move the drilling machine to an alternate location and continue work until the access road can be repaired.

**Figure 5** – Moisture and erosion made access for large equipment impossible in some areas.

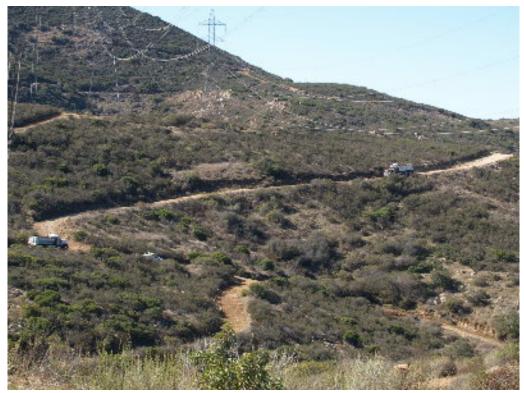
The grading crew attempted to access Tower Site 181, but encountered a section of very soft material and one of the dump trucks became stuck. The excavator was brought down to free the truck, but work did not resume. The access road will be repaired to allow easier wheeled-vehicle access (see Figure 6).

**Figure 6** – Moisture and erosion made access for trucks impossible in some areas.

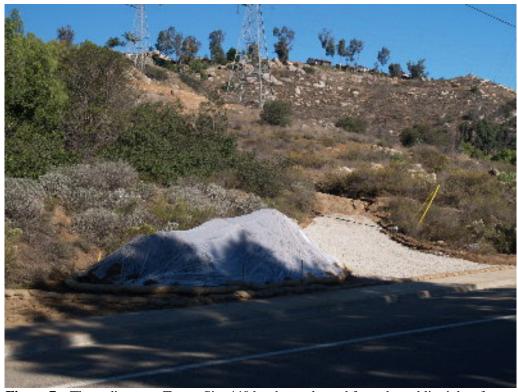
The CPUC EM noted that the contractor has used the time between the storms to address many of the SWPPP issues from the previous weeks. Many of the water bars have been removed, but the access roads are passable. The waters bars on the steep access road to Tower Site 440 were completely washed away, resulting in sediment on the public road and into the adjacent storm drain. Crews cleaned the sediment from the public road at this location and placed rock to control tracking of mud onto the street (see Figure 7).

**Figure 7** – The sediment at Tower Site 440 has been cleaned from the public right-of-way and the spoil pile stabilized.
