PROJECT MEMORANDUM SDG&E – MIGUEL-MISSION 230 KV #2 PROJECT

Subject: Weekly Report #36: April 3 – April 9, 2005.

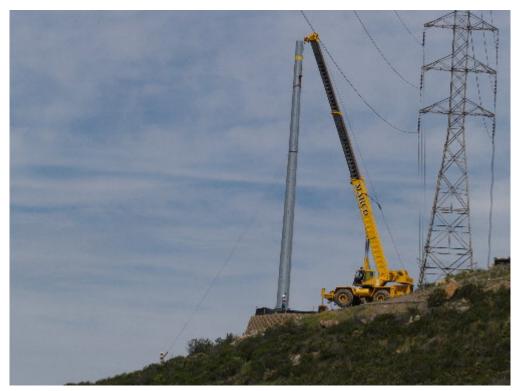
Figure 1 – PAR worked to raise the steel pole sections at Pole Site 181.

- 2. The PAR crew worked to set the two sections of the steel pole at Site 181 during the site visit (see Figure 1). The upper section was prepared on the ground and then raised into position.

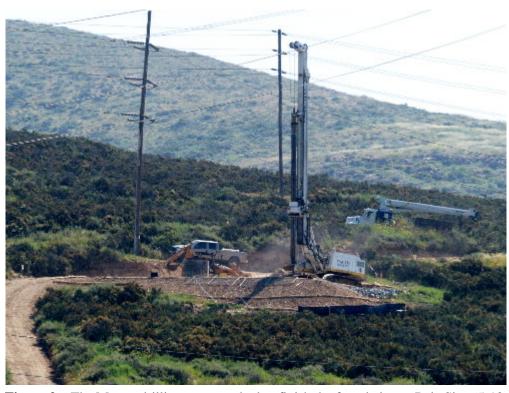
Figure 2 – The Magco drilling crew worked to finish the foundation at Pole Site 65-10.

- 3. The Magco drilling crew near the Miguel Substation continued work at Pole Site 65-10 during the subject week. The excavation was within a foot of the final depth at the time of the site visit and the concrete form crew was preparing the forms for the site (see Figure 2). The Essex EI was on-site watching for any sensitive birds in the adjacent coastal sage scrub habitat. No California gnatcatchers were observed foraging in the area during the site visit; however, raptors are often observed in the area (see Figure 3). The foundation has been poured at Pole Site 65-40 and the area stabilized.

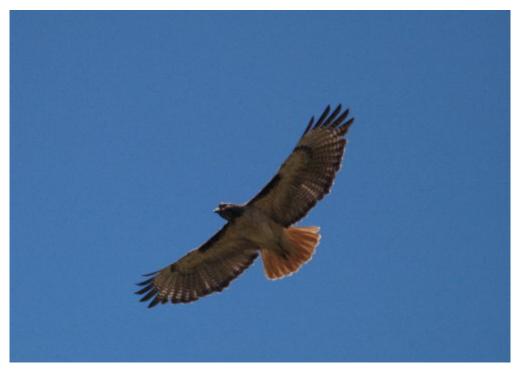
Figure 3 – Raptors are routinely observed in the Miguel Substation area.

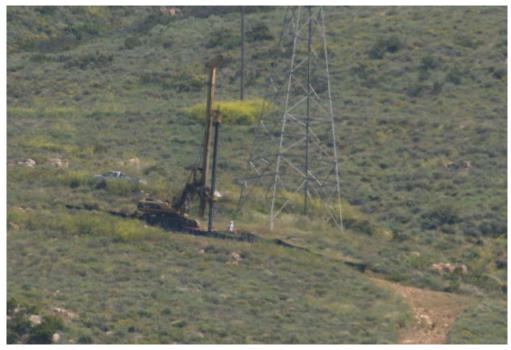
Figure 4 – The Woodward drilling crew worked at Pole Site 30 to complete the final 138 kV foundation excavation on the project.

- 4. The Woodward crew continued drilling in the hard rock at Pole Site 30 during the subject week (see Figure 4). The crew used a rock-hammer to assist in breaking up the material in between drilling. This foundation is the final 138 kV excavation and the drilling contractors have started to demobilize from the project.

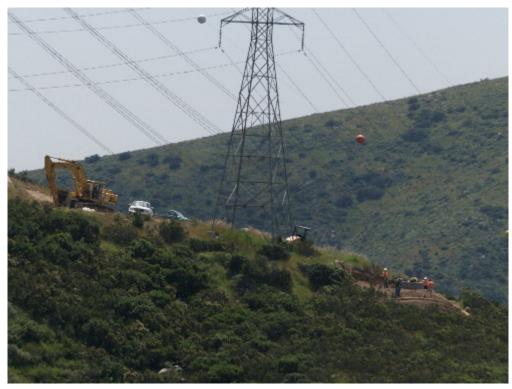
Figure 5 – The PAR grading crew worked with the Testing Engineers inspector at Pole Site 161 to repair the pad.

- 5. A PAR grading crew worked with the Testing Engineers inspector to expand work pads for the transmission line crew stringing work. Work was observed at Pole Site 161 where the crew repaired damage from the drilling and foundation pouring activities and pulled loose material from the slopes under the pad site (see Figure 5).

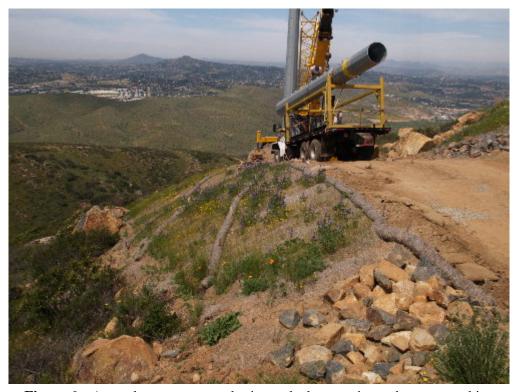
Figure 6 – Areas that were restored prior to the heavy rains and recent sunshine have started to revegetate.

1. Several sites that were restored earlier in the project are now starting to get new vegetation (see Figure 6). Depending on the schedule for restoration of the rest of the disturbed sites, revegetation may have to wait until the next growing season for the plants to get established prior to the dry, hot summer.
