PROJECT MEMORANDUM PG&E NORTHEAST SAN JOSE TRANSMISSION REINFORCEMENT PROJECT

Subject: Weekly Report #42: March 10, 2003 – March 16, 2003

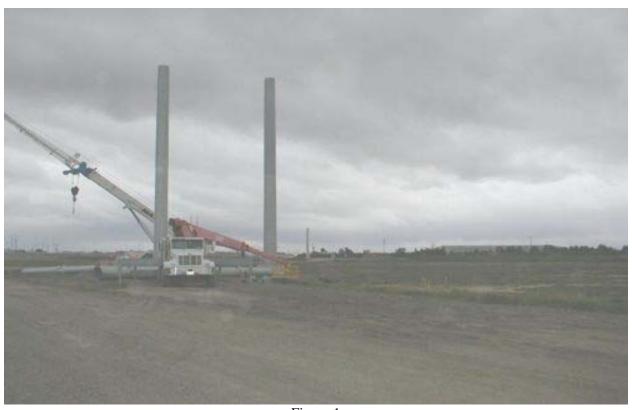
Figure 1
Poles #12 (a) and (b) on the King & Lyon's Property
March 13, 2003

At the King & Lyon's property, crews had partially erected pole #13 today and then moved on to poles #12(a) and (b) that were also partially erected (see Figure 1). High winds caused crews to quit early today. The CPUC EM noted that equipment and vehicles were being kept within the project right-of-way.

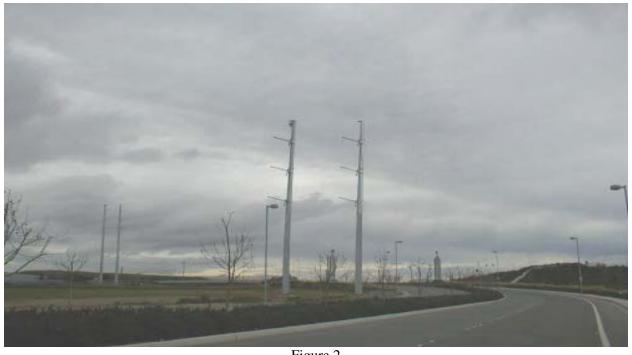
Figure 2
Poles #15(L) and (R) in foreground & Poles #14(L) and (R) in background to the left March 13, 2003

Along McCarthy Boulevard, a chain link fence had blown over around poles #14(a) and (b). The CPUC EM informed the Essex Environmental Inspector (EI) of the situation. Poles #15(a) and (b) were both erected with the arms attached (see Figure 2). Pole #16 was fully erected with the arms and temporary travelers attached. Pole #17(R) was fully erected, but pole #17(L) is still only partially erected due to the steel pole flaw (see Figure 3).

On March 13, the CPUC EM noted that a chain link fence had been blown over around poles #14(L) and (R) along McCarthy Boulevard. The CPUC EM informed the Essex EI about the situation and he was going to notify construction management. The CPUC EM observed that all other sites were in compliance with the mitigation measures adopted in the EIR and other permitting documents.

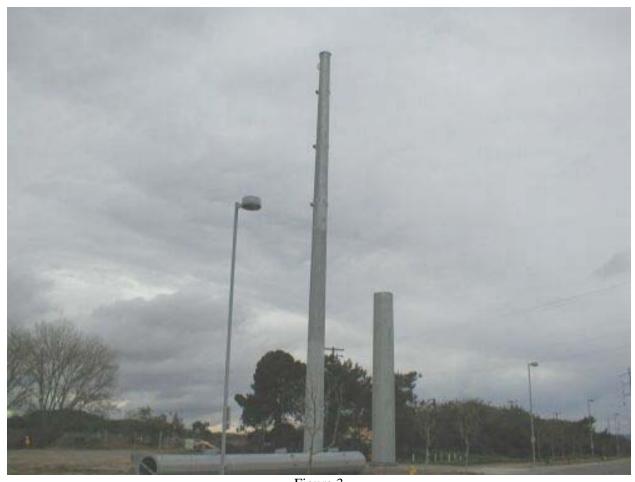
Figure 3
Poles #17(L) and (R)
March 13, 2003

The CPUC EM conducted a site visit of pole area #17(L) and (R) along McCarthy Boulevard where a crew was working on erecting both poles. However, there was a manufacturer's problem with the left pole and it was not fitting correctly. Crews finished erecting #15(L) and (R) earlier today and have now moved on to pole #16. At the south end of Fremont Boulevard, crews were working on installing cables/circuits from the underground segment onto pole #10 (L). They have one more cable/circuit installation to complete on pole #10 (L) and then they will move to the right pole. Crews were staying within the project right-of-way and the area was neat and clean.
