**GEOTECHNICAL SITING STUDY**

**SAN DIEGO GAS & ELECTRIC**  
**PROPOSED OCEAN RANCH SUBSTATION**  
**PACIFIC COAST BUSINESS PARK – PARCELS 7, 16 AND 17**  
**OCEANSIDE, CALIFORNIA**

**June 26, 2012**

**GEOTECHNICAL STUDY  
SDG&E OCEAN RANCH  
SUBSTATION  
PACIFIC COAST BUSINESS PARK  
OCEANSIDE, CALIFORNIA  
20154777.001A**

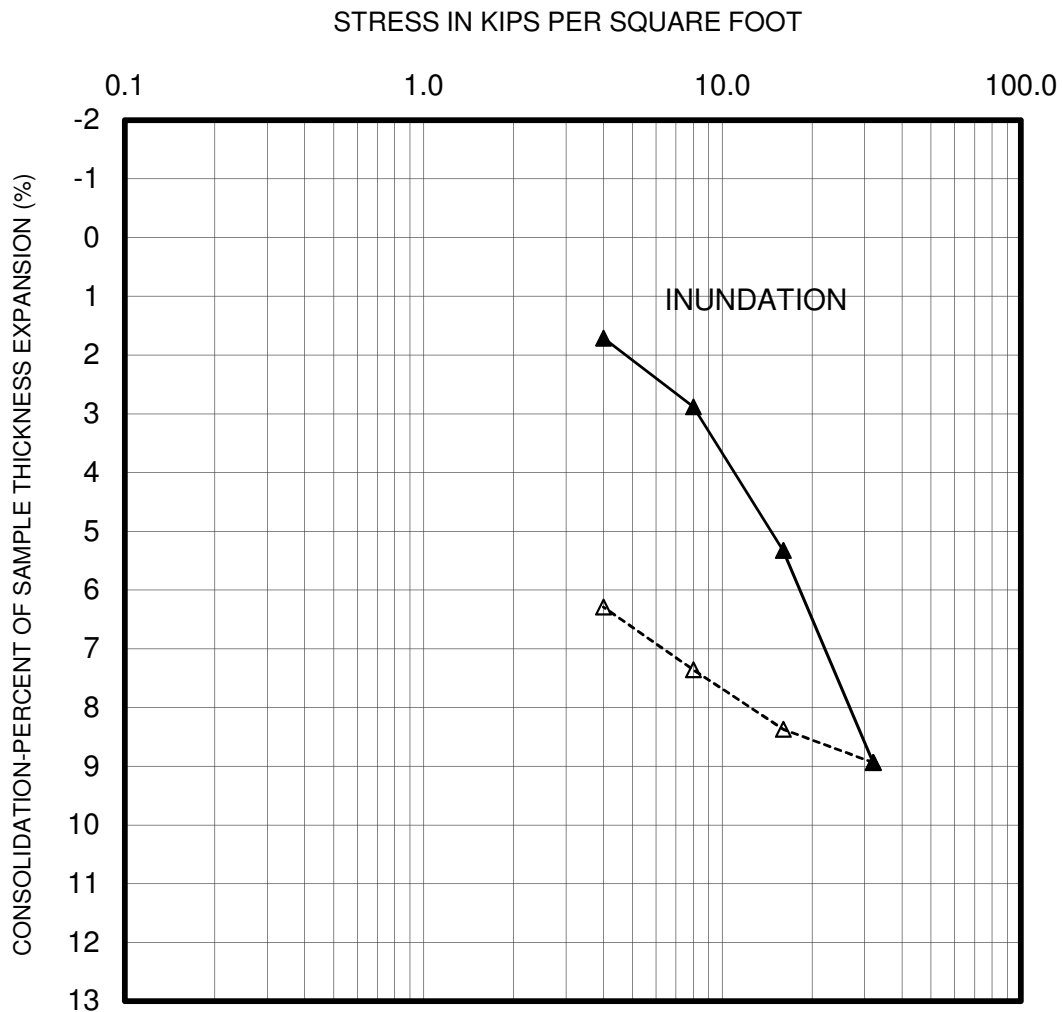
Two consolidation tests were performed on soils samples of the alluvium / colluvium to aid in evaluating the compressibility of the soils when subjected to new loads. The tests were performed in general accordance with ASTM Test Method D 2435. The results of the test are presented on Plates B1 and B2.

- Seating Cycle
- Loading Prior to Inundation
- ▲— Loading After Inundation
- △-- Rebound Cycle

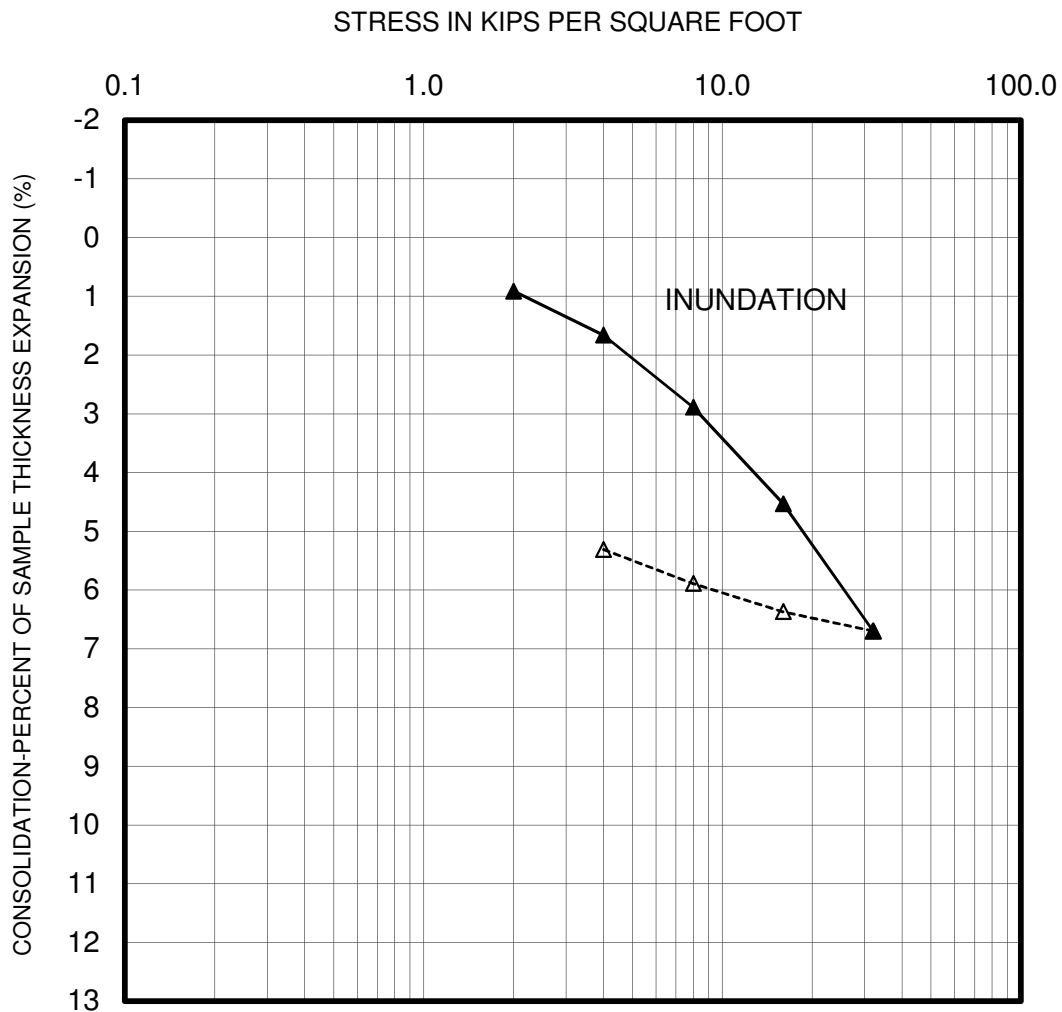
- Seating Cycle
- Loading Prior to Inundation
- ▲— Loading After Inundation
- △-- Rebound Cycle

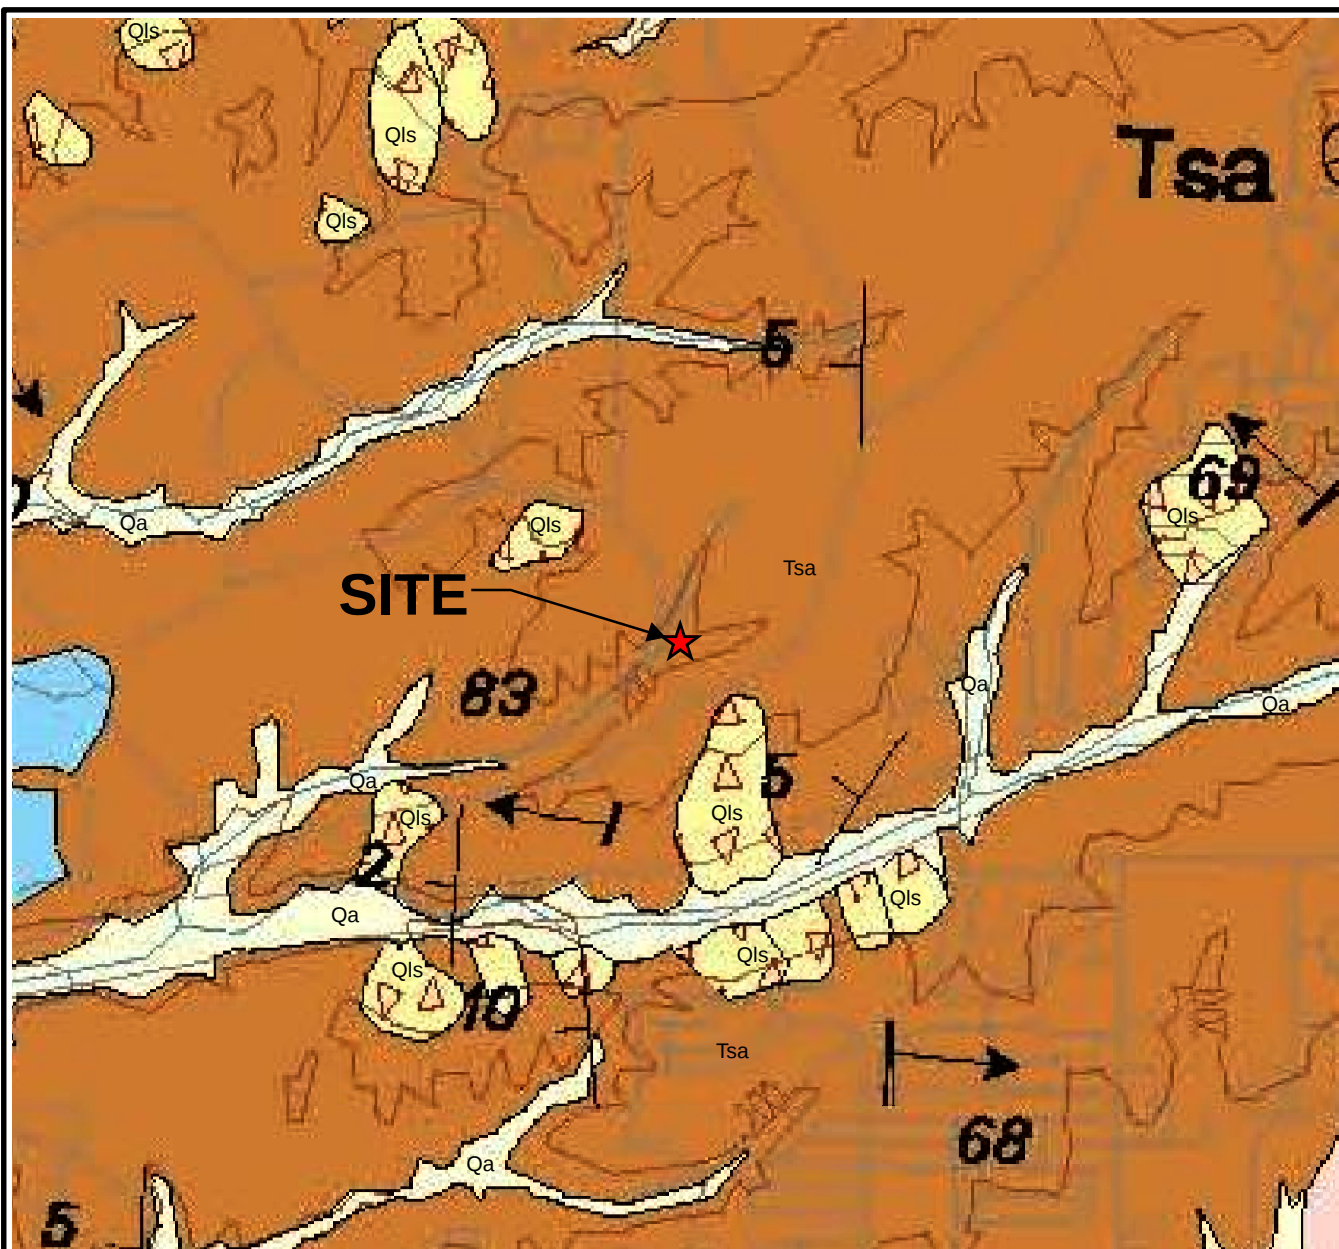
SOURCE:  
GEOLOGY OF THE OCEANSIDE 30' X 60'  
QUADRANGLE, CALIFORNIA BY  
M. P. KENNEDY AND S. S. TAN, 2005

Our geologic evaluation consisted of reviewing aerial photographs, geologic reports and maps reasonably available to our office, previous geotechnical and as-graded reports provided by SDG&E, and observation of the geotechnical conditions in the field at the time of our field reconnaissance and subsurface investigation. The geology of the site area is shown Regional Geologic Map, Plate 3.

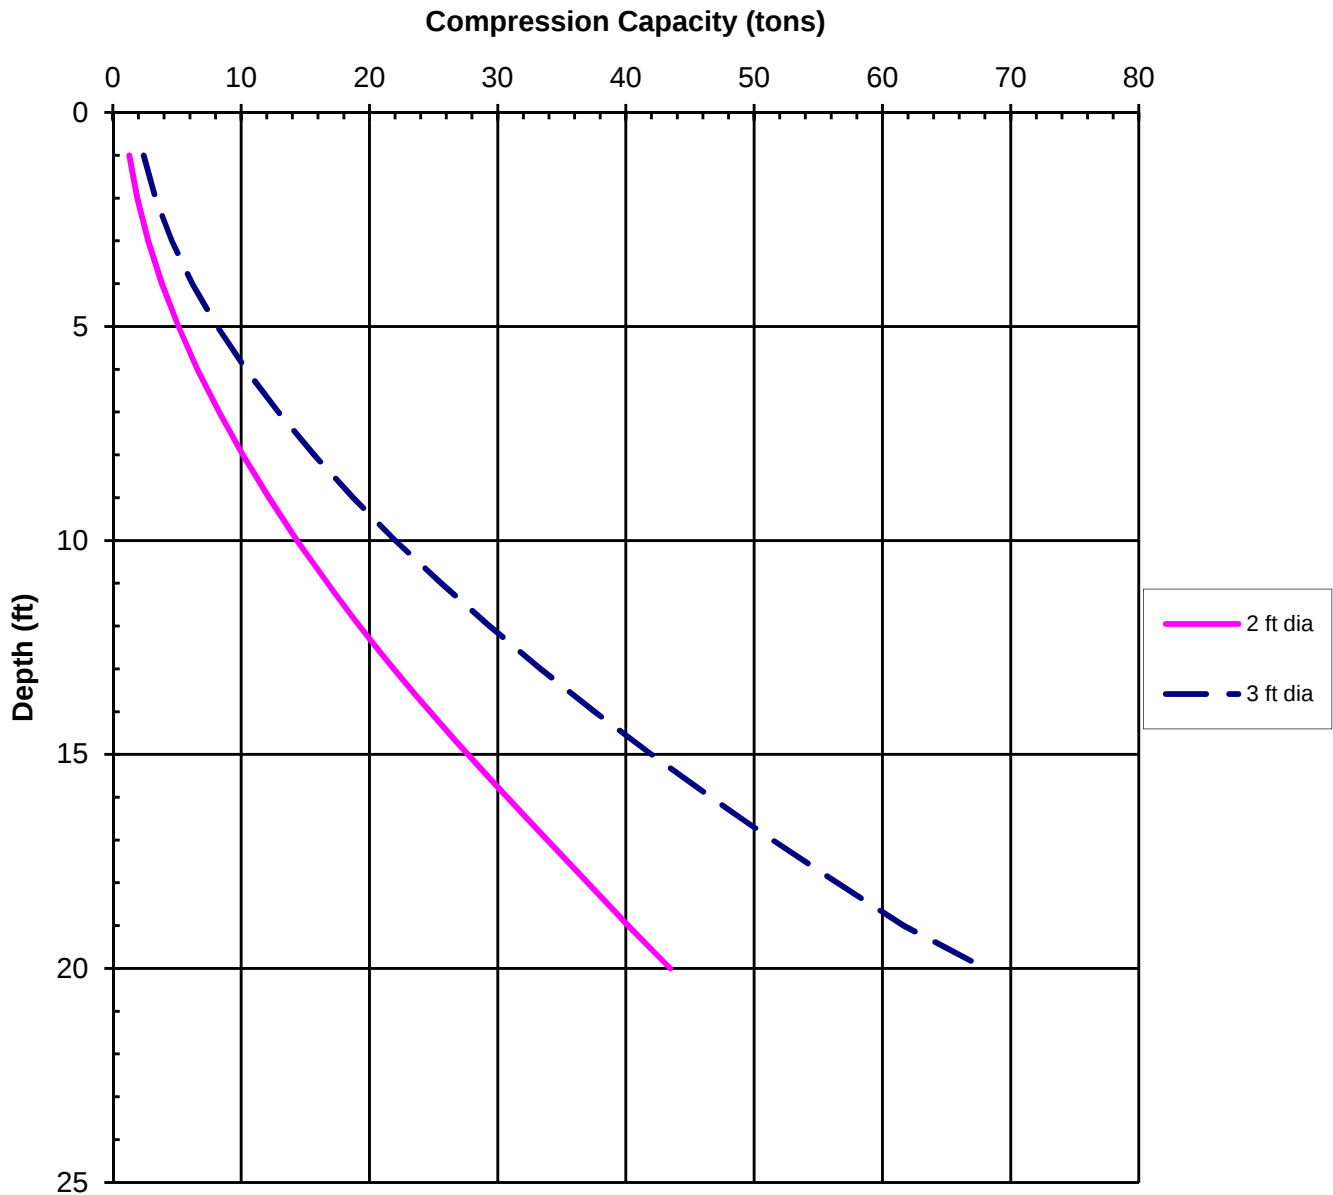
## Allowable Axial Capacity Curves For Drilled Piers Southern Area of Site

These results are based on the following assumptions and conditions. Piles with conditions different from those assumed should be re-evaluated by Kleinfelder.

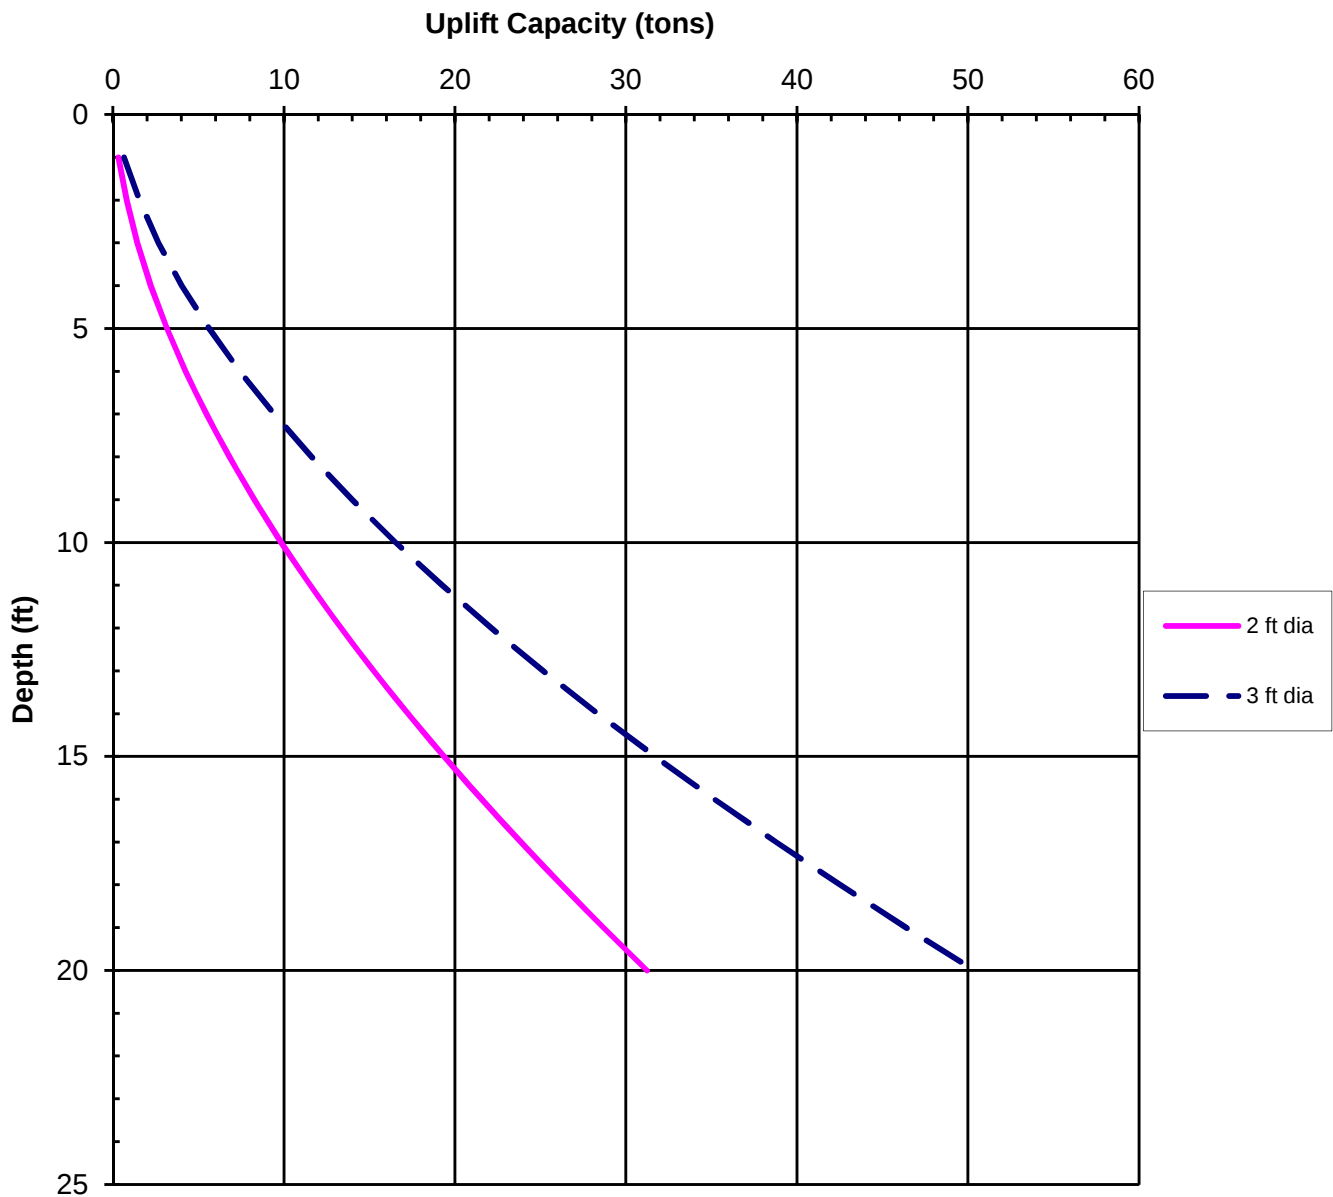
## Allowable Axial Capacity Curves For Drilled Piers Southern Area of Site

These results are based on the following assumptions and conditions. Piles with conditions different from those assumed should be re-evaluated by Kleinfelder.

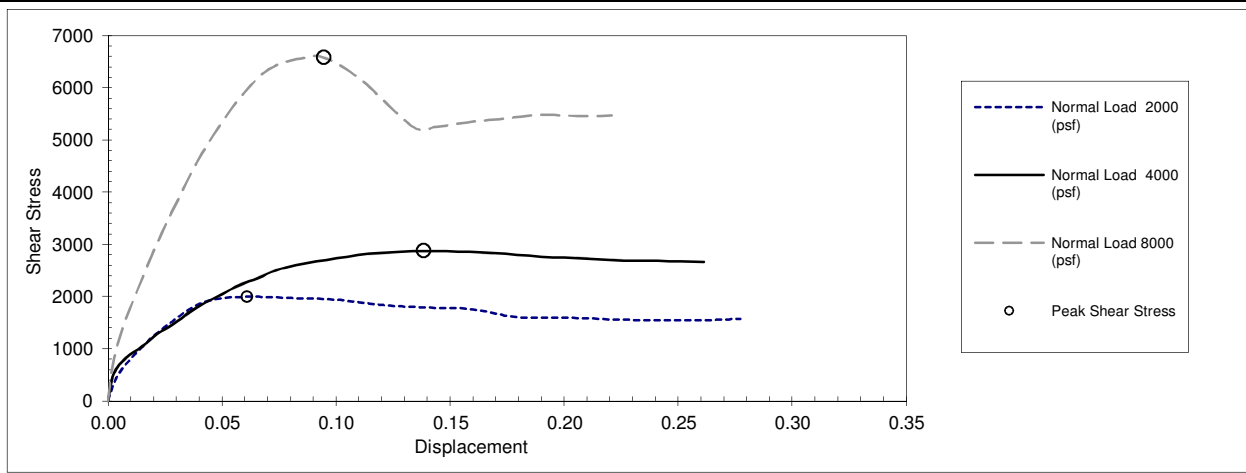
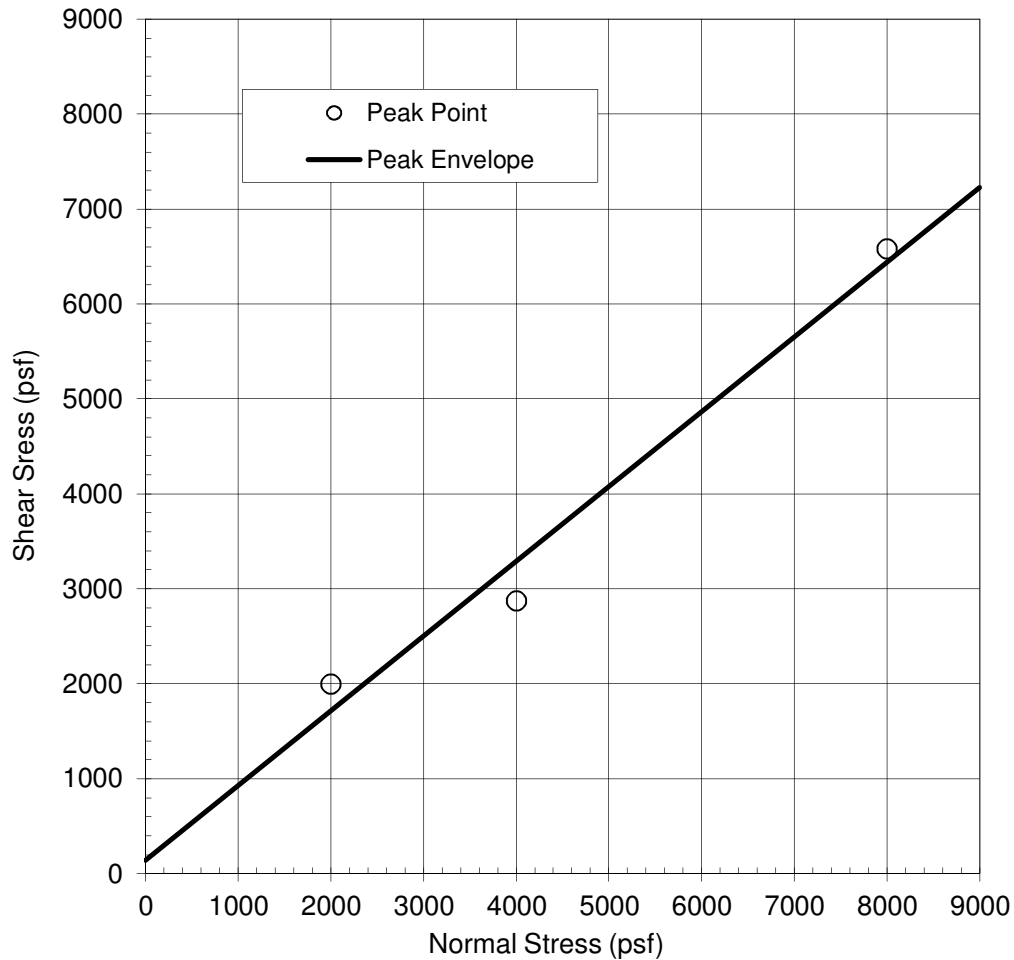
Strain Rate = 0.0118 inch/min

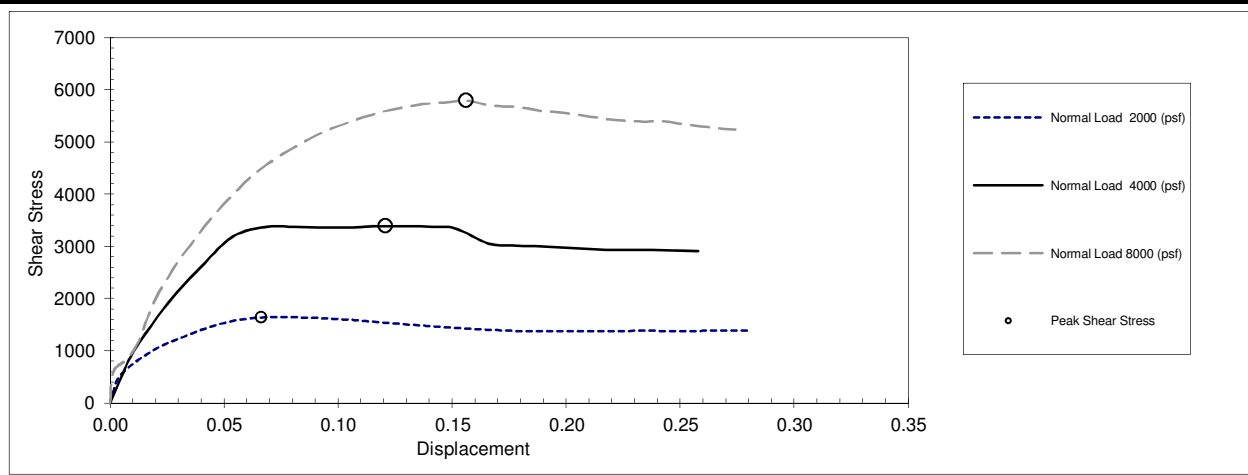
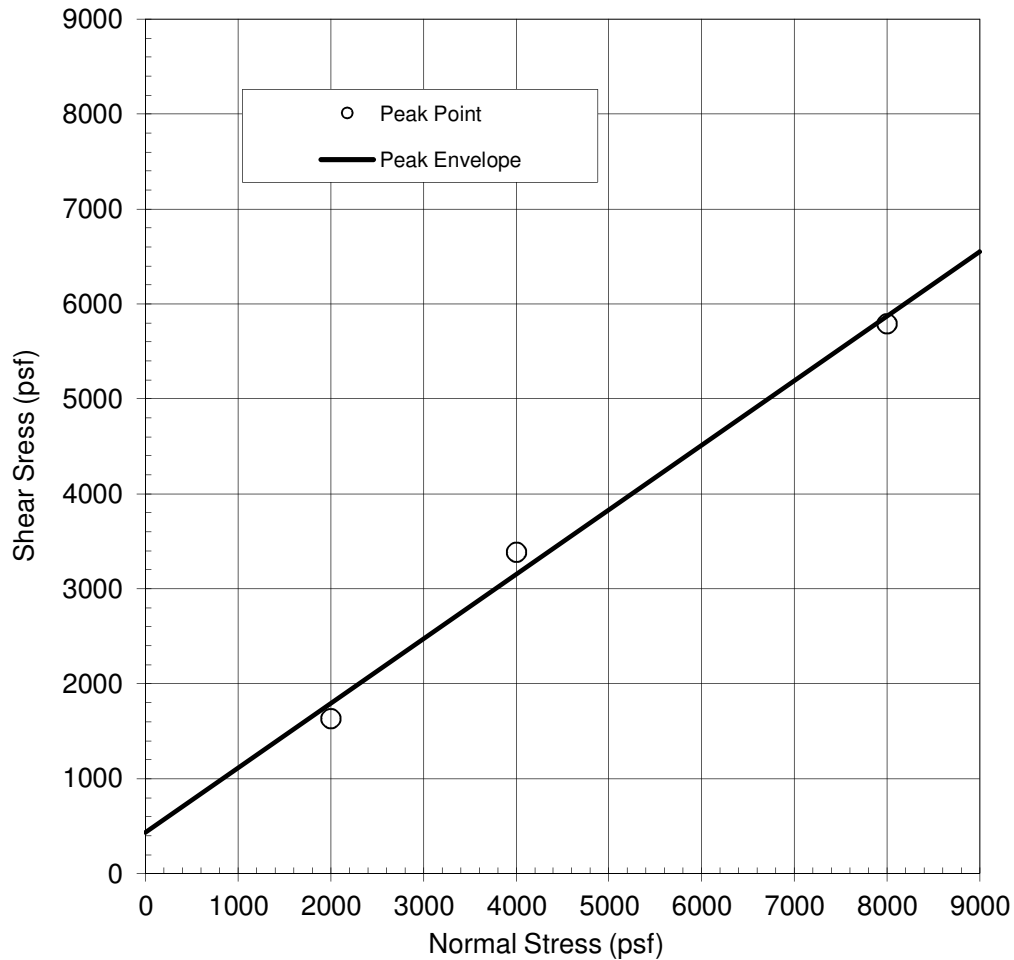
Strain Rate = 0.0118 inch/min

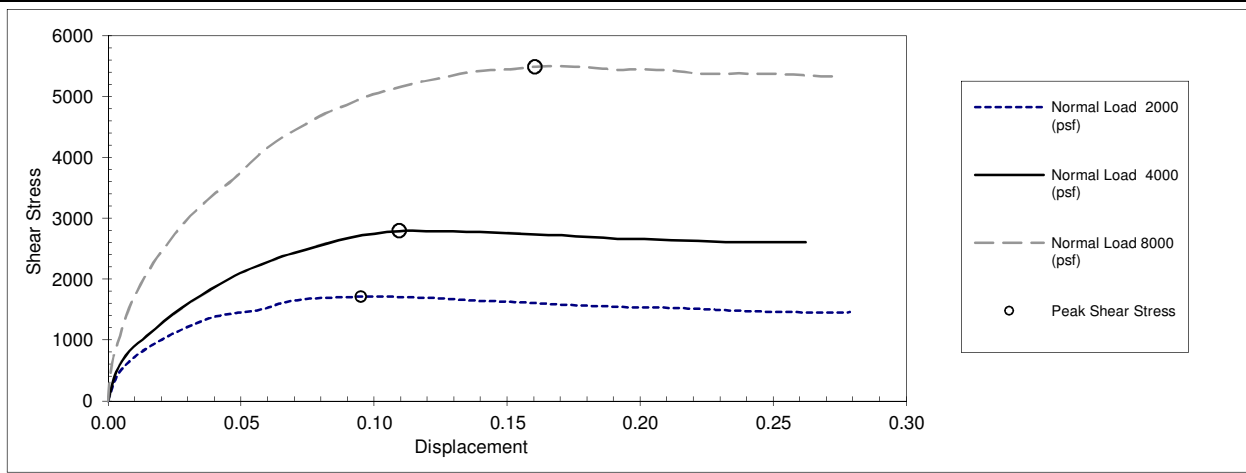
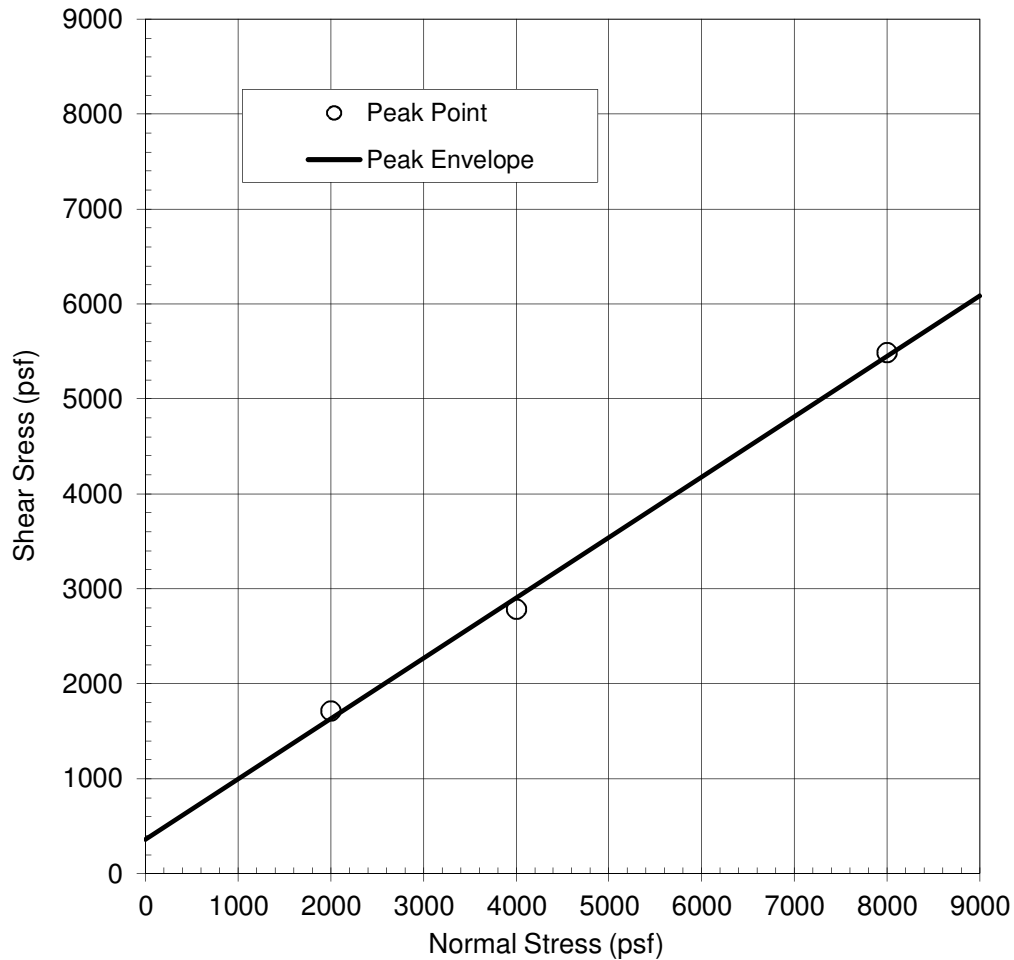
Strain Rate = 0.0118 inch/min

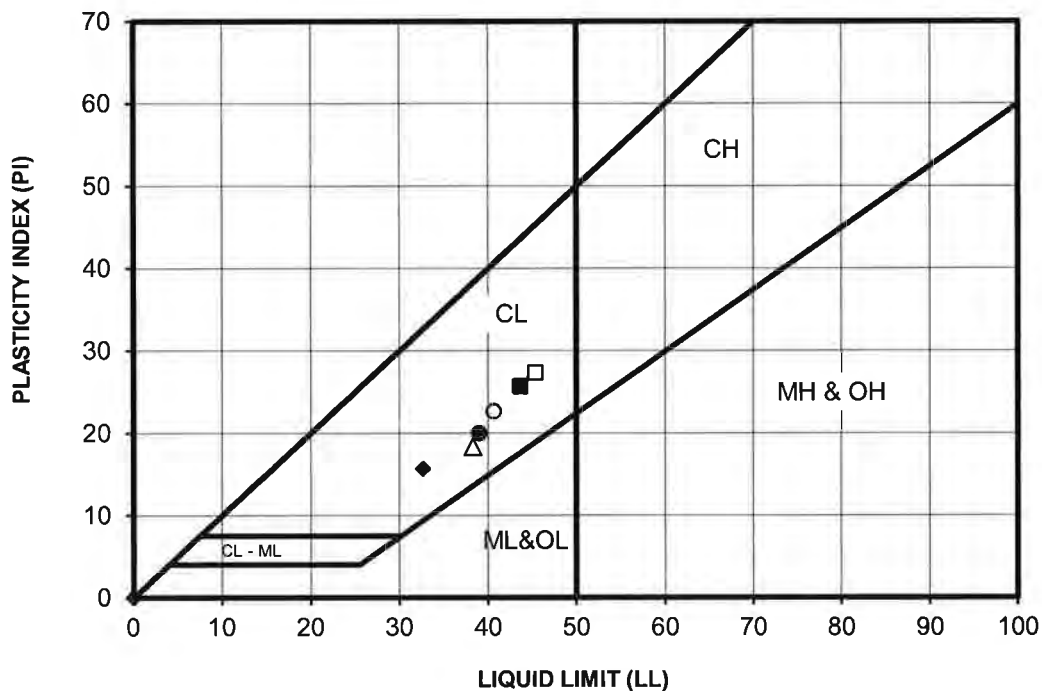
PERFORMED IN GENERAL ACCORDANCE WITH ASTM D 4318
