<p>Site Location Environmentally Superior Southern Route Sunrise Powerlink San Diego and Imperial Counties, California</p>	
<p>Geosyntec

Features of Interest MP-0 to MP-17
Yuha Desert Region 1
 Environmentally Superior Southern Route
 Sunrise Powerlink

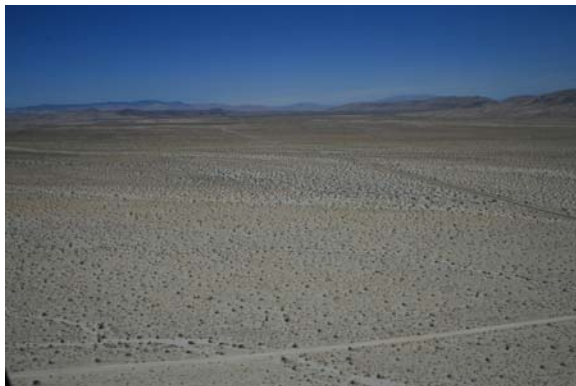
Geosyntec Site ID	1
Mile Post:	MP 7
Sempra Segment:	2
EDR Map ID	-
EDR Focus Map	-
EDR Listing ID:	-
Site Name:	Camp Seeley Ordinance Training Center
Site Address:	Sections 21, 22, 27, & 28 Township 16 S, Range 11 E
APN:	15101031, 15101032, & 05101033
REC:	SREC
Comments:	The Action Area passes through a portion of the former Camp Seeley Ordinance Training Center controlled by the US Army from 1941 to 1947. In 1997, an investigation discovered 10 "ammunition storage holes" near the Action Area. Reportedly, desert conditions may have concealed additional unexploded ordinances in the area. The approximate limits of the former Camp Seeley are delineated on Figure 2. An existing transmission line is present south of the Action Area (closer to the former Camp Seeley), and issues related to the construction of the existing line with respect to former Camp Seeley was not reported to Geosyntec. Furthermore, no physical evidence of a material threat was identified. Based on the identified information, it appears that the former Camp Seeley Ordinance Training Center may present a low to medium potential to adversely affect construction. It is recommended that construction personnel are notified and trained on safety procedures for working in areas with a potential to contain unexploded ordinances.

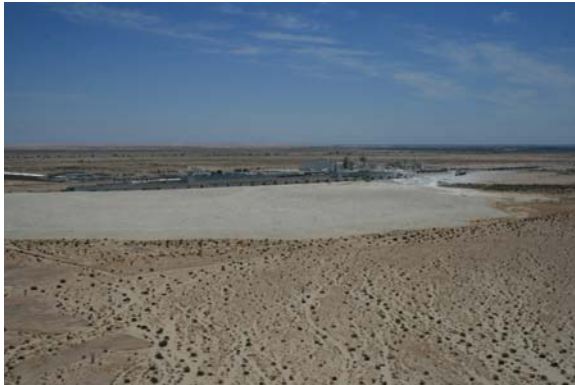
Geosyntec Site ID	2
Mile Post:	MP 10
Sempra Segment:	2
EDR Map ID	-
EDR Focus Map	-
EDR Listing ID:	-
Site Name:	US Gypsum Co. Factory
Site Address:	3810 W. Highway 80, Plaster City, CA 92243
APN:	03436091
REC:	SREC
Comments:	Nearby gypsum factory may use hazardous materials. Disturbed soil extends into Action Area 1/4-mile buffer area. Based on historical aerials, the area of observed disturbed soil may be a former gypsum waste pile area. However, no proposed tower locations are plotted in the area of disturbed soil. Based on the identified information and the proximity of the site to the Action Area and proposed tower locations, the potential for the site to adversely affect construction appears low.

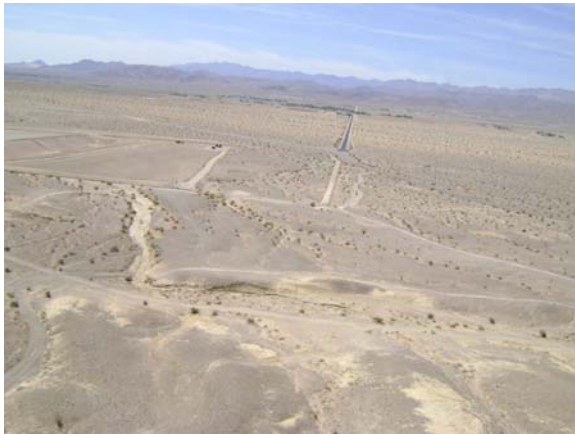
Geosyntec Site ID	3
Mile Post:	MP 18
Sempra Segment:	2
EDR Map ID	71
EDR Focus Map	32
EDR Listing ID:	S102360220, S105964516
Site Name:	Ocotillo Solid Waste Site and Transfer Station
Site Address:	Shell Canyon, 3 Miles Northwest of Ocotillo
APN:	03322023
REC:	SREC
Comments:	Solid waste disposal site for C&DD and mixed municipal waste, closed in 2004. No significant impacts to groundwater reported. Limited volume transfer operation for C&DD and mixed municipal waste also located at this site. Based on the proximity to the site, the potential for impacts from the landfill to adversely affect construction appears low.

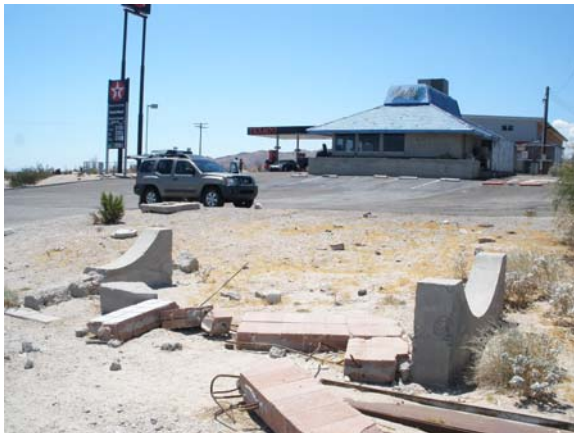
Geosyntec Site ID	4
Mile Post:	MP 21
Sempra Segment:	3
EDR Map ID	-
EDR Focus Map	-
EDR Listing ID:	-
Site Name:	Disturbed soil
Site Address:	Unknown
APN:	03357105
REC:	SREC
Comments:	Disturbed soil may be related to former industrial use of the property. A concrete cradle possibly for an AST was observed among other concrete debris. However, based on the proposed use of the site, it appears that the potential for the site to adversely affect construction is low.

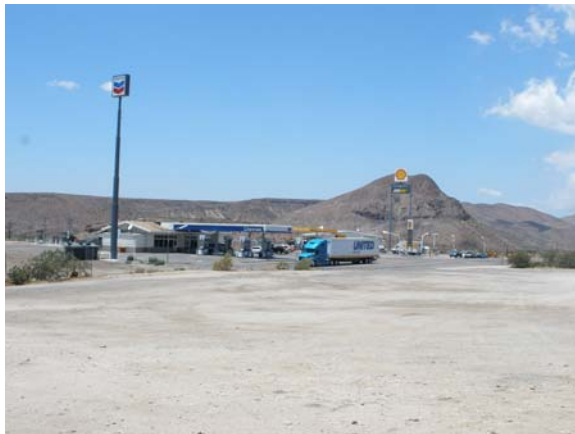
Geosyntec Site ID	9
Mile Post:	MP 33
Sempra Segment:	5
EDR Map ID	87
EDR Focus Map	76
EDR Listing ID:	S105024248, S106152929, S106152927, S106152928
Site Name:	Jacumba Texaco
Site Address:	1451 Carrizo Gorge Road, Jacumba, CA
APN:	66101028
REC:	REC
Comments:	Gasoline LUST cleanup case open as of 2003 affecting groundwater. Waste oil LUST soils only cleanup completed in 1993 and case closed. Gasoline cleanup for tank failing integrity test closed in 1990. Reportedly, a benzene plume extends offsite beneath Carrizo Gorge Road within the 1/4 mile buffer zone of the corridor. However, groundwater is reportedly greater than 70 feet below ground surface and flows to the northeast away from the Action Area; therefore, potential for the site to adversely affect the proposed construction of tower pilings appears low.

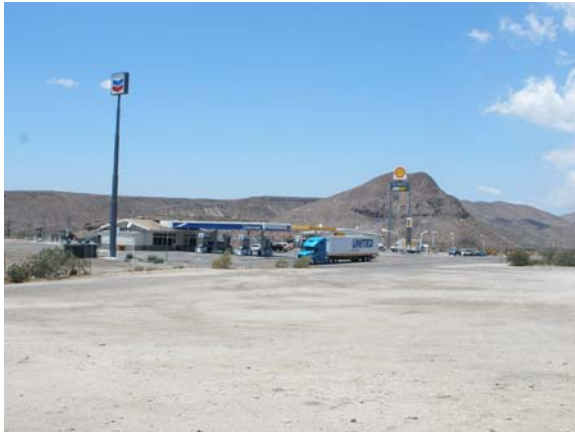
Geosyntec Site ID	10
Mile Post:	MP 33
Sempra Segment:	5
EDR Map ID	87
EDR Focus Map	76
EDR Listing ID:	S104745640, S106060318, U003789082
Site Name:	Woodward Shell/Jacumba Shell
Site Address:	1494 Carrizo Gorge Road, Jacumba, CA
APN:	66101028
REC:	HREC
Comments:	Case closed: LUST affecting aquifer with cleanup completed as of 1999. Nine USTs listed: 6 unleaded gasoline, one diesel, and two of unknown contents. Based on the proximity to the Action Area and the nature of the site, the potential for the site to adversely affect construction appears low.

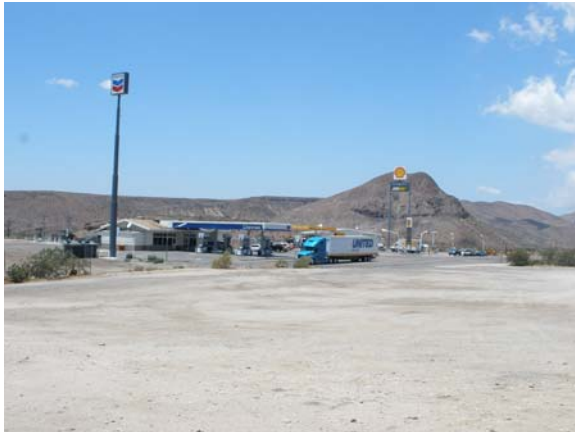
Geosyntec Site ID	10
Mile Post:	MP 33
Sempra Segment:	5
EDR Map ID	87
EDR Focus Map	76
EDR Listing ID:	S104745640, S106060318, U003789082
Site Name:	Woodward Shell/Jacumba Shell
Site Address:	1494 Carrizo Gorge Road, Jacumba, CA
APN:	66101028
REC:	HREC
Comments:	Case closed: LUST affecting aquifer with cleanup completed as of 1999. Nine USTs listed: 6 unleaded gasoline, one diesel, and two of unknown contents. Based on the proximity to the Action Area and the nature of the site, the potential for the site to adversely affect construction appears low.

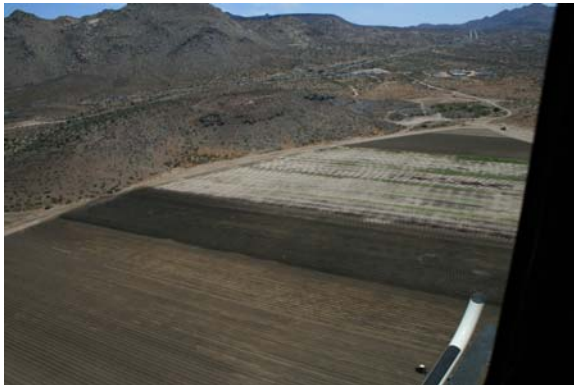
Geosyntec Site ID	11
Mile Post:	MP 34
Sempra Segment:	5
EDR Map ID	-
EDR Focus Map	-
EDR Listing ID:	-
Site Name:	Jacumba Airport - Disturbed soil
Site Address:	Unknown
APN:	66106024
REC:	SREC
Comments:	<p>Disturbed soil is adjoining an airfield. The US Navy apparently constructed the airstrip in 1941 for emergency landings. The only reported improvements include the airstrip and a windsock. The land was conveyed to SD Co. in 1953. Although airstrips are sometimes associated with fueling activities, no indications of current or former fueling at the site were identified in file review, review of available historical aerials, or reconnaissance. Currently the site is used by private single engine and glider planes. Based on the available information, and the proposed use of the site as a storage yard, it appears that the site's potential to adversely affect construction is low.</p>

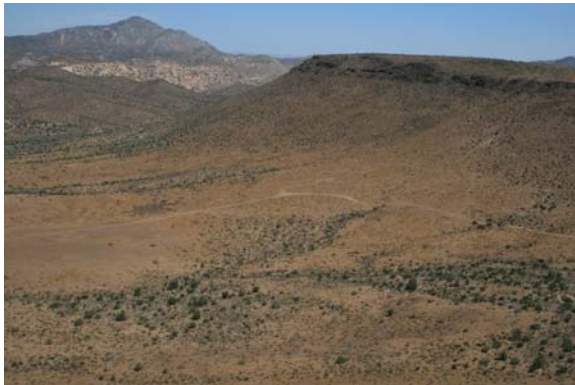
Image:

Geosyntec Site ID	16
Mile Post:	MP 35
Sempra Segment:	5
EDR Map ID	-
EDR Focus Map	-
EDR Listing ID:	-
Site Name:	Agricultural field
Site Address:	Unknown
APN:	66001001
REC:	None
Comments:	Yard appears to be developed with an access road traversing the site and may have been historically used as pasture land. Based on reviewed historical aerials from 1980, 2005, and 2008, it does not appear that the site was actively cultivated. Furthermore, it does not appear that soil testing per the CPUC Mitigation Measures would be required .

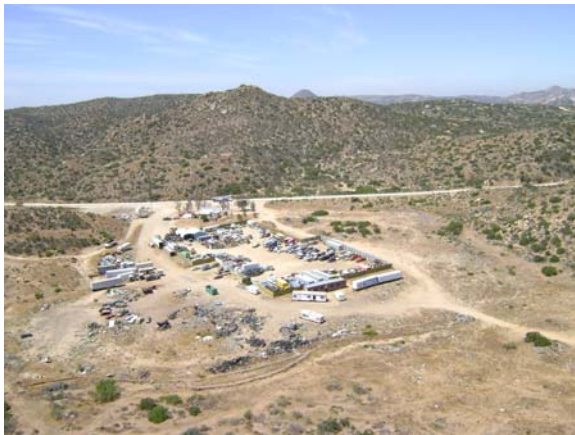
Image:

Geosyntec Site ID	18
Mile Post:	MP 37
Sempra Segment:	5
EDR Map ID	-
EDR Focus Map	-
EDR Listing ID:	-
Site Name:	Junk Yard - Holes Property
Site Address:	Unknown
APN:	61308040
REC:	SREC
Comments:	Junk yard is located on an unpaved surface. Disabled vehicles may have leaked petroleum hydrocarbons to shallow soil. Proposed construction in the vicinity of this site includes towers on the ridgeline north of the site and a new access road beginning in previously undisturbed land north of the site. Potential impacts from the site would likely be limited to low-lying areas; therefore, the potential to adversely affect proposed construction of pads, towers, and access roads on topographically elevated areas appears low.

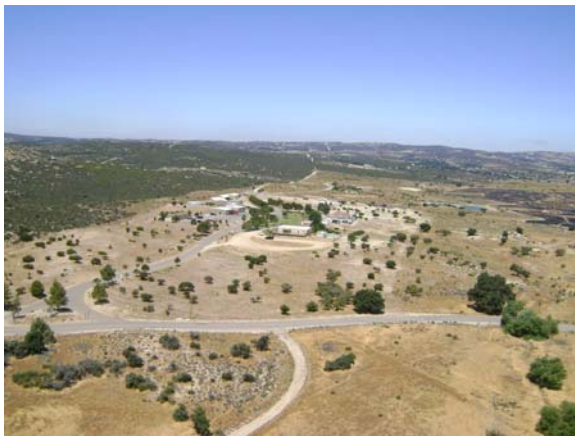
Image:

Geosyntec Site ID	22
Mile Post:	MP 41
Sempra Segment:	6
EDR Map ID	79
EDR Focus Map	59
EDR Listing ID:	1001217488, S103646867, S103866564, 1007739453
Site Name:	McCain Valley Conservation Camp/State of CA Department of F
Site Address:	2550 McCain Valley Road, Boulevard, CA 91905
APN:	61110006
REC:	REC
Comments:	Site assessment underway for LUST with potential aquifer impacts and case open as of 1999. One diesel 2,200-gal AST. Two USTs at site: one 550-gal leaded and one 1000-gal "other." RCRA-SQG handling PCE with notices of violation. Monitoring wells are located west of the corridor and groundwater reportedly flows to the north. Domestic sewage treatment facility is rated as a moderate threat to water quality and complexity category B. Groundwater depth is reportedly approximately 15 feet below ground surface. Due to the reported depth to groundwater and the distance from the nearest proposed access road and tower location (approximately 1/2-mile), the potential for the site to adversely affect construction appears low.

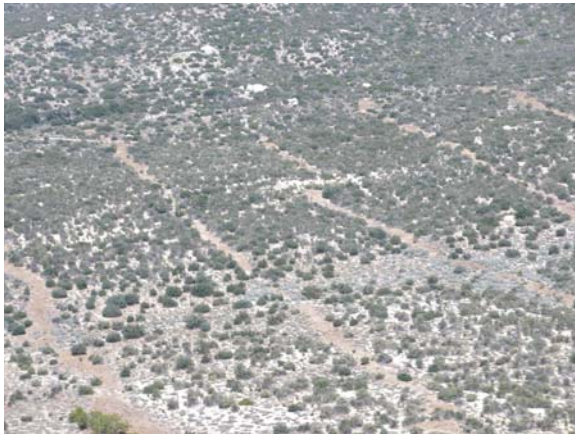
Image:

Geosyntec Site ID	24
Mile Post:	MP 49
Sempra Segment:	6
EDR Map ID	-
EDR Focus Map	-
EDR Listing ID:	-
Site Name:	Disturbed soil
Site Address:	Unknown
APN:	52823011
REC:	None
Comments:	Yard appears to be contain disturbed soil and suspicious berms. However, a plat map viewed on the BLM webpage indicated that the area is used as a fire break, which would not likely present a material threat to the environment. Therefore, the potential for the site to adversely affect construction appears low.

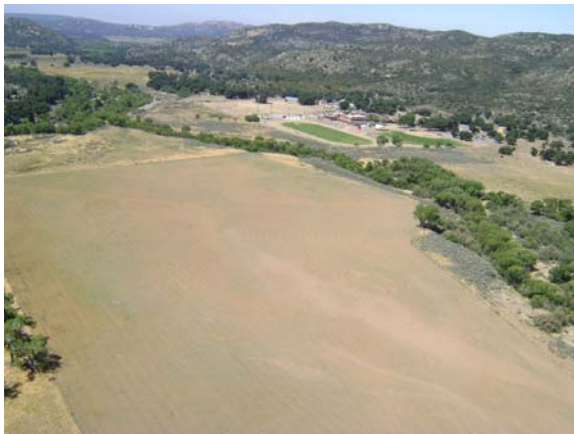
Image:

Geosyntec Site ID	34
Mile Post:	MP 61
Sempra Segment:	7
EDR Map ID	-
EDR Focus Map	-
EDR Listing ID:	-
Site Name:	Agricultural field
Site Address:	Unknown
APN:	52711005
REC:	SREC
Comments:	<p>Yard appears to be graded land adjacent to a stream on the west. Reviewed historic aerals from 1980, 2005, and 2008 do not positively indicate that the land has been historically cultivated. However, the land appears to be currently maintained free of native vegetation. Although no farming equipment was observed near the site, it may have been applied with pesticides or herbicides. Currently, Geosyntec is awaiting a response from the local Building Department regarding information about the site. However, the San Diego Assessors Office lists the property use as "field crops." Therefore, it appears that soil testing per the CPUC Mitigation Measures may be required. Furthermore, it appears that the potential for the site to adversely affect construction is low to medium.</p>

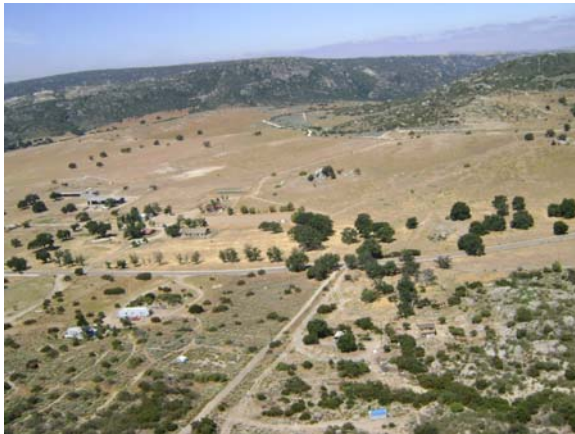
Image:

Geosyntec Site ID	41
Mile Post:	MP 67
Sempra Segment:	9
EDR Map ID	-
EDR Focus Map	-
EDR Listing ID:	-
Site Name:	Agricultural field
Site Address:	Unknown
APN:	60710029
REC:	None
Comments:	A cleared yard appears to be current or former pasture land. Reviewed historical aerials from 1980, 2005, and 2008 do not indicate that the land has been historically cultivated. It does not appear that soil testing per the CPUC Mitigation Measures would be required. Furthermore, it appears that the potential for the site to adversely affect construction is low.

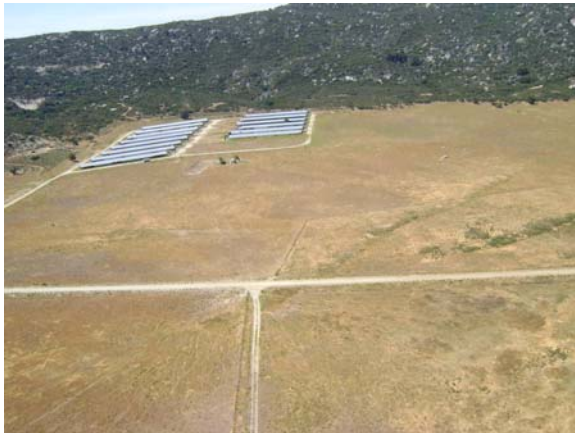
Image:

Geosyntec Site ID	42
Mile Post:	MP 73
Sempra Segment:	10
EDR Map ID	-
EDR Focus Map	-
EDR Listing ID:	-
Site Name:	Agricultural field
Site Address:	Unknown
APN:	60405001
REC:	None
Comments:	Structure, pad, and access road lies within a yard that appears to be current or former pasture land. Reviewed historical aerials from 1980, 2005, and 2008 do not indicate that the land has been historically cultivated. Therefore, it does not appear that soil testing per the CPUC Mitigation Measures would be required. Furthermore, it appears that the potential for the site to adversely affect construction is low.

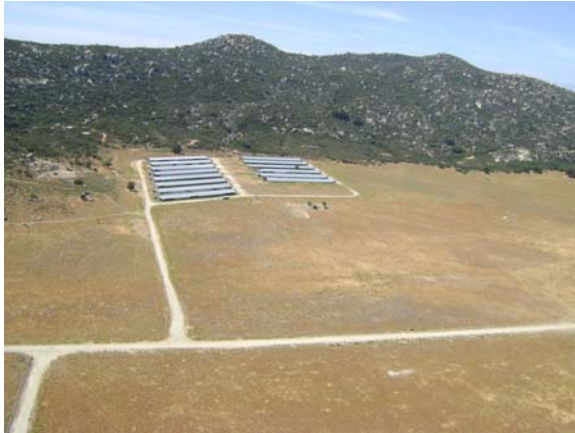
Image:

Geosyntec Site ID	43
Mile Post:	MP 74
Sempra Segment:	10
EDR Map ID	-
EDR Focus Map	-
EDR Listing ID:	-
Site Name:	Agricultural field
Site Address:	Unknown
APN:	60409001 & 60217002
REC:	None
Comments:	<p>The proposed yard appears to be current or former pasture land, egg farm, and/or cattle ranch. Based on historic aerials reviewed, it does not appear that the site was historically cultivated. Therefore, it does not appear that soil testing per the CPUC Mitigation Measures would be required. Furthermore, it appears that the potential for the site to adversely affect construction is low.</p>

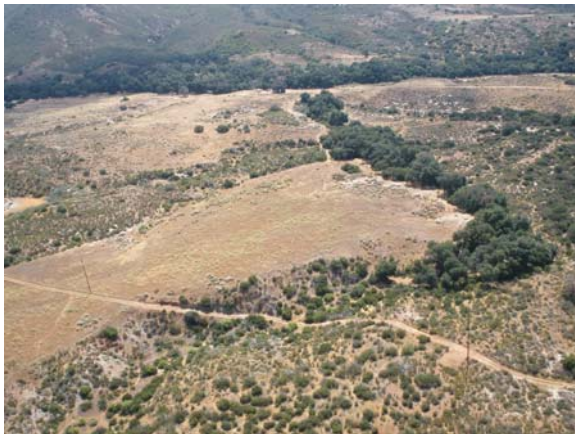
Image:

Geosyntec Site ID	44
Mile Post:	MP 82
Sempra Segment:	12
EDR Map ID	-
EDR Focus Map	-
EDR Listing ID:	-
Site Name:	Agricultural field
Site Address:	Unknown
APN:	60106001, 60107004, 60107003, & 60106003
REC:	None
Comments:	A cleared yard appears to be former pasture land, cleared prior to 1980. Reviewed historical aerials from 1971, 1980, 2005, and 2008 do not indicate that the land has been historically cultivated. The land is currently owned by the City of San Diego. It does not appear that soil testing per the CPUC Mitigation Measures would be required. Furthermore, it appears that the potential for the site to adversely affect construction is low.

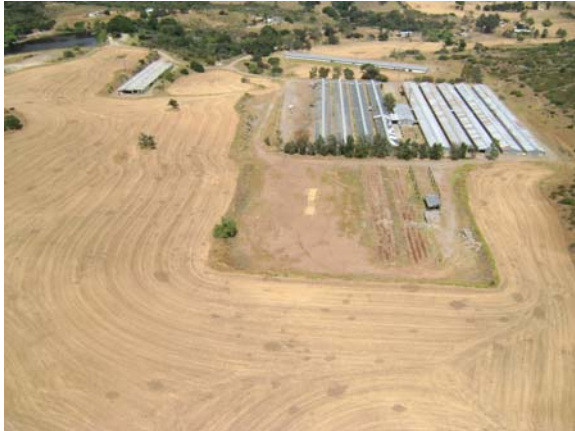
Image:

Geosyntec Site ID	47
Mile Post:	MP 86
Sempra Segment:	12
EDR Map ID	-
EDR Focus Map	-
EDR Listing ID:	-
Site Name:	Agricultural field
Site Address:	Unknown
APN:	52401002
REC:	SREC
Comments:	Access road cuts through an apparent current or former agricultural field observed in a 1953 historical aerial. Pesticides or herbicides may have been applied to the site. Testing of soil for pesticides/herbicides per CPUC Mitigation Measures in the area proposed for the access road may be necessary. Furthermore, it appears that the potential for the site to adversely affect construction is low to medium.

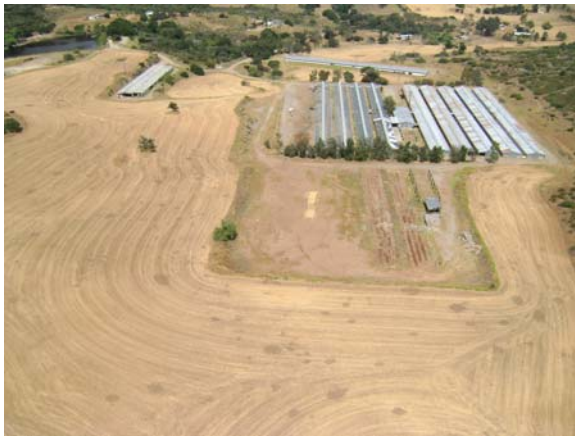
Image:

Geosyntec Site ID	48
Mile Post:	MP 86
Sempra Segment:	12
EDR Map ID	72
EDR Focus Map	23
EDR Listing ID:	S104761233
Site Name:	Woodcrest Egg Ranch
Site Address:	20676 Japatul Road, Alpine, CA 91901
APN:	52401002
REC:	None
Comments:	No incidents reported. Agricultural field may have had applications of pesticides or herbicides. However, construction is not proposed in this area. Furthermore, it appears that the potential for the site to adversely affect construction is low.

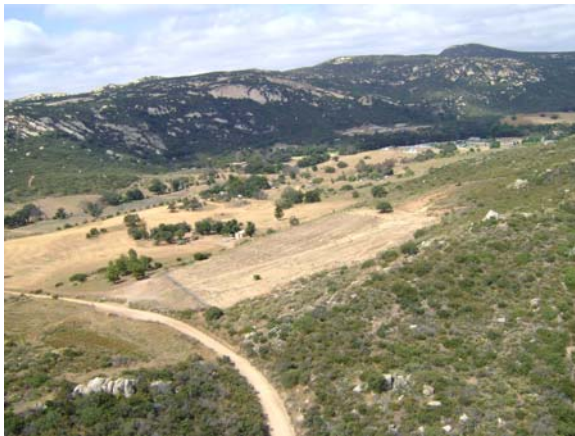
Image:

Geosyntec Site ID	49
Mile Post:	MP 87
Sempra Segment:	12
EDR Map ID	70
EDR Focus Map	23
EDR Listing ID:	S106070098
Site Name:	Cramer Egg Ranch
Site Address:	19737 High Glen Road, Alpine CA 91901
APN:	52313009
REC:	None
Comments:	No incidents reported. Agricultural field may have had applications of pesticides or herbicides. However, construction is not proposed in this area. Furthermore, it appears that the potential for the site to adversely affect construction is low.

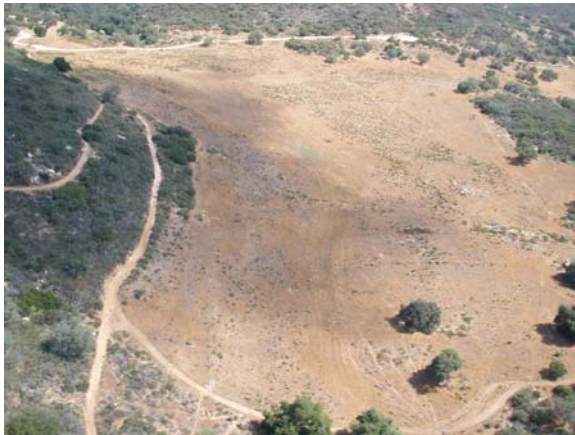
Image:

Geosyntec Site ID	54
Mile Post:	MP 90
Sempra Segment:	12
EDR Map ID	-
EDR Focus Map	-
EDR Listing ID:	-
Site Name:	Agricultural field
Site Address:	Unknown
APN:	52304008
REC:	None
Comments:	Yard appears to be a former pasture land. Reviewed historical aerials from 1953, 1980, 2005, and 2008 do not indicate that the land has been historically cultivated. It does not appear that soil testing per the CPUC Mitigation Measures would be required. Furthermore, it appears that the potential for the site to adversely affect construction is low.

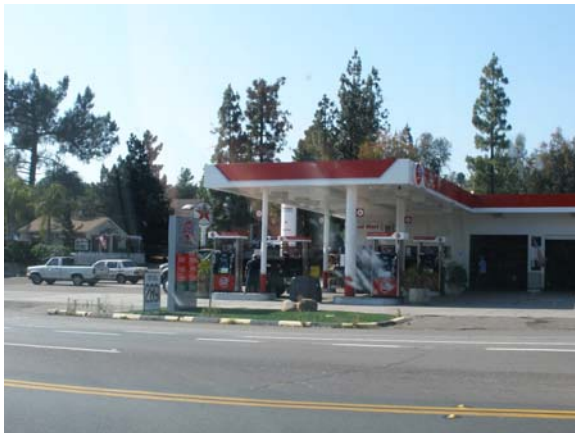
Geosyntec Site ID	79
Mile Post:	MP 96
Sempra Segment:	15
EDR Map ID	53
EDR Focus Map	17
EDR Listing ID:	S101669472, S102863950, S104746248, S106063921, S106071002, U001570888, S104576207
Site Name:	Alpine Country Station/ Texaco/Mobil/Progressive Auto Center
Site Address:	2232 Alpine Boulevard, Alpine, CA 91901
APN:	40326219
REC:	REC
Comments:	Gasoline release found during tank closure in 1999, groundwater affected. LUST cleanup site with remediation in progress, case open as of 2002. Ten USTs listed: 4 regular unleaded, 2 premium unleaded, 2 diesel, and 2 of unknown content. Currently under investigation and suspected of impacting upgradient supply wells. No violations reported for the disposal of unspecified oil-containing waste and organic liquid mixture. According to the DEH, delineation has not been achieved, and pump and treat remediation began in 2006. Based on the nature and proximity of the site to the Action Area, the potential for the LUST site to adversely affect construction appears medium to high. It is recommended that excavation near this site be monitored for impacted soils and a contingency plan be in place to properly handle and dispose impacted soils if encountered.

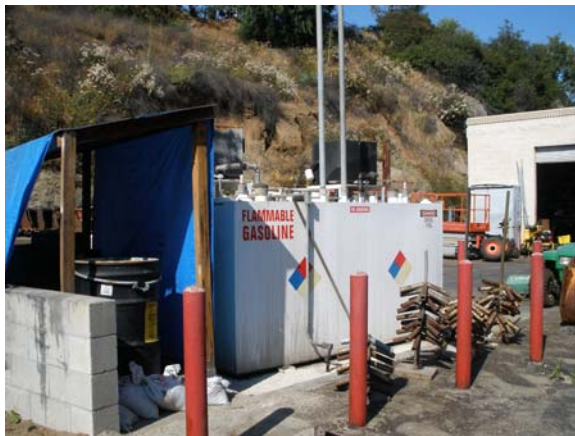
Image:

Geosyntec Site ID	88
Mile Post:	MP 96
Sempra Segment:	15
EDR Map ID	51
EDR Focus Map	17
EDR Listing ID:	S106065334, S104580582
Site Name:	Alpine Equipment Rentals, Inc.
Site Address:	2110 Alpine Boulevard, Alpine, CA 91901
APN:	40325019
REC:	SREC
Comments:	No violations reported for disposal of motor/hydraulic oil, gasoline, diesel, acetylene, propane, oxygen, waste oil, oily absorbent, sump sludge, and used oil filters. No USTs reported. During ground reconnaissance, an AST was observed with poor housekeeping and stained ground surface topographically upgradient of Alpine Boulevard. Due to the proximity to the proposed trench, petroleum impacted soil may be encountered during excavation. Therefore, it appears that the potential for the site to adversely affect construction is low to medium. It is recommended that excavation near this site be monitored for impacted soils and a contingency plan be in place to properly handle and dispose impacted soils if encountered.

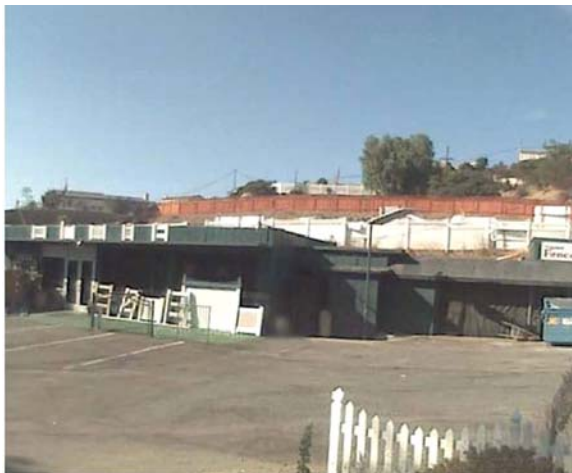
Image:

Geosyntec Site ID	90
Mile Post:	MP 96
Sempra Segment:	15
EDR Map ID	51
EDR Focus Map	17
EDR Listing ID:	S103949615, S106060308, U001570886
Site Name:	Alpine Auto Center/Discount Batteries Etc.
Site Address:	2042 Alpine Boulevard, Alpine, CA 91901
APN:	40325028
REC:	SREC
Comments:	Four USTs installed at site: 6,200-gal of unleaded gasoline, 6,200-gal of regular, 6,200-gal of premium, and one for waste oil (size not reported). No violations reported for disposal of unspecified oil-containing waste. The site generally appeared well maintained in good condition. Based on the nature of the site and close proximity to the Action Area, the potential for the site to adversely affect construction appears low to medium. It is recommended that excavation near this site be monitored for impacted soils and a contingency plan be in place to properly handle and dispose impacted soils if encountered.

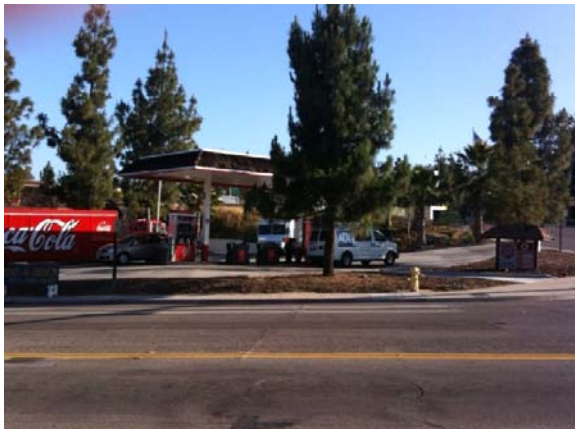
Image:

Geosyntec Site ID	103
Mile Post:	MP 97
Sempra Segment:	15
EDR Map ID	44
EDR Focus Map	17
EDR Listing ID:	S109285352, 1008200922, S104750590, U003939176, S108210978, S103634987
Site Name:	Conoco Phillips/Circle K #8581/Kayo Oil Co.
Site Address:	1666 Alpine Boulevard, Alpine, CA 91901
APN:	40339019
REC:	REC
Comments:	Assessment and interim remedial action in progress: drinking water aquifer affected, began 1/4/08. No violations reported for permitted air emissions of hydrocarbons. A letter dated 1 October 2008 from the SD DEH approved a workplan to install 4 groundwater monitoring wells at the site to assess the unauthorized leak. Three USTs reported: two 10,000-gal unleaded gasoline, one 10,000-gal leaded gasoline. No violations reported for disposal of organic residue and solids. Due to the proximity to the proposed trench location, it appears likely that contaminated soil and/or groundwater may be encountered during excavation; therefore, it appears that the potential for the site to adversely affect construction is medium to high. It is recommended that excavation near this site be monitored for impacted soils and a contingency plan be in place to properly handle and dispose impacted soils if encountered.

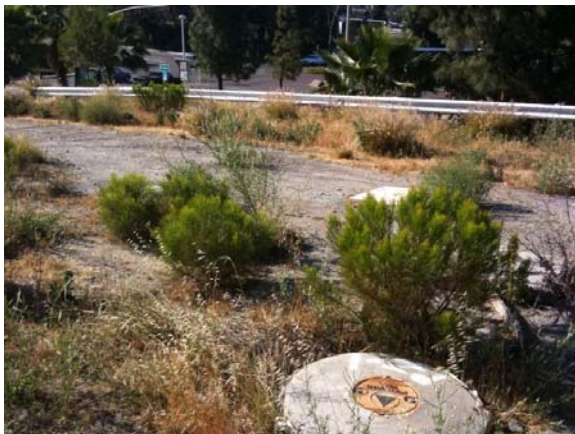
Geosyntec Site ID	104
Mile Post:	MP 97
Sempra Segment:	15
EDR Map ID	50
EDR Focus Map	17
EDR Listing ID:	S104494684, U001570893, 1000256361
Site Name:	Alpine Shell Service Station/Sterling Thomas
Site Address:	1340 Tavern Road, Alpine, CA 91901
APN:	40339011
REC:	REC
Comments:	<p>Site assessment underway as of 2000. RCRA-SQG (historically LQG) with no violations found. Nine USTs reported: 3 regular unleaded, 2 premium unleaded, 1 midgrade unleaded, 1 leaded, and 1 with unknown contents. Facility has been demolished, however remediation is ongoing. One groundwater monitoring well in Alpine Blvd. reportedly contained 3ppb MTBE during a 2008 monitoring event. Active remediation is reportedly ongoing. Groundwater appears to be approximately 15 feet bgs in the vicinity of Alpine Boulevard. Two wells are apparently located on both sides of Alpine Boulevard. Due to the proximity to the proposed trench location, it appears likely that groundwater monitoring wells, contaminated soil, and/or groundwater may be encountered during excavation; therefore, it appears that the potential for the site to adversely affect construction is medium to high. It is recommended that excavation near this site be monitored for impacted soils and a contingency plan be in place to properly handle and dispose impacted soils if encountered.</p>

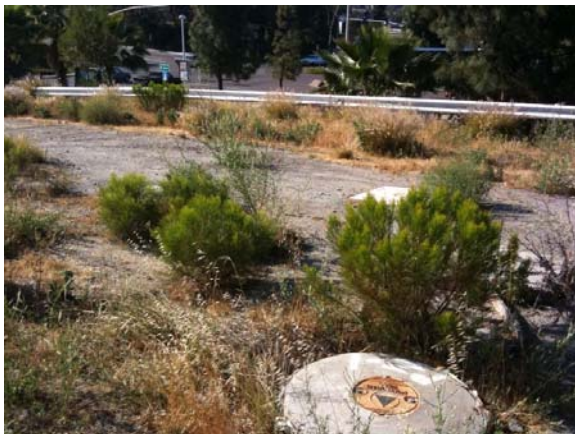
Geosyntec Site ID	104
Mile Post:	MP 97
Sempra Segment:	15
EDR Map ID	50
EDR Focus Map	17
EDR Listing ID:	S104494684, U001570893, 1000256361
Site Name:	Alpine Shell Service Station/Sterling Thomas
Site Address:	1340 Tavern Road, Alpine, CA 91901
APN:	40339011
REC:	REC
Comments:	<p>Site assessment underway as of 2000. RCRA-SQG (historically LQG) with no violations found. Nine USTs reported: 3 regular unleaded, 2 premium unleaded, 1 midgrade unleaded, 1 leaded, and 1 with unknown contents. Facility has been demolished, however remediation is ongoing. One groundwater monitoring well in Alpine Blvd. reportedly contained 3ppb MTBE during a 2008 monitoring event. Active remediation is reportedly ongoing. Groundwater appears to be approximately 15 feet bgs in the vicinity of Alpine Boulevard. Two wells are apparently located on both sides of Alpine Boulevard. Due to the proximity to the proposed trench location, it appears likely that groundwater monitoring wells, contaminated soil, and/or groundwater may be encountered during excavation; therefore, it appears that the potential for the site to adversely affect construction is medium to high. It is recommended that excavation near this site be monitored for impacted soils and a contingency plan be in place to properly handle and dispose impacted soils if encountered.</p>

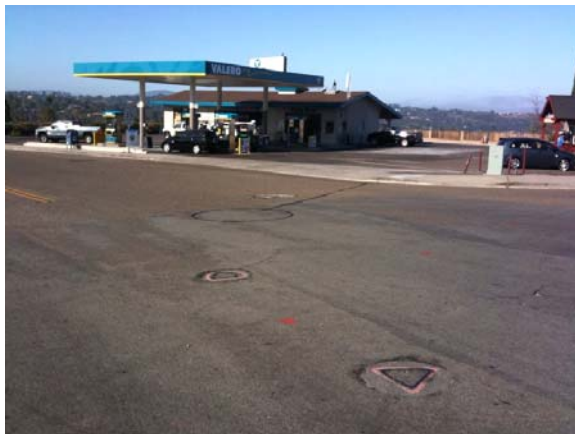
Image:

Geosyntec Site ID	110
Mile Post:	MP 97
Sempra Segment:	15
EDR Map ID	41
EDR Focus Map	17
EDR Listing ID:	S106072526
Site Name:	Tavern Road Texaco/Daniel Smith Trust
Site Address:	1140 Tavern Road, Alpine, CA 91901
APN:	40338045
REC:	REC
Comments:	<p>Site assessment underway: diesel release reported 10/19/04. Two cases closed: one release of waste-oil to soil closed 11/4/96; and one release of diesel closed 11/20/08. Nine USTs listed for the site: 6 unleaded gasoline, 1 waste-oil, and 2 diesel. One AST 1,550-gal AST reported onsite. Reportedly, groundwater is greater than 30 feet below ground surface and flows southwest, away from the nearby Action Area. Additionally, the site is topographically downgradient of the nearby Action Area; therefore, it is unlikely that impacted soil or groundwater as a result of the site will be encountered during the proposed construction activities in the nearby Action Area. Therefore, the potential for the site to adversely affect construction appears low.</p>

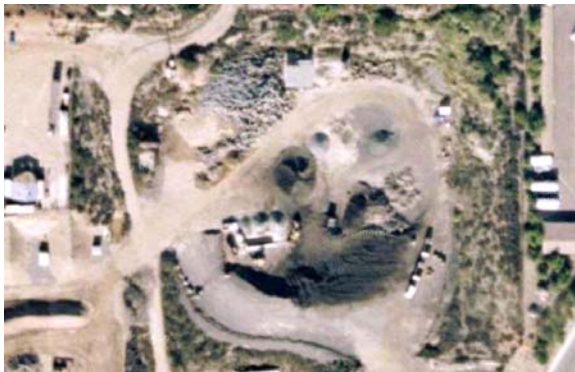
Geosyntec Site ID	111
Mile Post:	MP 97
Sempra Segment:	15
EDR Map ID	41
EDR Focus Map	17
EDR Listing ID:	U003789905
Site Name:	Impac Ready Mix
Site Address:	1117 Tavern Road, Alpine, CA 91901
APN:	40338056
REC:	REC
Comments:	Two USTs reported: one 25,000-gal unleaded gasoline, one 20,000-gal motor vehicle fuel. No incidents reported. Discolored soil was observed in recent aerial photographs which may indicate impacted soil at the site. However, due to access limitations, the nature of the dark soil was not evaluated. Currently, Geosyntec is awaiting a response from the local Building Department regarding files related to the site. Therefore, the potential for the site to adversely affect construction appears medium to high. It is recommended that an onsite reconnaissance be performed to further evaluate the potential to affect construction.

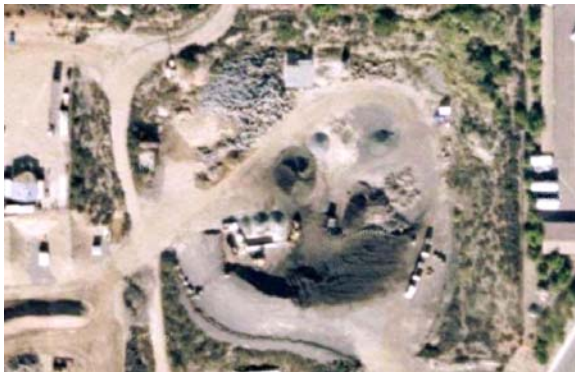
Geosyntec Site ID	111
Mile Post:	MP 97
Sempra Segment:	15
EDR Map ID	41
EDR Focus Map	17
EDR Listing ID:	U003789905
Site Name:	Impac Ready Mix
Site Address:	1117 Tavern Road, Alpine, CA 91901
APN:	40338056
REC:	REC
Comments:	Two USTs reported: one 25,000-gal unleaded gasoline, one 20,000-gal motor vehicle fuel. No incidents reported. Discolored soil was observed in recent aerial photographs which may indicate impacted soil at the site. However, due to access limitations, the nature of the dark soil was not evaluated. Currently, Geosyntec is awaiting a response from the local Building Department regarding files related to the site. Therefore, the potential for the site to adversely affect construction appears medium to high. It is recommended that an onsite reconnaissance be performed to further evaluate the potential to affect construction.

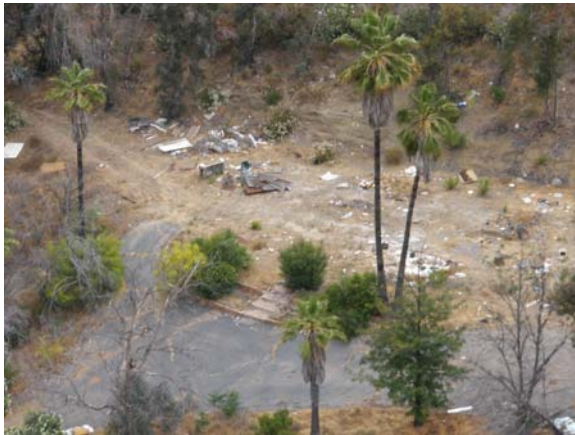
Image:

Geosyntec Site ID	122
Mile Post:	MP 98
Sempra Segment:	15
EDR Map ID	-
EDR Focus Map	-
EDR Listing ID:	-
Site Name:	Burned Residential Structure
Site Address:	Unknown
APN:	40222038
REC:	SREC
Comments:	A group of former homes appear to have been burned. Residual hazardous materials are often associated with burned structures. However, surficial impacts are unlikely to have impacted the subsurface below the paved Alpine Boulevard. Therefore, based on the nature of the site and proximity to the Action Area, the potential for the site to adversely affect construction appears low.

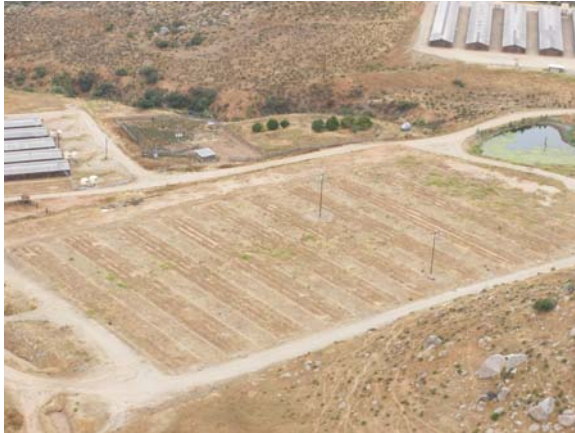
Image:

Geosyntec Site ID	130
Mile Post:	MP 100
Sempra Segment:	16
EDR Map ID	-
EDR Focus Map	-
EDR Listing ID:	-
Site Name:	Agricultural field
Site Address:	Unknown
APN:	40214054
REC:	None
Comments:	Yard appears to be the former location of henhouses from between 1964 and 1968 to sometime between 1981 and 1989. It does not appear that the site was actively cultivated. Therefore, it does not appear that soil testing per the CPUC Mitigation Measures would be required. Additionally, it appears that the potential for the site adversely affect construction is low.

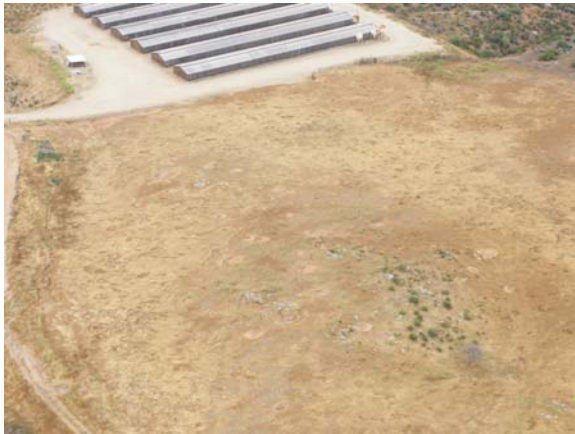
Image:

Geosyntec Site ID	131
Mile Post:	MP 100
Sempra Segment:	16
EDR Map ID	-
EDR Focus Map	-
EDR Listing ID:	-
Site Name:	Agricultural field
Site Address:	Unknown
APN:	40214120
REC:	None
Comments:	Yard appears to be a current or former pasture land and egg farm with a nearby pond. Although the land was cleared sometime between 1964 and 1968, evidence of active cultivation was not identified. Therefore, it does not appear that soil testing per the CPUC Mitigation Measures would be required.

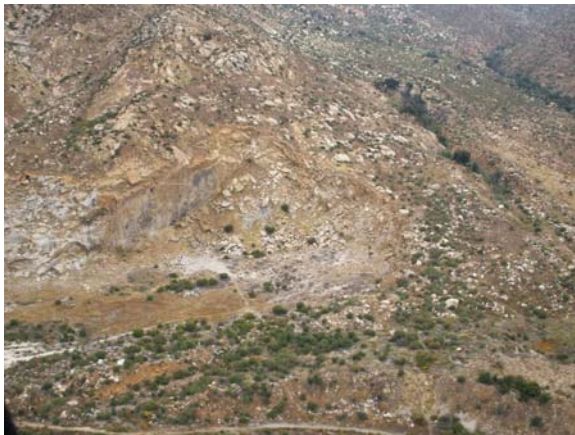
Image:

Geosyntec Site ID	135
Mile Post:	MP 103
Sempra Segment:	16
EDR Map ID	27
EDR Focus Map	13
EDR Listing ID:	S106931988, 1010727238, S105960462
Site Name:	SD City-Water, El Capitan Lake/El Capitan Quarry/El Cajon Moun
Site Address:	16820 El Monte Road, Lakeside, CA 92040
APN:	40207004
REC:	HREC
Comments:	Abandoned granite quarry where 415 55-gallon drums containing paint, sludge, and byproducts were illegally disposed. VOCs and heavy metals were detected in soil. According to DTSC, the responsible party, Frazee, had remediated the site satisfactorily in 1989. Two USTs reported: one 550-gal and one 2,000-gal unleaded gasoline UST. Nearby proposed tower locations are located topographically upgradient of the site. Therefore, it appears that the potential for the site to adversely affect construction is low.

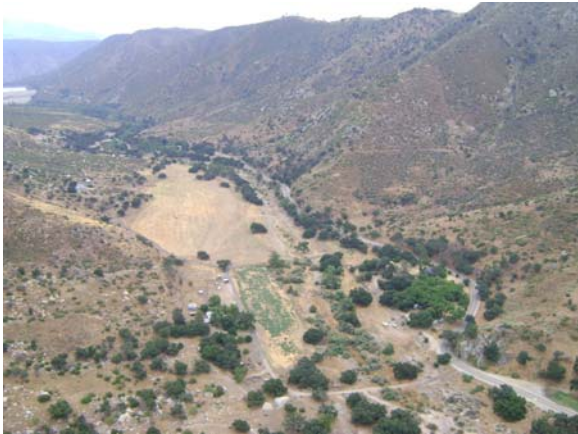
Image:

Geosyntec Site ID	136
Mile Post:	MP 103
Sempra Segment:	16
EDR Map ID	-
EDR Focus Map	-
EDR Listing ID:	-
Site Name:	Agricultural field
Site Address:	Unknown
APN:	39006008
REC:	SREC
Comments:	Disturbed soil may be a former agricultural field. Pesticides or herbicides may have been applied to the site. Site was cleared prior to 1953. A 1971 historic aerial indicates the site may have been tilled. Therefore, testing of soil for pesticides/herbicides per CPUC Mitigation Measures in the area proposed for the access road may be necessary.

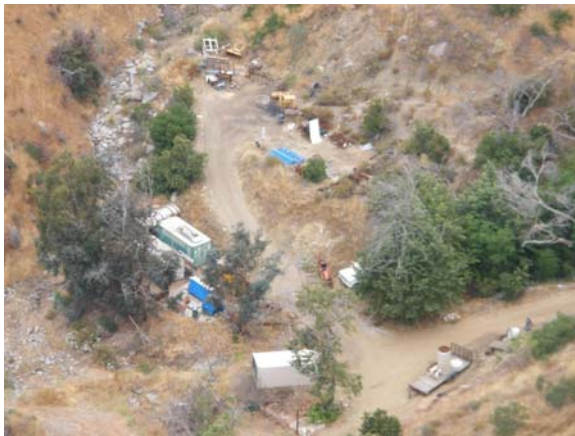
Image:

Geosyntec Site ID	138
Mile Post:	MP 105
Sempra Segment:	16
EDR Map ID	-
EDR Focus Map	-
EDR Listing ID:	-
Site Name:	Storage area with AST
Site Address:	Unknown
APN:	39001008
REC:	SREC
Comments:	Various heavy equipment and an abandoned damaged AST were observed. However, due to the proximity of proposed nearby towers located on the ridgeline, the potential for the AST site to adversely affect construction appears unlikely.

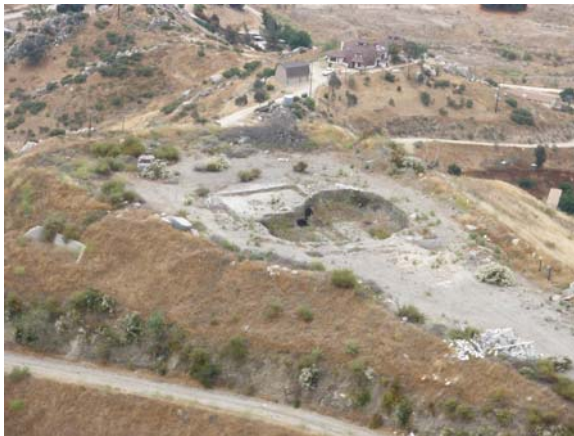
Image:

Geosyntec Site ID	140
Mile Post:	MP 105
Sempra Segment:	16
EDR Map ID	-
EDR Focus Map	-
EDR Listing ID:	-
Site Name:	Burned Residential Structure
Site Address:	Unknown
APN:	39004050
REC:	SREC
Comments:	A group of former homes appear to have been burned. Residual hazardous materials are often associated with burned structures. However, based on the nature of the site and proximity to the Action Area, the potential for the site to adversely affect construction appears low. Furthermore, the nearby proposed towers locations are situated up on ridgelines, further reducing the likelihood of impacts from topographically downgradient sources.

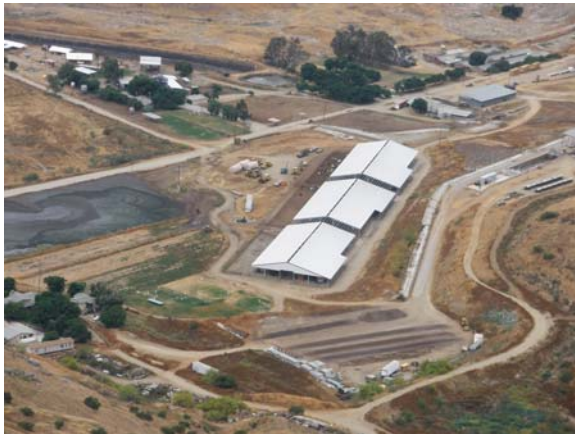
Image:

Geosyntec Site ID	142
Mile Post:	MP 106
Sempra Segment:	17
EDR Map ID	25
EDR Focus Map	12
EDR Listing ID:	S104761324
Site Name:	Van Ommering Dairy
Site Address:	15010 Willow Road, Lakeside, CA 92040
APN:	39004047
REC:	SREC
Comments:	No violations reported for use of oxygen, acetylene, iodine, phosphoric acid, gasoline, and diesel. Dairies are often associated with methane, sewage, and wastewater impacts. However, based on the nature of the site and proximity to the Action Area, the potential for the site to adversely affect construction appears low.

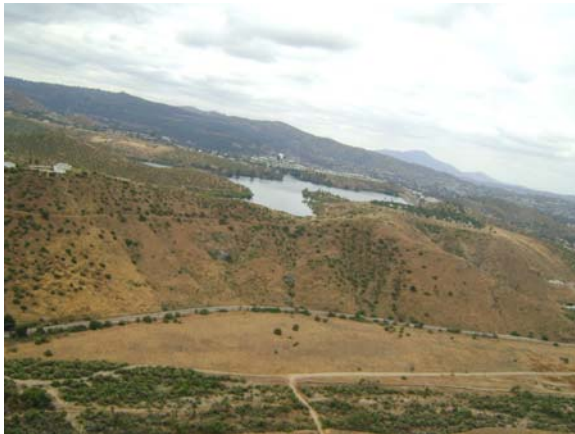
Image:

Geosyntec Site ID	144
Mile Post:	MP 107
Sempra Segment:	17
EDR Map ID	-
EDR Focus Map	-
EDR Listing ID:	-
Site Name:	Agricultural field
Site Address:	Unknown
APN:	39106101
REC:	SREC
Comments:	Yard appears to be a current or former agricultural field. Pesticides or herbicides may have been applied to the site. The site was cleared between 1964 and 1968 and row crops were noted in a 2003 aerial photo. Site may be required to be tested for pesticides and herbicides in accordance with the CPUC Mitigation Measures. Furthermore, it appears that the potential for the site to adversely affect construction is low to medium.

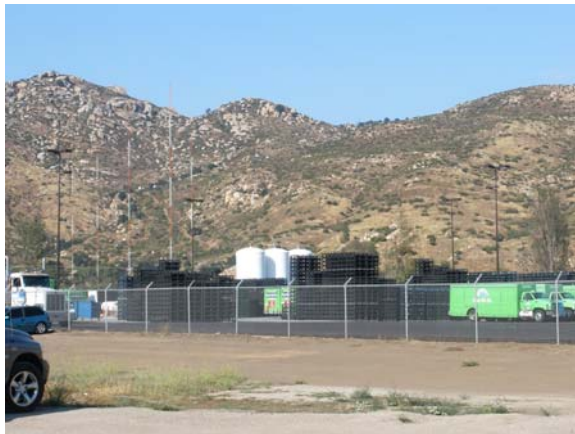
Image:

Geosyntec Site ID	149
Mile Post:	MP 109
Sempra Segment:	17
EDR Map ID	23
EDR Focus Map	11
EDR Listing ID:	1000363605
Site Name:	Sparkletts Drinking Water Corp.
Site Address:	11811 Highway 67, Lakeside, CA 92040
APN:	39004054
REC:	HREC
Comments:	Two diesel USTs listed for the site with no reported violations. No further remedial action planned for CERCLIS case, no additional case information provided. Historical USTs include 10,000-gal and 12,000-gal motor vehicle fuel USTs. No violations reported for permitted waste discharge. Due to the nature of the proposed nearby construction in the staging area, the potential for the site to adversely affect construction appears low.

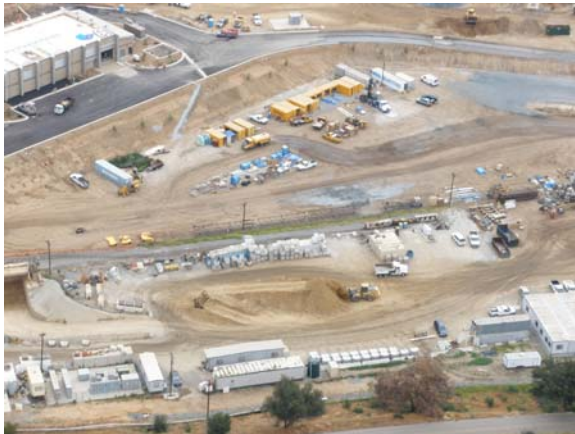
Image:

Geosyntec Site ID	151
Mile Post:	MP 110
Sempra Segment:	17
EDR Map ID	17
EDR Focus Map	11
EDR Listing ID:	S109279428, S109428007, S109457267
Site Name:	Kiewit Pacific Co./San Vicinte Pipeline
Site Address:	12393 Moreno Avenue, Lakeside, CA 92040
APN:	32912103
REC:	SREC
Comments:	One 12,110-gal diesel AST onsite. No violations reported for disposal of 3.15 tons of organic solids or stormwater construction permit. Due to the nature of the proposed nearby tower locations on the topographically upgradient ridgeline, the potential for the site to adversely affect construction appears low.

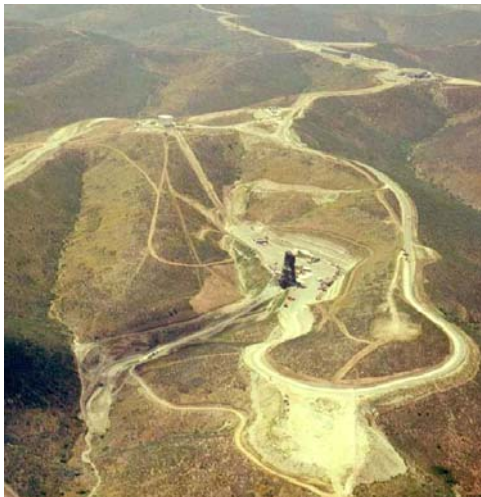
Image:

Geosyntec Site ID	175
Mile Post:	MP 115
Sempra Segment:	18
EDR Map ID	8
EDR Focus Map	4
EDR Listing ID:	S108407638
Site Name:	Sycamore Canyon Site - General Dynamics
Site Address:	11975 Beeler Canyon Road, San Diego, CA
APN:	32502108, 32505012, 32505016, & 32502106
REC:	SREC
Comments:	No incidents reported. However, site was a rocket and weapons test site used by Lockheed-Martin, Hughes Aircraft, and General Dynamics. Several test stands were located in the vicinity. Test sites are often associated with impacts from perchlorate and other propellants. GeoTracker reports an open site assessment case for PCBs in soil related to the former rocket testing. The location of the testing facility is delineated on Figure 13. Based on the historical photographs of the testing facility, it appears that the test stands were located on hillsides and were constructed with partially lined channels draining into the canyons below, which appear to generally drain to the southeast, away from the Action Area. The nearby proposed tower locations are situated on topographically prominent ridgelines which likely reduces the potential for impacts from downgradient sources. Furthermore, an existing transmission line is present south of the Action Area (closer to the Sycamore site), and issues related to the construction of the existing line with respect to the Sycamore Canyon site was not reported to Geosyntec. Therefore, based on the nature of the site and proximity to the Action Area, the potential for the site to adversely affect construction appears low to medium.

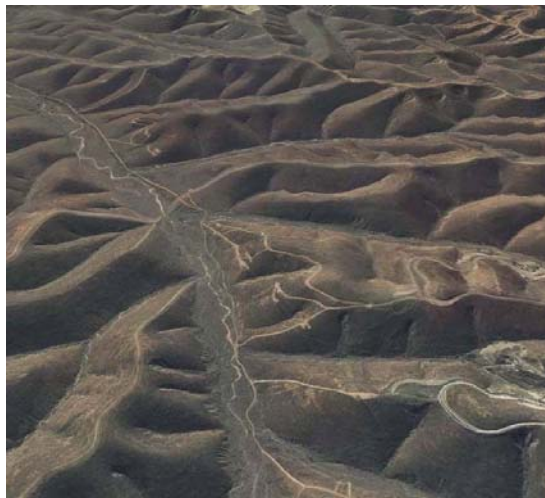
Image:

Geosyntec Site ID	176
Mile Post:	MP 118.1
Sempra Segment:	18
EDR Map ID	0
EDR Focus Map	4-5-9-10
EDR Listing ID:	CUSA145303
Site Name:	El Centro Naval Air Facility/MCAS Miramar/Former Camp Elliot
Site Address:	Unknown
APN:	37401101
REC:	None
Comments:	Appears to refer to existing Marine Corps Air Station (MCAS) Miramar and/or former Camp Elliot. No incidents were reported; however, similar sites are often associated with unexploded ordnances. An existing transmission line is present south of the Action Area (closer to the MCAS Miramar), and issues related to the construction of the existing line with respect to MCAS Miramar was not reported to Geosyntec. Furthermore, no physical evidence of a material threat was identified. Based on the identified information, it appears that the site may present a low to medium potential to adversely affect construction. It is recommended that construction personnel are notified and trained on safety procedures for working in areas with a potential to contain unexploded ordnances.
