# PROJECT MEMORANDUM PG&E ATLANTIC-DEL MAR REINFORCEMENT PROJECT

**Subject:** Weekly Report #4: May 8, 2005 – May 14, 2005

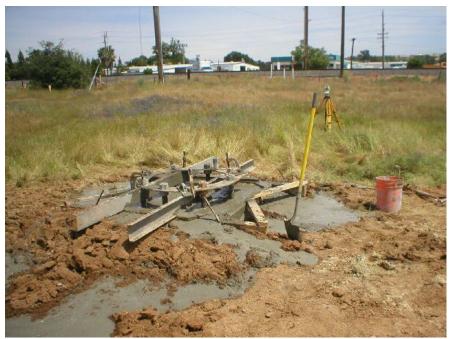
On May 12<sup>th</sup>, the CPUC EM toured the Pole 2/16 site. Crews had augured the foundation hole that morning. The pole is located adjacent to a drainage swale area and it was noted that no erosion controls were installed around the pole location. The PG&E EI was notified that erosion controls need to be placed to protect drainage areas. Per the crew Foreman during drilling, groundwater was encountered at 17 ft below ground surface (bgs). The foundation hole was drilled to 20 ft bgs. There was standing water located close to the pole area, but when asked about it the Foreman said that the water was from the recent rains, no ground water was removed from the hole. During the concrete pour, the pit overflowed due to ground water intrusion. During the tour, crews were trying to contain the overflow. It was noted that no resource areas were impacted and the area was being cleaned up (see Figure 1). A CTS survey report had not been submitted prior to construction at the Pole 2/16 site. The CPUC EM asked if the area had been surveyed for CTS prior to construction. The PG&E EI said that it had, but the report had not been written or submitted. The CPUC EM told the PG&E EI that prior to construction at all pole locations a CTS survey report must be submitted to the CPUC. If work occurs at another location with out the submittal of a CTS survey report a CPUC Project Memorandum would be issued. The next pole location to be augured, Pole 2/15 was toured. There exists a vernal pool area east of the location. The PG&E EI had begun installing the protective sediment fencing as outlined in the USFWS letter of no effect.

On May 12<sup>th</sup>, the CPUC EM toured the Pole 2/16 site, which had been augured. The pole is located adjacent to a drainage swale area and it was noted that no erosion controls were installed around the pole location. The PG&E EI was notified that erosion controls need to be placed to protect drainage areas.

**Figure 1** – Pole 2/16 location after the concrete pour, May 12, 2005. Note the lack of erosion controls.

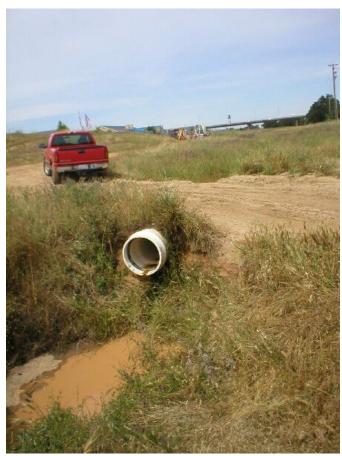
During the site tour on May 12<sup>th</sup>, the CPUC EM and the PG&E EI walked the area around the access road leading to pole 13/17 and pole 3/18. The access road that leads to these locations goes over a culvert which the crew Foreman said would be crushed by the heavy equipment (see Figure 2). Alternate access was looked at; however, after evaluation of the culvert, PG&E decided to bridge/reinforce the area over the culvert to allow heavy equipment travel. The CPUC EM confirmed that clean gravel could be brought in to stabilize and level the area in order to lay down steel plates.

**Figure 2** – Culvert within an access road slated for use, May 12, 2005.
