PROJECT MEMORANDUM PG&E ATLANTIC-DEL MAR REINFORCEMENT PROJECT

Subject: Weekly Report #41: January 22, 2006 – January 28, 2006

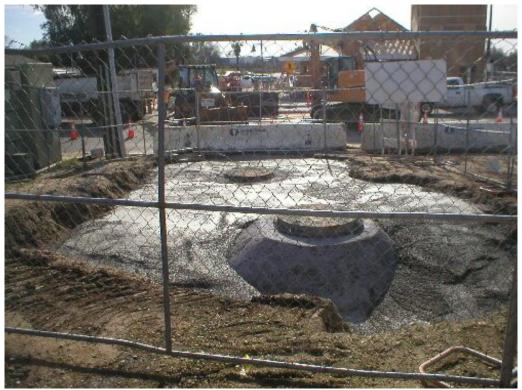
Figure 1 – Vault 3 location adjacent to Rocklin Road, January 26, 2006.

Zayas Construction worked on the excavation of the trench line from Vault #3 (see Figure 1) into Rocklin Road. The crew hand dug around all existing utilities throughout the street and placed steel plates over the trench at the end of each workday. Storm water continues to fill the trench. Crews have been discharging storm water through a filter bag to overland areas devoid of resources. The completed trench from Vault #3 to approximately Station 44+00 was backfilled.

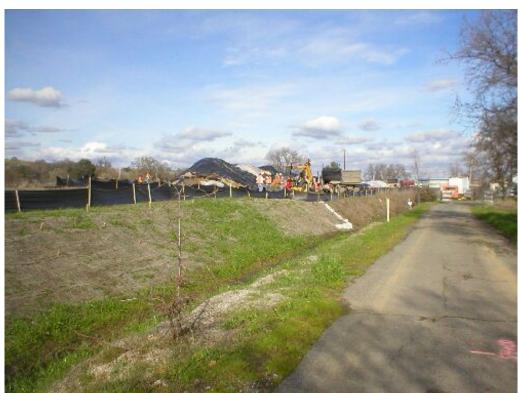
Spoils piles adjacent to Drainage #30 remain large. Erosion controls have been installed around the piles. The spoil pile which showed elevated metals located approximately 15 feet west of Seasonal Drainage #30 was removed during the subject week. The material was hauled to an approved refuse site.

Figure 2 – Meeting held near Drainage #30, January 26, 2006. Note current erosion of bank and spoil piles.

Wilson Construction and Zayas Construction met with the CPUC EM and the PG&E EI s on Thursday, January 26, to discuss the upcoming excavation and tie-in work on the west side of Seasonal Drainage #30 to complete the conduit installation approximately three feet from the bank line. Potential damage to the frail and degrading bank is a concern (see Figure 2). In addition, compliance with the CDFG 1603 Permit which covers the trenching and conduit installation through Drainage #30 within the seasonal window of April 15th and October 15th was discussed. The CPUC EM, Anne Sweet Coronado pointed out that the CPUC cannot prohibit the proposed tie-in work, but that after her correspondence with CDFG representatives both Wilson and Zayas should be informed that if they begin work prior to April 15th they are taking a risk. If a resulting bank failure were to occur, the CDFG could assess fines for resource damages and the existing permit might be impacted.
