**PROJECT MEMORANDUM
SCE TRANSMISSION PROJECTS, SEGMENTS 1–11**

To: Ken Lewis and Jason Coontz, Project Managers, CPUC
From: Vida Strong, Aspen Project Manager
Date: December 19, 2013
Subject: Weekly Report 304: November 17 to November 23, 2013

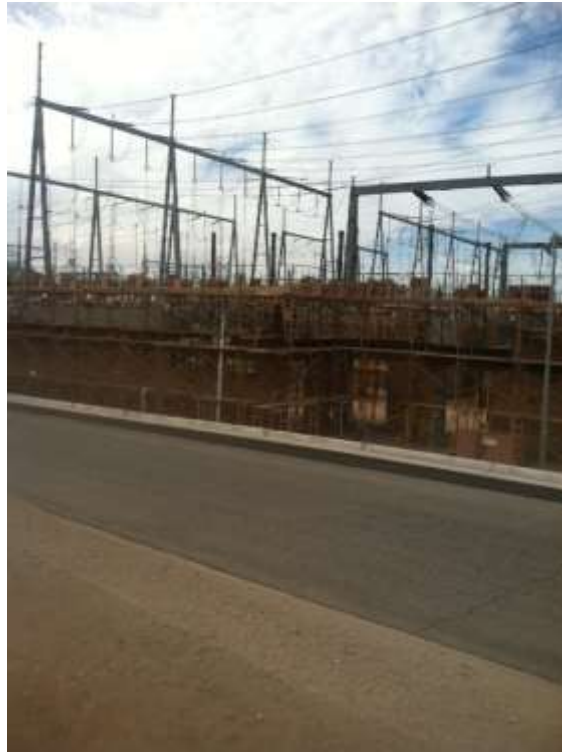
Figure 1: Vincent Control Building construction on Segment 9.

4. Construction of control building structure continued at the Vincent Substation (see Figure 1).
5. Segment 10 Telecom: Work has been completed.
6. Whirlwind Substation: Remaining work includes the testing and commissioning of the 500 kV Shunt CAPs and bus extensions.

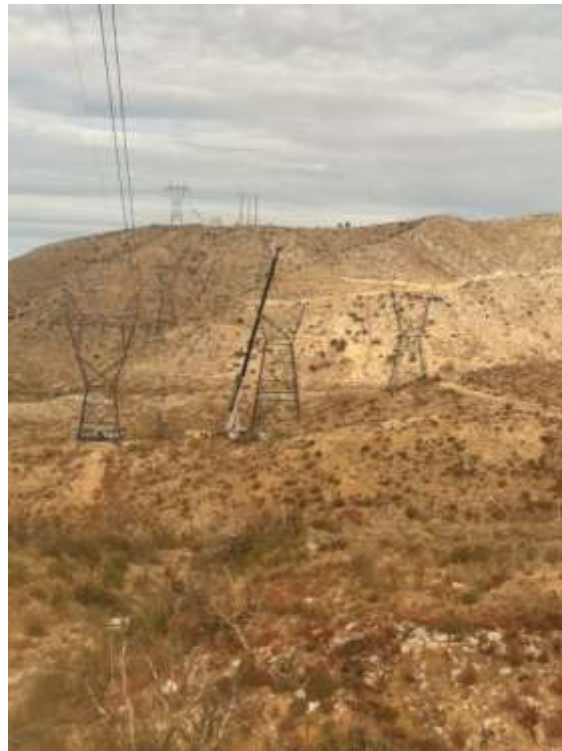
Figure 2: Structure assembly occurring at Construct 21 on Segment 6.

1. Foundation excavation occurred at Constructs (towers) 3, 5, 6, 7, and 8. Foundation pouring activities occurred at Construct 8.
2. Structure assembly and erection occurred at Constructs 16, 17, 18, 19, 20, 21, and M79-T2 (see Figure 2).
3. Grading occurred on Loop Road A, Loop Road L between Constructs 72 and 73, 76 and 78, Helicopter Support Yard (HSY) 1,2, and Constructs 17 and 113.
4. Drainage improvements and wet crossing installation/maintenance occurred on Loop Road L between Constructs 72 to 73, and 76 to 78.
5. Wire stringing operations (such as preparation, wire install, clipping wire, and wire cleanup) occurred from Constructs 62, 63, 72 to 84, and 104.
6. BMP installation, maintenance, and inspection occurred at various construction locations. BMPs were also removed at Construct 79.
7. Fugitive dust control activities occurred in areas where construction occurred.

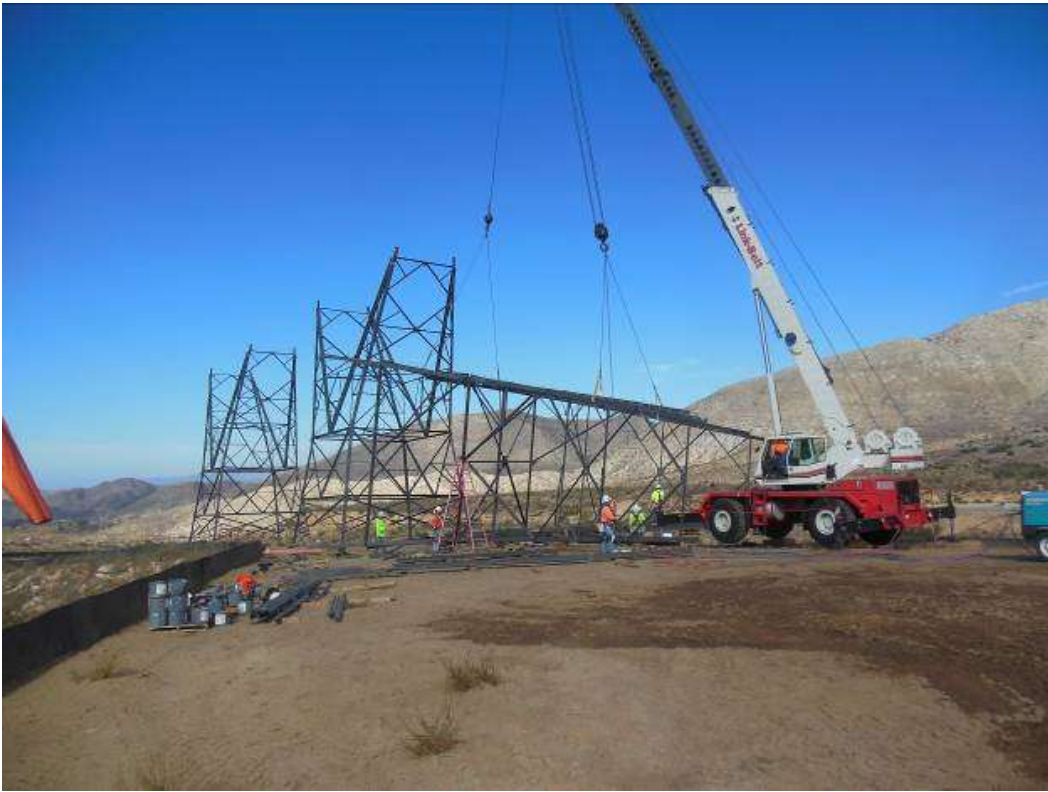
Figure 3: Assembly of towers for Segment 11C occurring at Aliso HAY.

13. Guard poles were installed at the Guard Structure between Constructs 3 and 4.
14. PAR haul crews delivered several steel bundles and UPC crews conducted tower assembly at the Aliso HAY (see Figure 3).

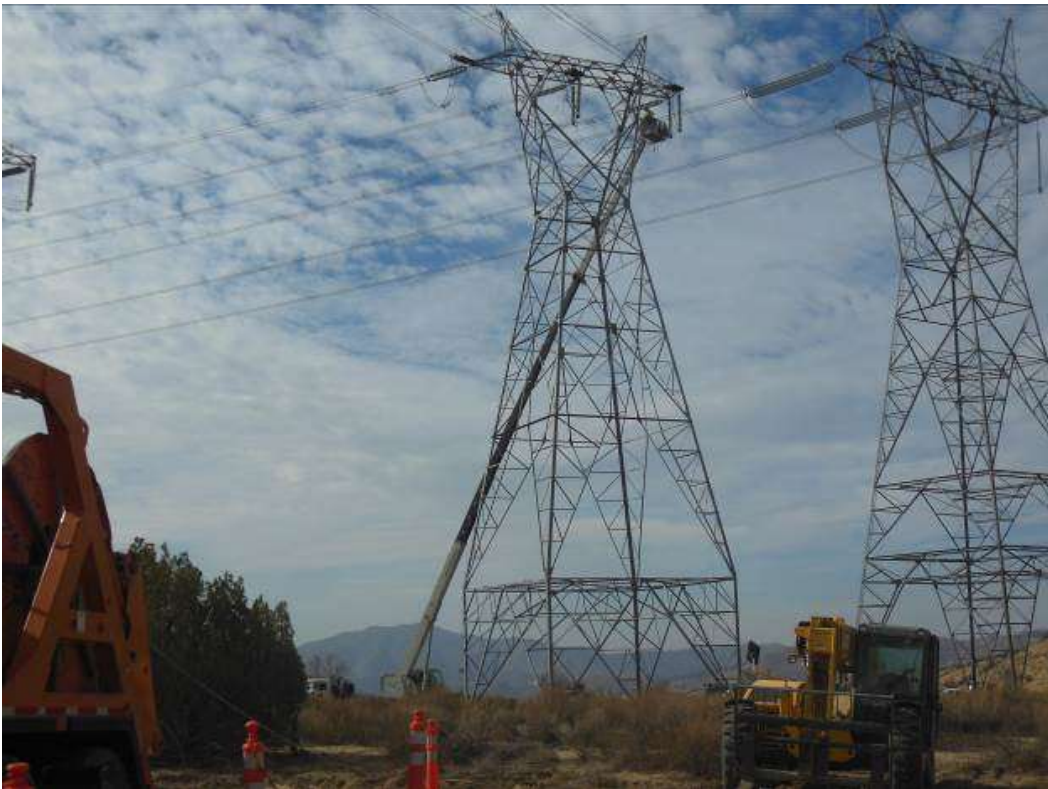
Figure 4: Removing jumpers from existing Tower M32-T3, Segment 11C.

15. PAR crews removed jumpers from existing Towers M30-T2 and M32-T3, and conducted wreck-out activities associated with the removal of existing wire between Constructs 2 and 11 (see Figure 4).

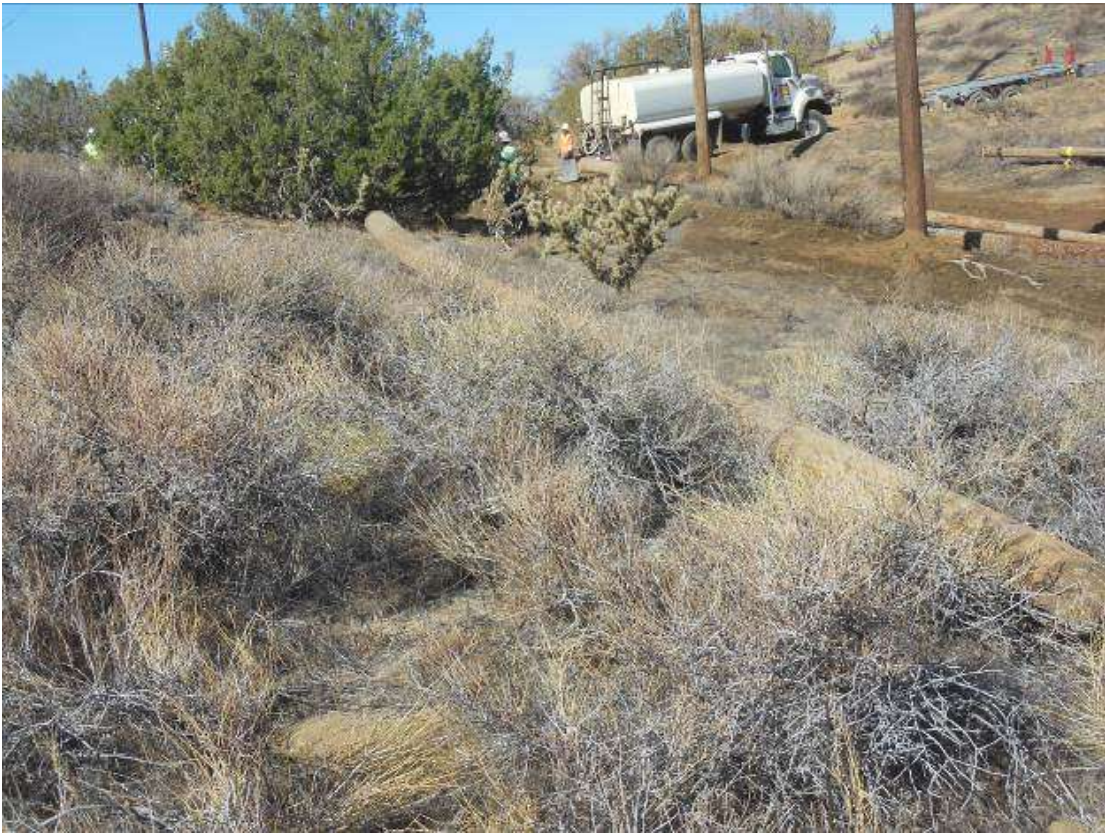
9. On November 18, the CPUC EM observed a guard pole lying on the ground outside of approved disturbance limits while the PAR crew was installing the Guard Structure between Constructs 3 and 4, resulting in crushed vegetation (see Figure 5). The CPUC EM immediately notified the appropriate construction personnel. To date, this incident has not been recorded by SCE.

Figure 5: Guard pole lying on ground outside of disturbance limits at Guard Structure between Constructs 3 and 4 on Segment 11C.

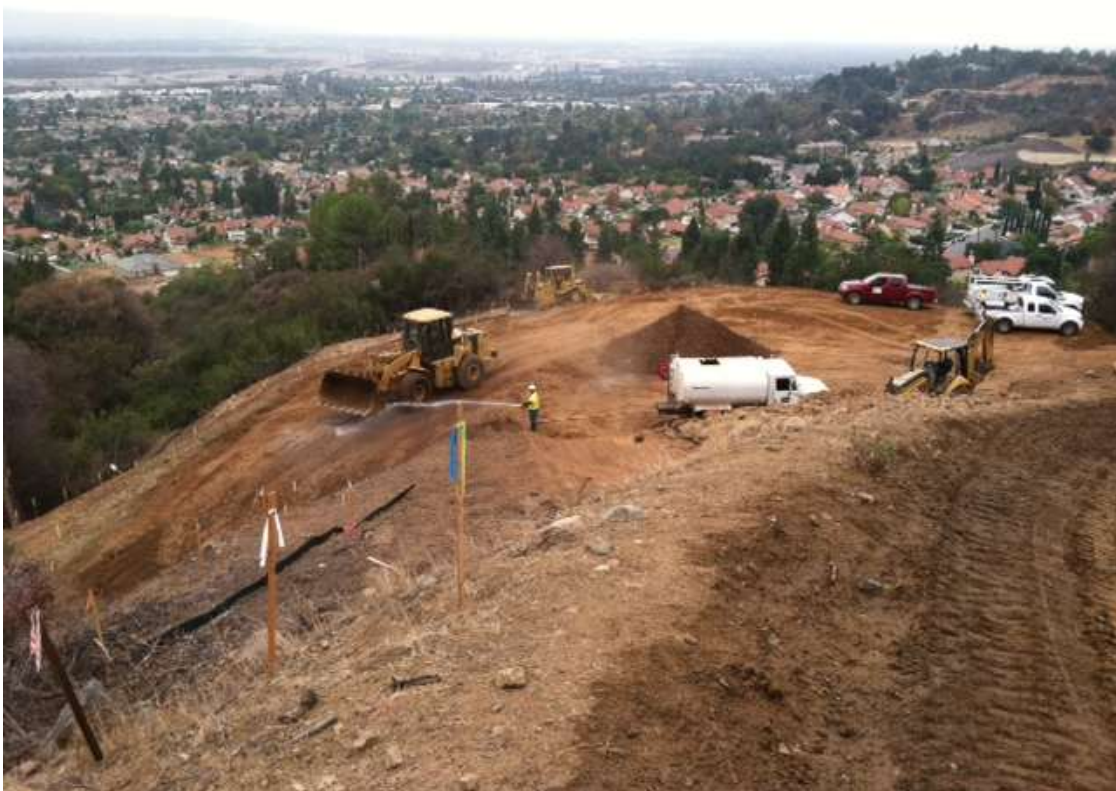
2. Union Construction continued grading of the access road and tower disturbance area for Tower M27-T3 in Duarte (see Figure 6).

Figure 6: Grading access road to Segment 7 Tower M27-T3 in Duarte.

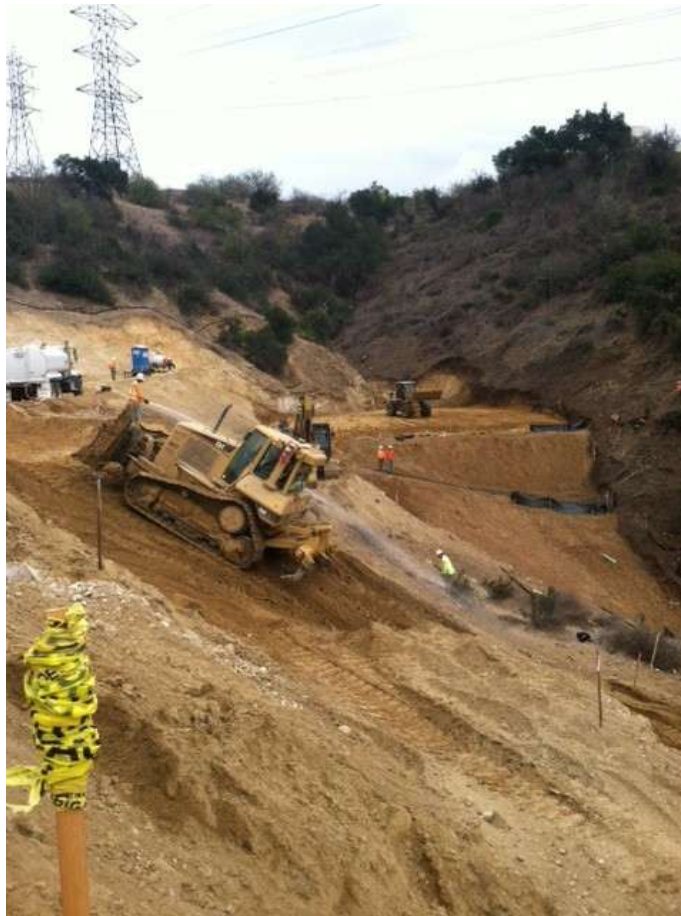
3. Union Construction continued vegetation clearing and grading of the access road and temporary disturbance area for Tower M57-T1 in Tonner Canyon (see Figure 7).
4. Foundation removal occurred at Towers M27-T1, M60-T2, M60-T3, M61-T1, M61-T2, and M62-T5 in Chino Hills.
5. Steel from Towers M29-T2, M60-T2, M60-T3, M61-T1, and M62-T5 in Chino Hills was hauled off continued in preparation for the future underground work.
6. Recontouring of the tower site occurred at Tower M63-T3 in Chino Hills.
7. Maintenance of erosion control devices took place at various work areas.
8. To date, 100% of the conductor and structures have been removed from the existing 220 kV Chino-Mesa and Mira Loma–Walnut and Mira Loma–Olinda lines.

Figure 7: Grading access road to Segment 8 Tower M57-T1 in Tonner Canyon.

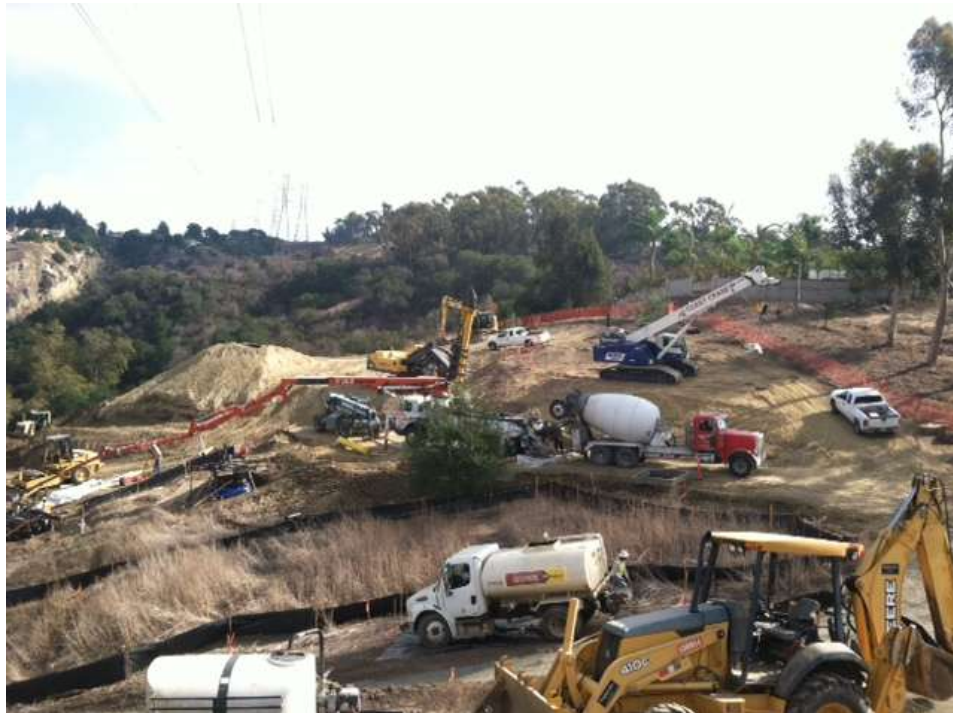
Figure 8: Foundation pouring at Segment 8 Tower M49-T1 near Puente Hills.

15. Patriot continued with vegetation clearing and grading of the access road to Tower M43-T3.
16. Patriot continued grading the disturbance area of Tower M49-T1.
17. KV Structures continued foundation excavation and pouring at Tower M49-T1 (see Figure 8).
18. ASB continued tower assembly at Tower M44-T3.
19. To date, 100% of the conductor and 100% of the structures on the existing 220 kV Chino-Mesa line have been removed.
