**PROJECT MEMORANDUM
SCE TRANSMISSION PROJECTS, SEGMENTS 1–11**

To: Jason Coontz, Project Manager, CPUC
From: Vida Strong, Aspen Project Manager
Date: January 9, 2014
Subject: Weekly Reports 306 and 307: December 1 to December 14, 2013

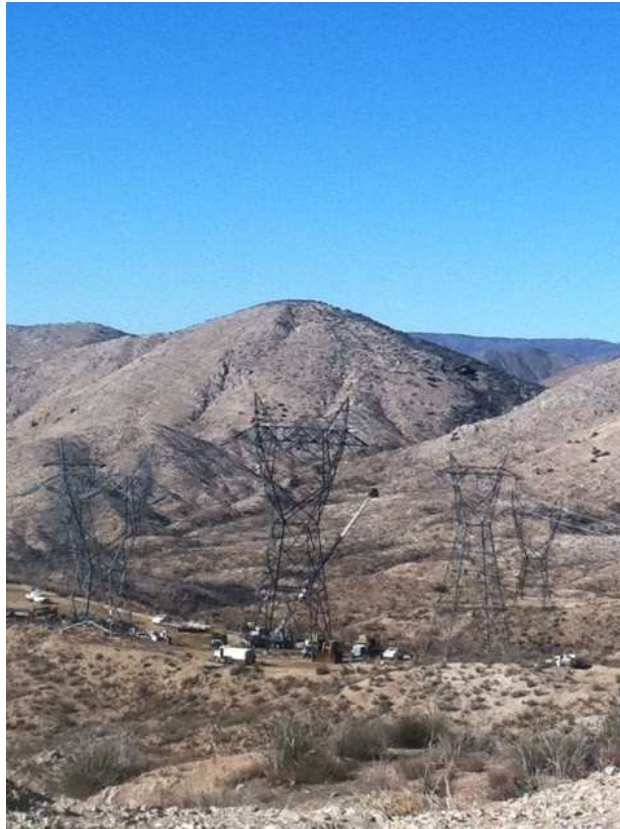
Figure 1: Construct 22 wire stringing activities, Segment 6.

7. Wire stringing operations (such as preparation, wire install, clipping wire, and wire cleanup) occurred at Constructs 5 to 22 and 72 to 108 (see Figure 1).

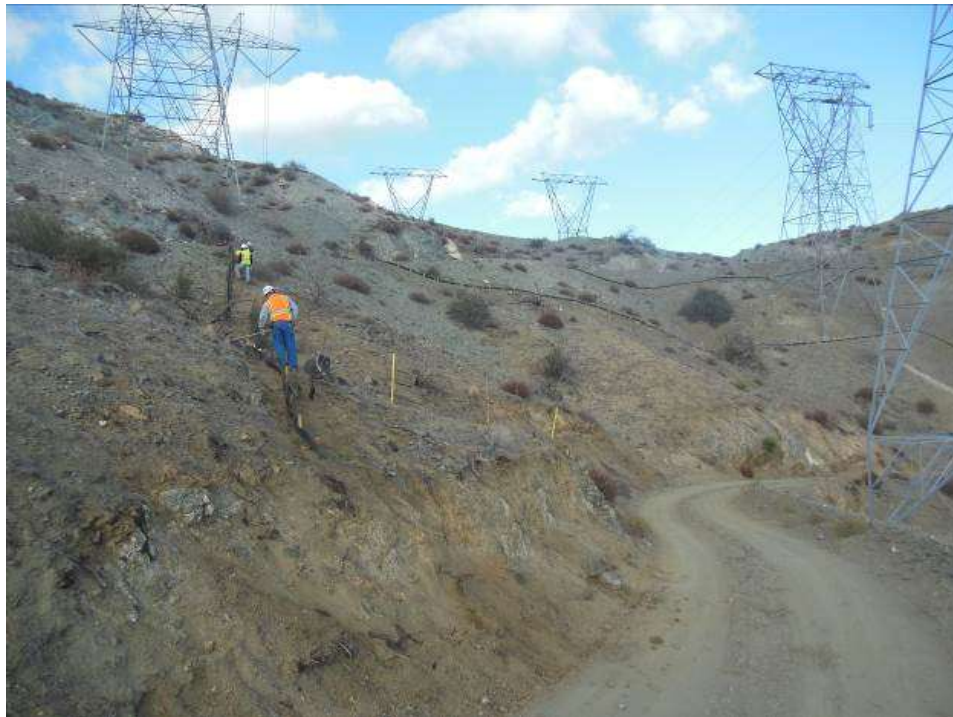
Figure 2: BMP installation at Construct 8 on Segment 11.

12. An NTP was issued by CPUC on October 10, 2013 for Segment 11C construction (see Table 1). Construction began in late-November 2013.
13. BMPs were installed at Constructs 0, 1, 2, 3, 4, 6, 7, 8, 9, 10, 11, 12, 19, 20, 21, 27, 28, 31 and M32-T2 and the Wire Setup/Pull Sites associated with Constructs 0, 11, 25, and 31 (see Figure 2).

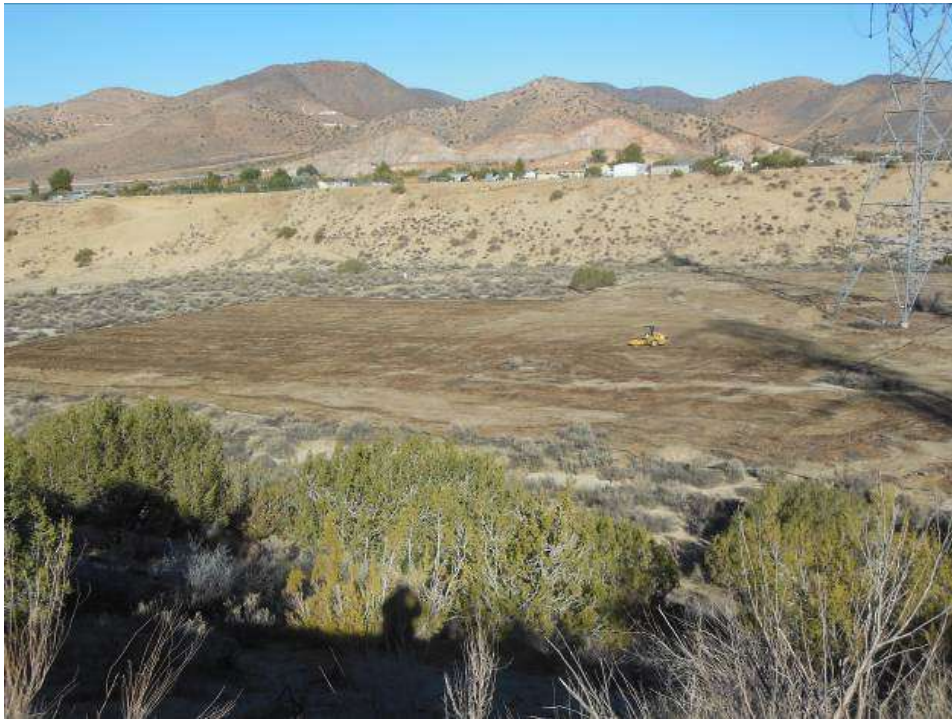
Figure 3: Grading at Wire Site associated with Construct 1 along Segment 11.

16. Grading activities were conducted at Constructs 0 through 12, M31-T5, and M32-T2, at the Wire Setup Sites for Constructs 1 and 11, and along Mt. Gleason Road and the spur road to Construct 9 (see Figure 3).

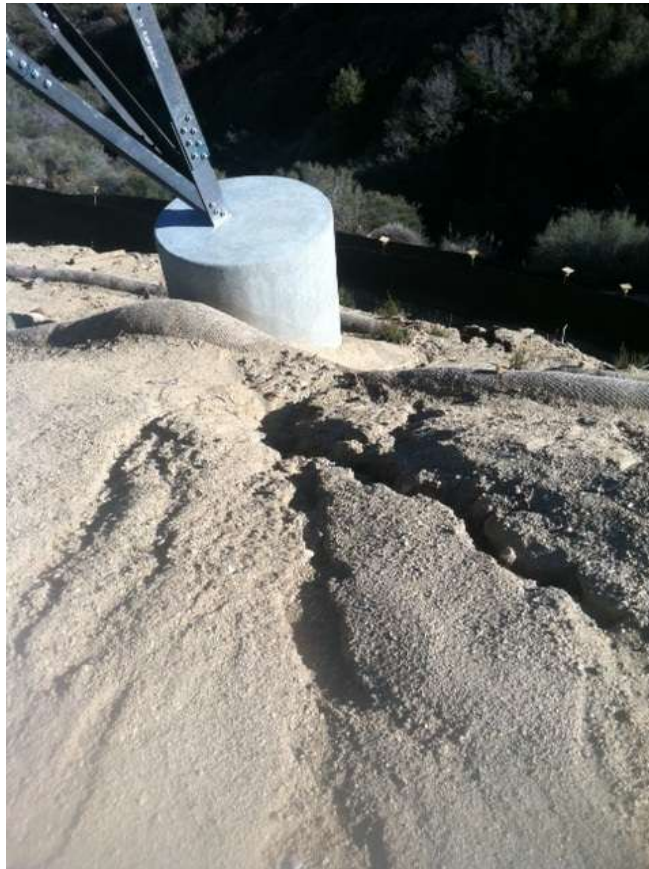
Figure 4: Rilling observed at Construct 58 on Segment 6.

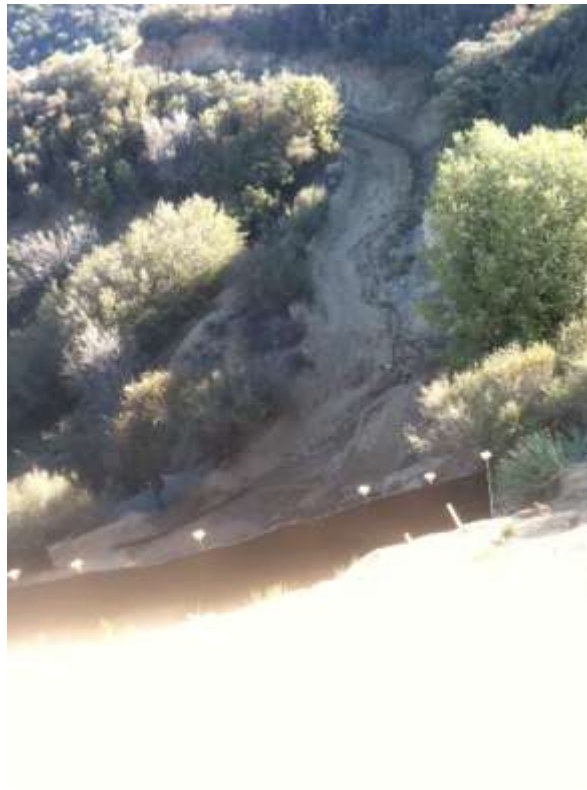
Figure 5: Sediment flow that can be seen going towards Waters of the US at Construct 58 on Segment 6.

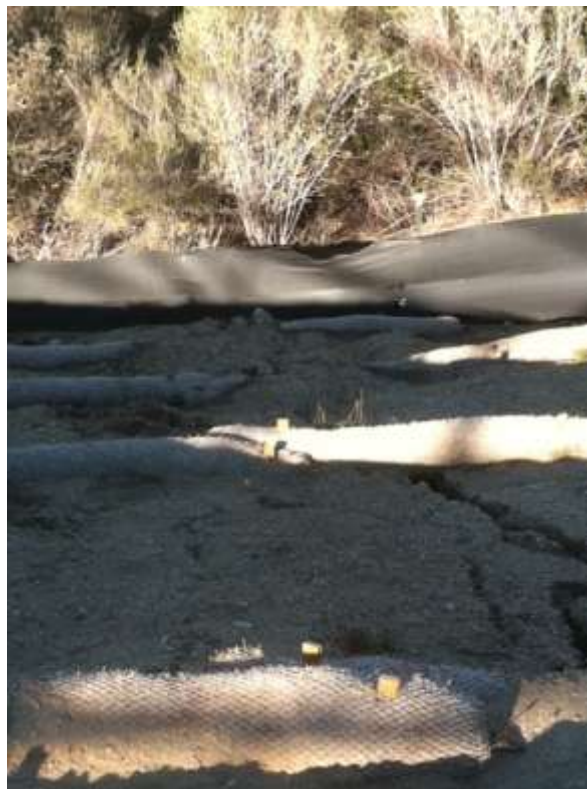
Figure 6: Sediment flow over installed BMPs at Construct 58 on Segment 6.

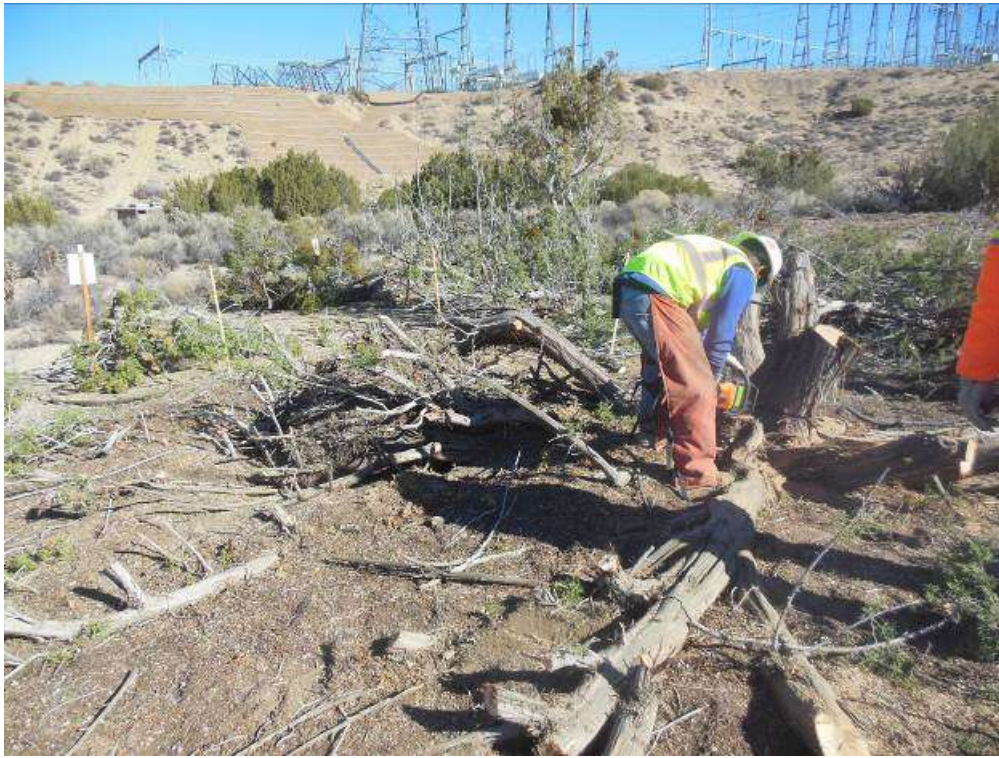
Figure 7: Woodrat midden daylighting (step 1 of the 2 step relocation process) along Segment 11.

20. No nesting bird buffer reduction requests were submitted by SCE to the USFS during the subject period.
21. San Diego desert woodrat middens located in Segments 6A off USFS lands were monitored by Project Biologists during the subject period. Several new middens were identified on Segment 11C. Thirty-five woodrat middens were relocated during the subject period (see Figure 7).

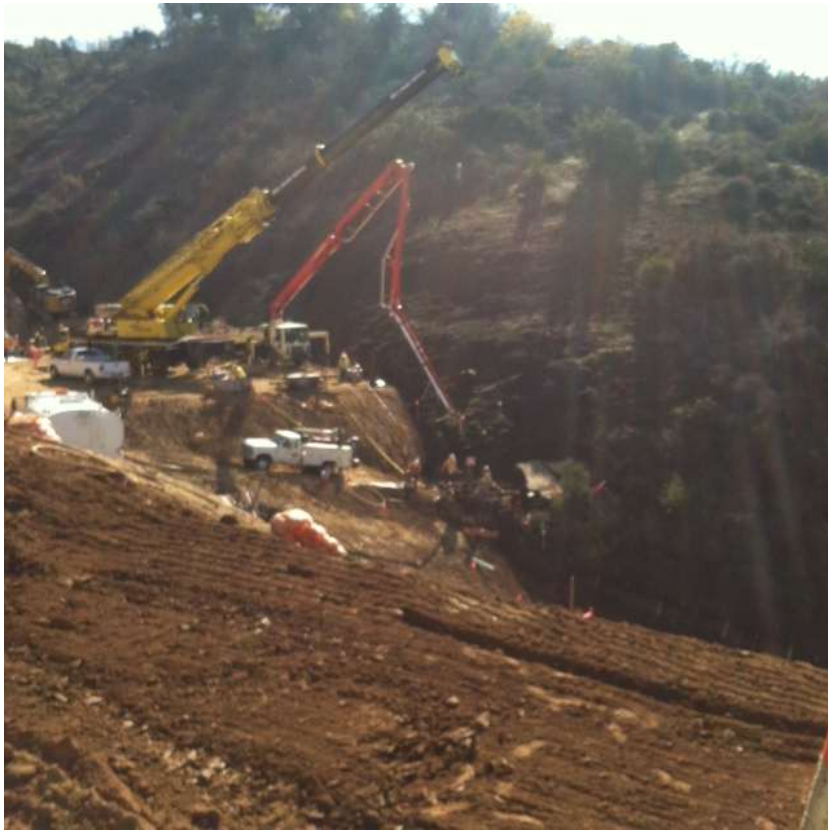
Figure 8: Union Engineering excavating and pouring foundations at Segment 8, Tower M57-T1.

5. Union Construction continued vegetation clearing and grading of the access road and temporary disturbance area for Tower M57-T1 in Tonner Canyon.
6. Union began the foundation excavation and pouring at Tower M57-T1 (see Figure 8).
7. Steel from Towers M60-T1, M60-T3, and M61-T1 in Chino Hills continued to be hauled off in preparation for the future underground work.
8. Recontouring of the disturbance area continued at Tower M60-T1 in Chino Hills.
9. Maintenance of erosion control devices took place at various work areas.
10. To date, 100% of the conductor and structures have been removed from the existing 220 kV Chino-Mesa and Mira Loma-Walnut and Mira Loma-Olinda lines.

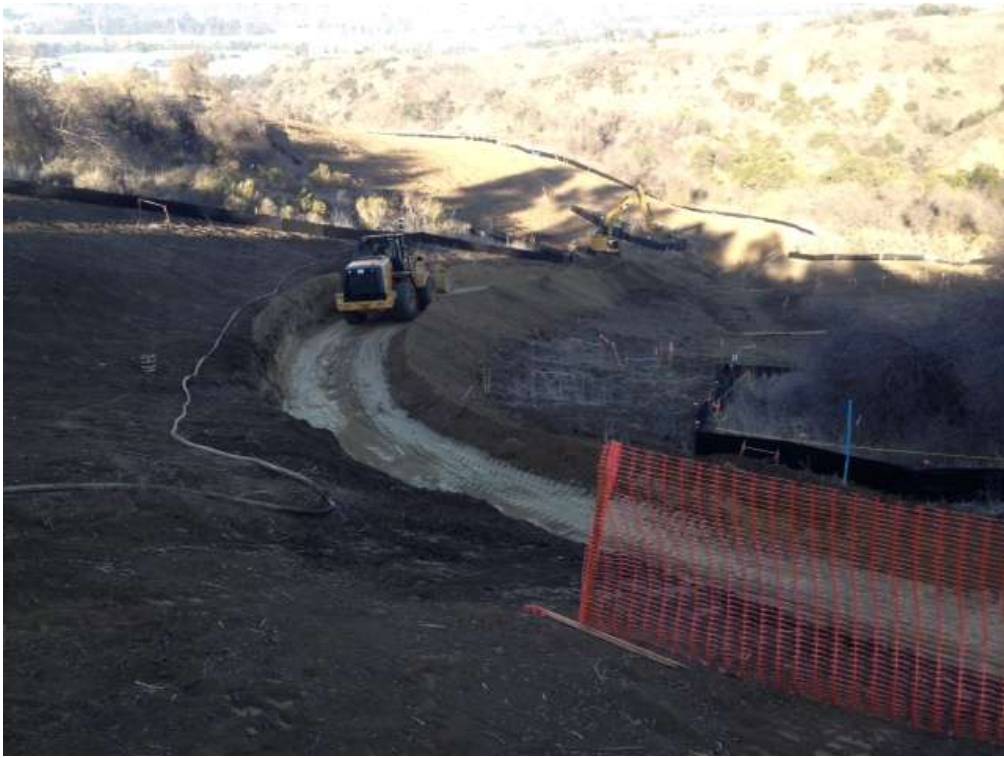
Figure 9: Patriot crews grading access road at Tower M43-T3 in Segment 8, Phase 4.

15. Patriot crews continued grading of the access road and tower disturbance area to Towers M43-T3 and M49-T1 (see Figures 9 and 10).
16. KV Structures continued foundation pouring at Towers M43-T3 and M49-T1.
17. ASB continued tower assembly at Tower M44-T3 (see Figure 11).
18. To date, 100% of the conductor and 100% of the structures on the existing 220 kV Chino-Mesa line have been removed.

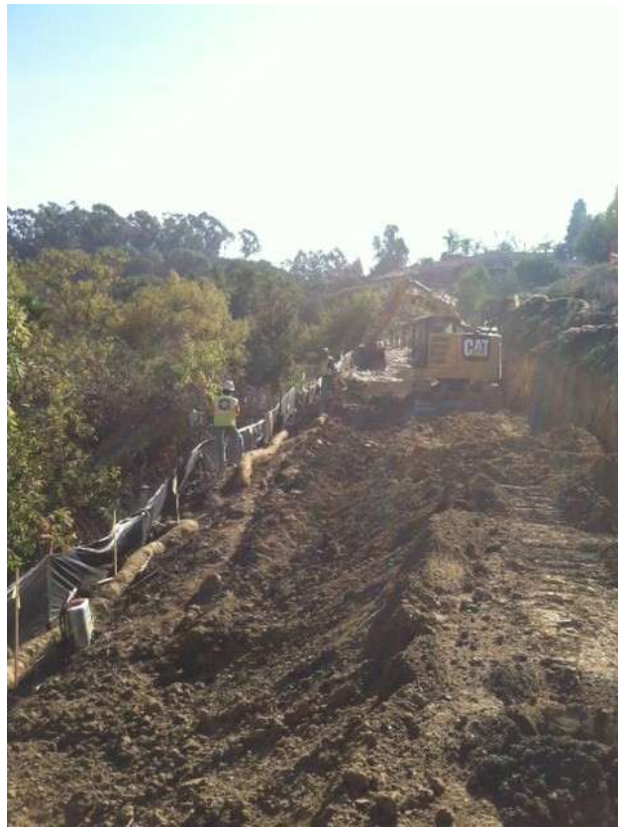
Figure 10: Patriot crews grading access road at Tower M49-T1 in Segment 8, Phase 4.

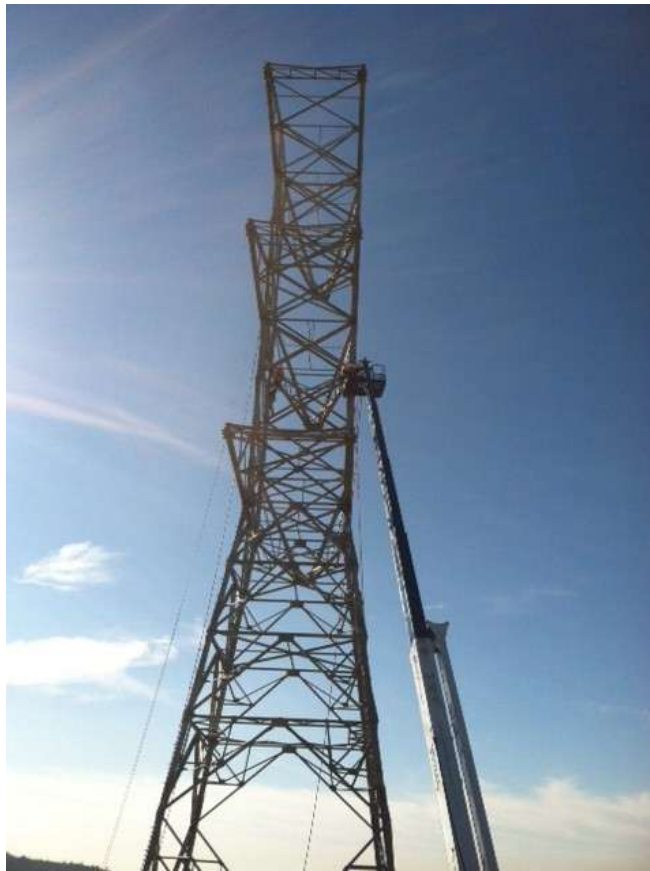
Figure 11: ASB crews assembling Tower M44-T3 in Segment 8, Phase 4.
