PROJECT MEMORANDUM SCE TRANSMISSION PROJECTS, SEGMENTS 1–11

Subject: Weekly Report 331: May 25 to 31, 2014

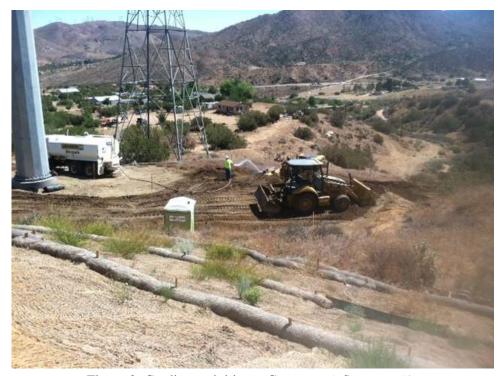
Figure 2: Grading activities at Construct 6, Segment 6A.

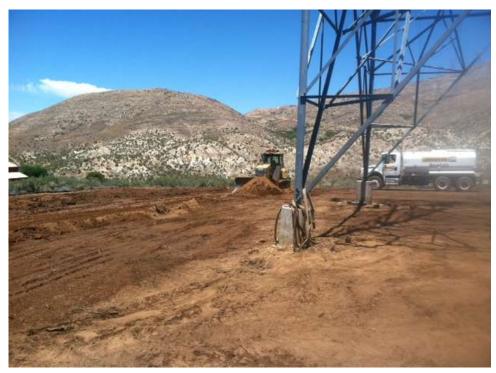
- 9. Vegetation clearing occurred at Construct 16, 46, 47, 48, 49, 50, 51, 52, and 55, and Mt. Gleason Road.
- 10. Road grading activities in areas of prior disturbance occurred at Constructs 9 and 16 (see Figure 3).

Figure 3: Grading activities at Construct 16, Segment 11C.

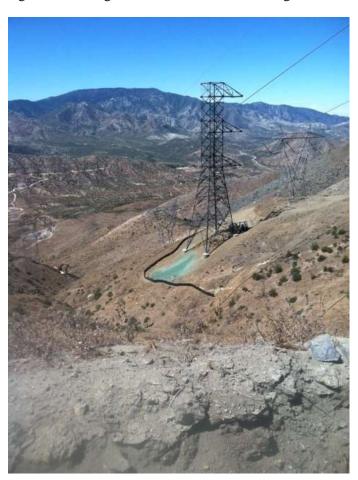
Figure 4: Hydromulching activities at Construct 9, Segment 11C.

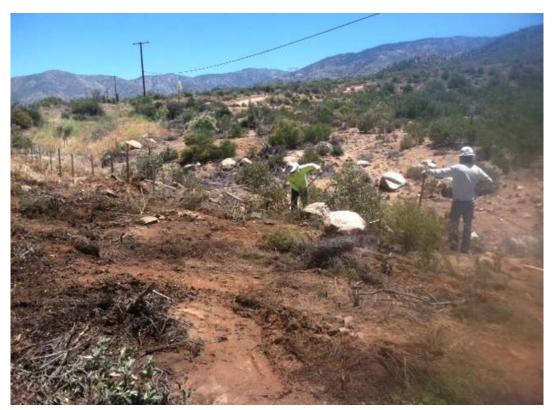
- 13. Foundation wreck-out occurred at Constructs 37, 46, and 47.
- 14. BMP installation, maintenance, and inspection occurred at various construction locations (see Figures 4 and 5).

Figure 5: BMP installation at Construct 16, Segment 11C.

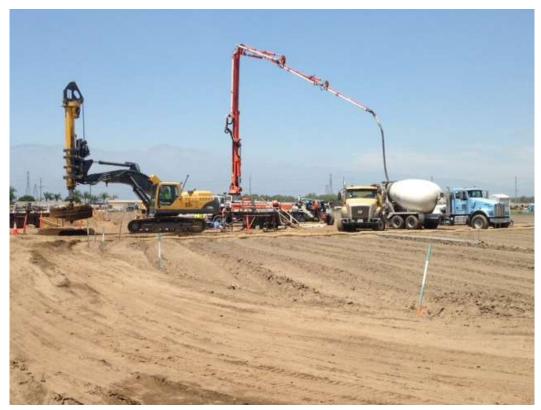
- 11. BMPs were installed/maintained at various locations.
- 12. Henkels and McCoy crews continued foundation installation activities at Tower M70-T5, M70-T6, M71-T1, and M71-T5 (see Figure 7).
- 13. Henkels and McCoy crews continued assembly activities at Towers M66-T6, M66-T7, M72-T1, M71-T6, M72-T2, M72-T3, and M73-T2 (see Figure 8).

Figure 7: Tower foundation pouring at Tower M70-T6, Segment 8, Phase 3.

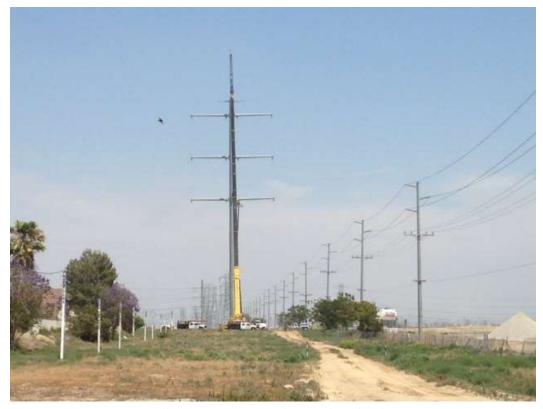
Figure 8: Crews assembling Tower M72-T2 in the City of Chino, Segment 8, Phase 3.

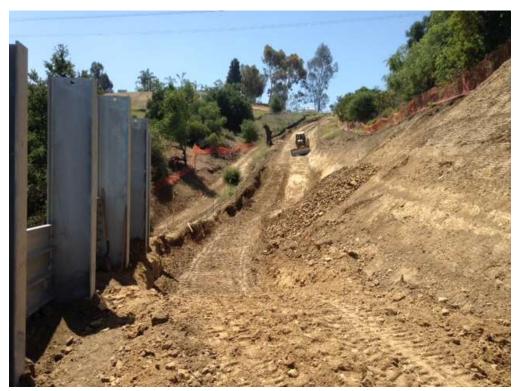
Figure 9: Patriot crews continue grading the access road and Hilfaker wall construction at Tower M49-T1, Segment 8, Phase 4.

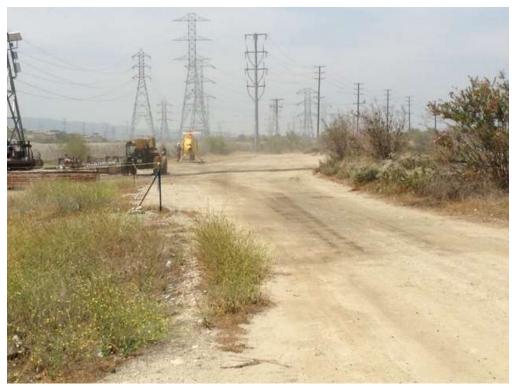
- 9. On May 29, the CPUC EM observed a PAR helicopter conducting operations from an access road outside of approved disturbance limits. During these operations large amounts of fugitive dust was observed leaving the area as it was not watered prior to the work beginning (see Figure 10). While the CPUC EM was onsite the helicopter moved to within the disturbance limits and a water truck arrived to control the fugitive dust. The SCE Environmental Coordinator was informed of the observations.

Figure 10: CPUC EM observed a PAR helicopter conducting operations from an access road outside of approved disturbance limits, Segment 8, Phase 4. During these operations large amounts of fugitive dust was observed leaving the area as it was not watered prior to the work beginning.

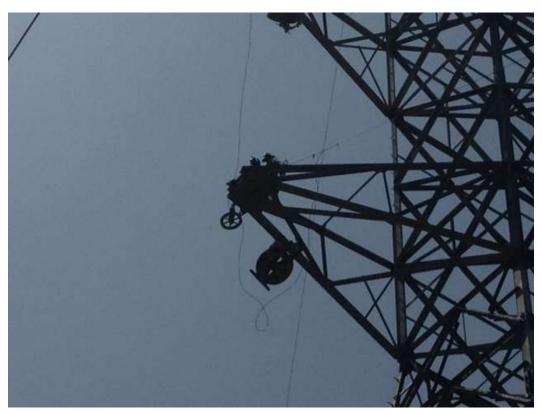
- 17. During the subject reporting period SCE provided notification of the removal of two active and one inactive nest on Segment 8. A house sparrow nest was removed from a crane at Tower M72-T3 and a Cassin's kingbird nest was removed from partially built Tower M72-T2. Both nests were in the early nest building stage. On May 30, and inactive raptor nest was removed from Tower M43-T1. The CPUC EM was onsite for the removal and observed the proper protocol was observed for the duration of the removal (see Figure 11).

Figure 11: Inactive, vacant raptor nest removal from an arm of Tower M43-T1, Segment 8, Phase 4. The CPUC EM was onsite for the removal and observed the proper protocol was observed for the duration of the removal.
