**PROJECT MEMORANDUM  
SCE TRANSMISSION PROJECTS, SEGMENTS 1–11**

**To:** John Boccio, Project Manager, CPUC  
**From:** Vida Strong, Aspen Project Manager  
**Date:** January 12, 2015  
**Subject:** Weekly Report 360: December 14-20, 2014

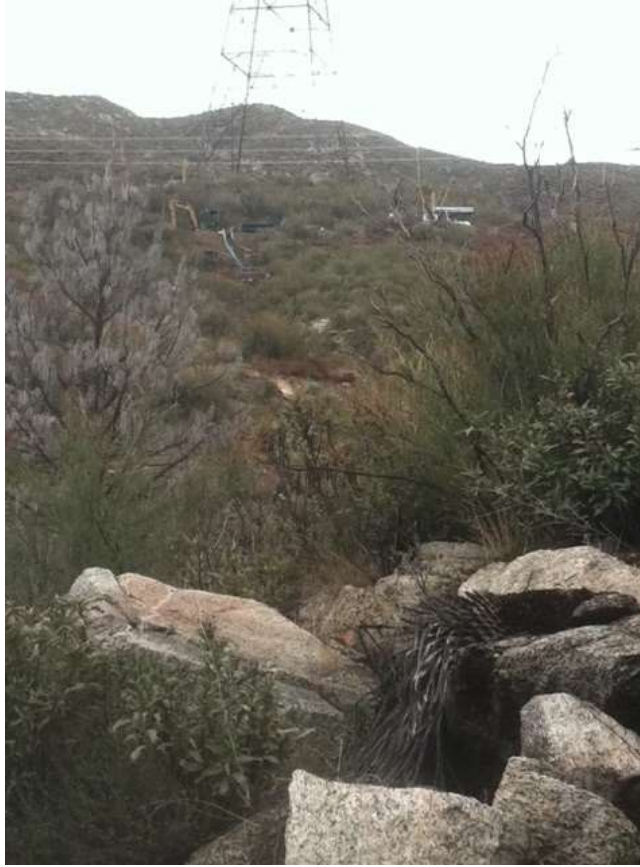
Figure 1: Road grading activities on Loop Road H, Segment 6B.

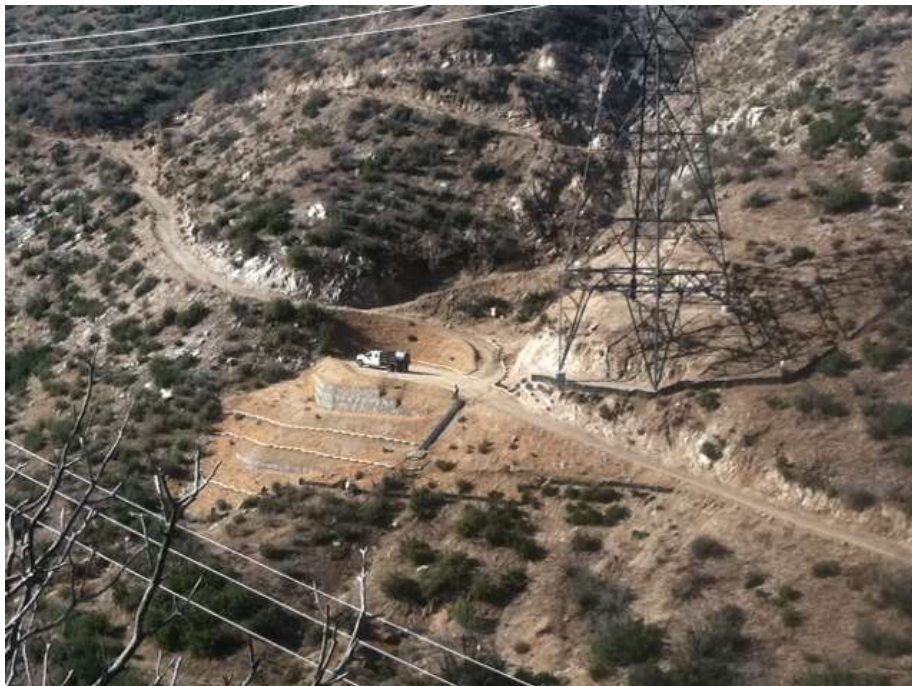
Figure 2: BMP maintenance at Construct 33, Segment 6A.

1. Due to rainy weather, work was cancelled by SCE on ANF lands for December 17.
2. Construction of the Segment 6 transmission line has been completed. Remaining work including restoration activities at temporary disturbed areas have yet to be scheduled. Erosion control maintenance, weed abatement, and road finalization are ongoing.
3. Road and tower grading activities occurred at the following locations: Constructs (towers) 5 and 21, and Loop Roads B and H (see Figure 1).
4. Drainage improvements and wet crossing installation/maintenance occurred at Jurisdictional Drainages throughout Segment 6.
5. BMP installation and maintenance occurred throughout Segment 6 (see Figure 2).

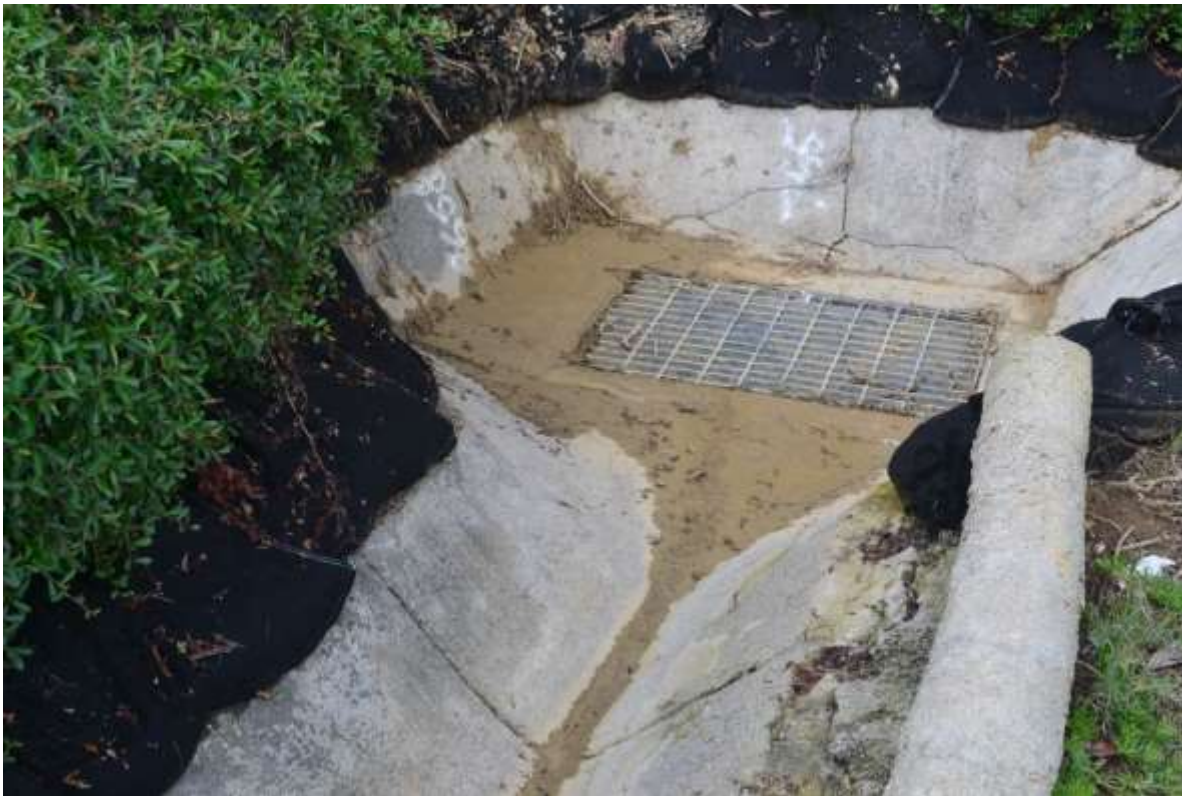
1. On December 18, the CPUC EMs conducted a field tour of the Chino Hills Underground right-of-way after the rain event that occurred the night before. Many areas of the right-of-way showed erosion and offsite sedimentation. A meeting with SCE's project management and SWPPP professionals was scheduled for the following day and these areas of concern were revisited. SCE's SWPPP Inspectors produced an Inspection Report documenting the necessary BMP repairs and additional recommendations that were identified on the field tour. Many of the outstanding items were addressed that day, and the others were completed by the following week. The CPUC EM prepared a memo for the CPUC outlining the areas of concern and the current status of repairs/clean-up for these areas (see Figures 3 and 4).

Figure 3: An unprotected storm drain with accumulated sedimentation from nearby project graded areas, Vault Cluster #11, 500 kV Underground.

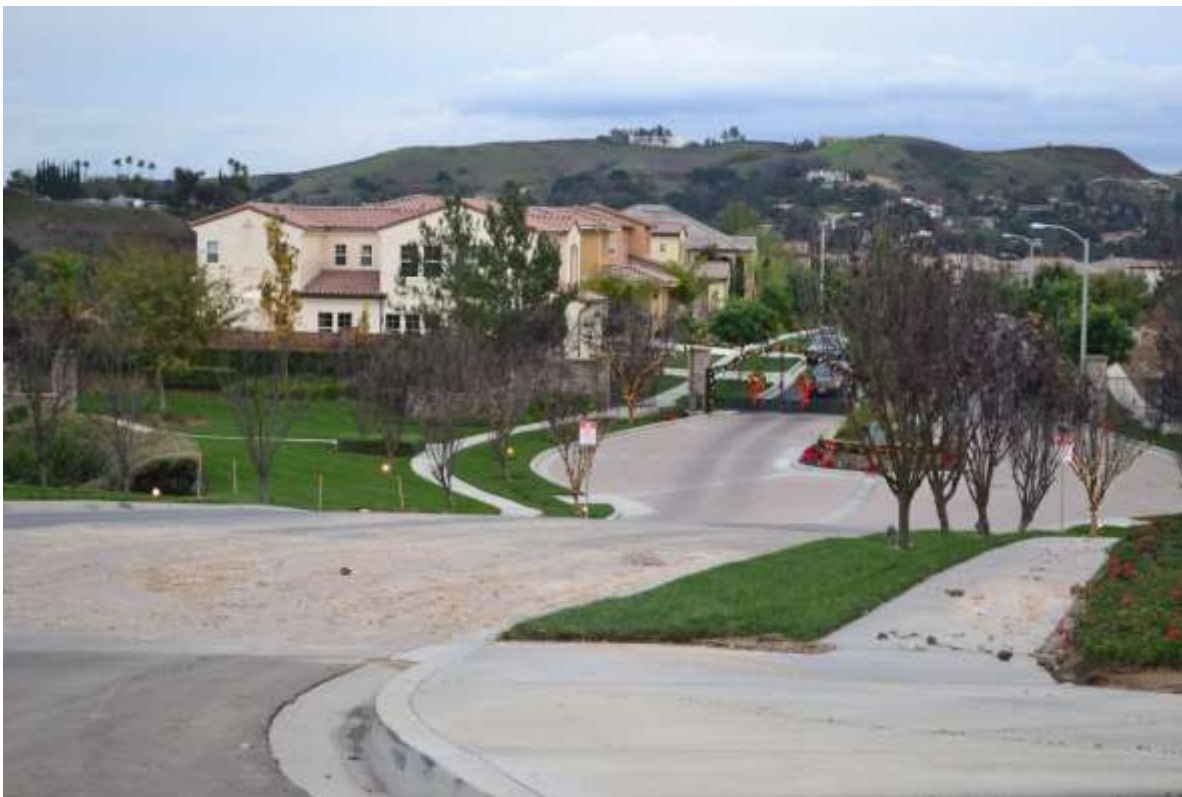
Figure 4: Offsite sedimentation onto Canon Lane in Chino Hills after the rain event on December 17. Construction street sweepers removed the sediment the following day.

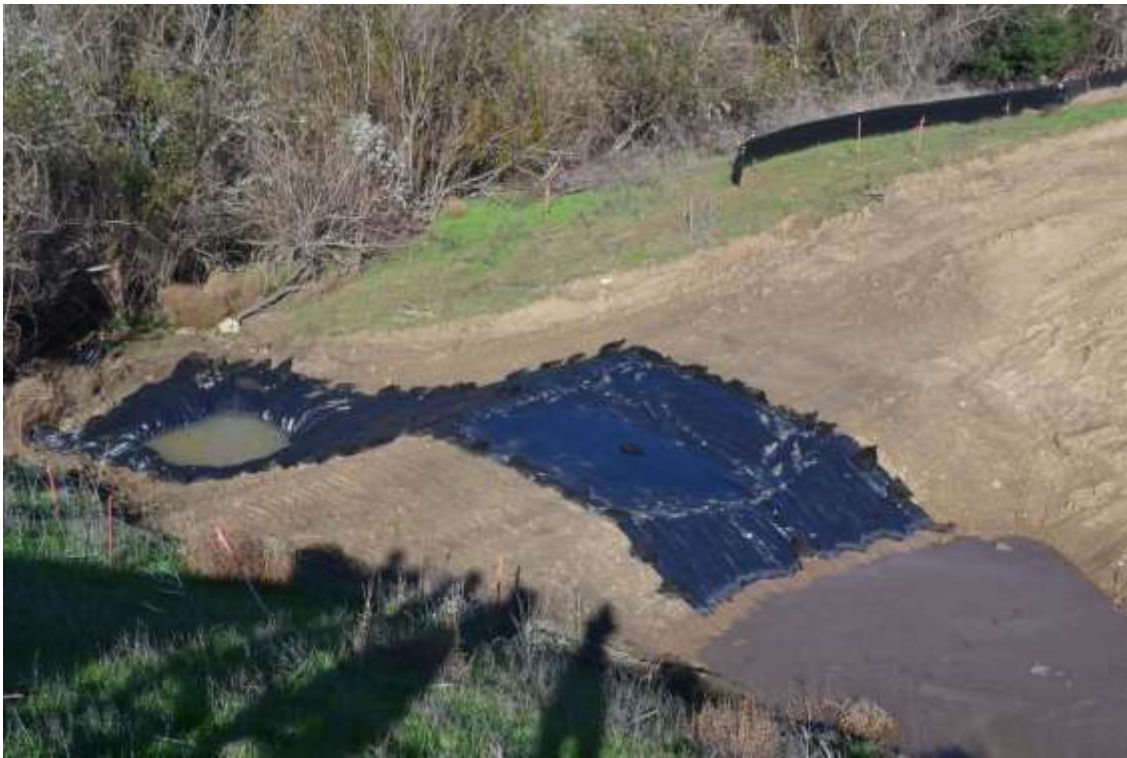
2. Keyway trenches used to collect rainwater were pumped out by crews into water trucks for use as dust control elsewhere on the site. The keyways and sediment traps at the WTS were observed to be a potential safety hazard to the public because the excavations are not fenced and also as a trap for wildlife because no escape ramps were in place. These concerns were relayed to SCE and corrected by December 23 (see Figure 5).

Figure 5: Settling ponds at the WTS used to collect and settle turbid water before it runs offsite. These pools were the subject of a safety concern for the public and were eventually fenced.

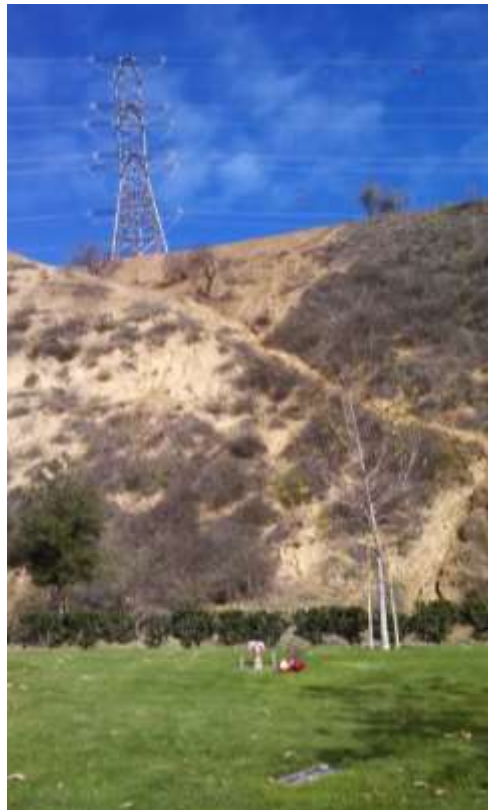
3. Details of incidents relating to offsite sediment discharge that occurred after the rain even on December 12 were provided and are summarized as follows: sedimentation discharging into JDID 8-20-S-400 near Segment 8, Construct M49-T1; sediment discharge in the JDID 8-33-S-200 on Segment 8 west of Construct M57-T1; and sedimentation discharging off site and into Rose Hills cemetery on Segment 8 near Construct M44-T2 (see Figure 6).

Figure 6: Erosion gully evident at Tower M44-T2 adjacent to Rose Hills Cemetery. Offsite sedimentation was documented by SCE's monitors.

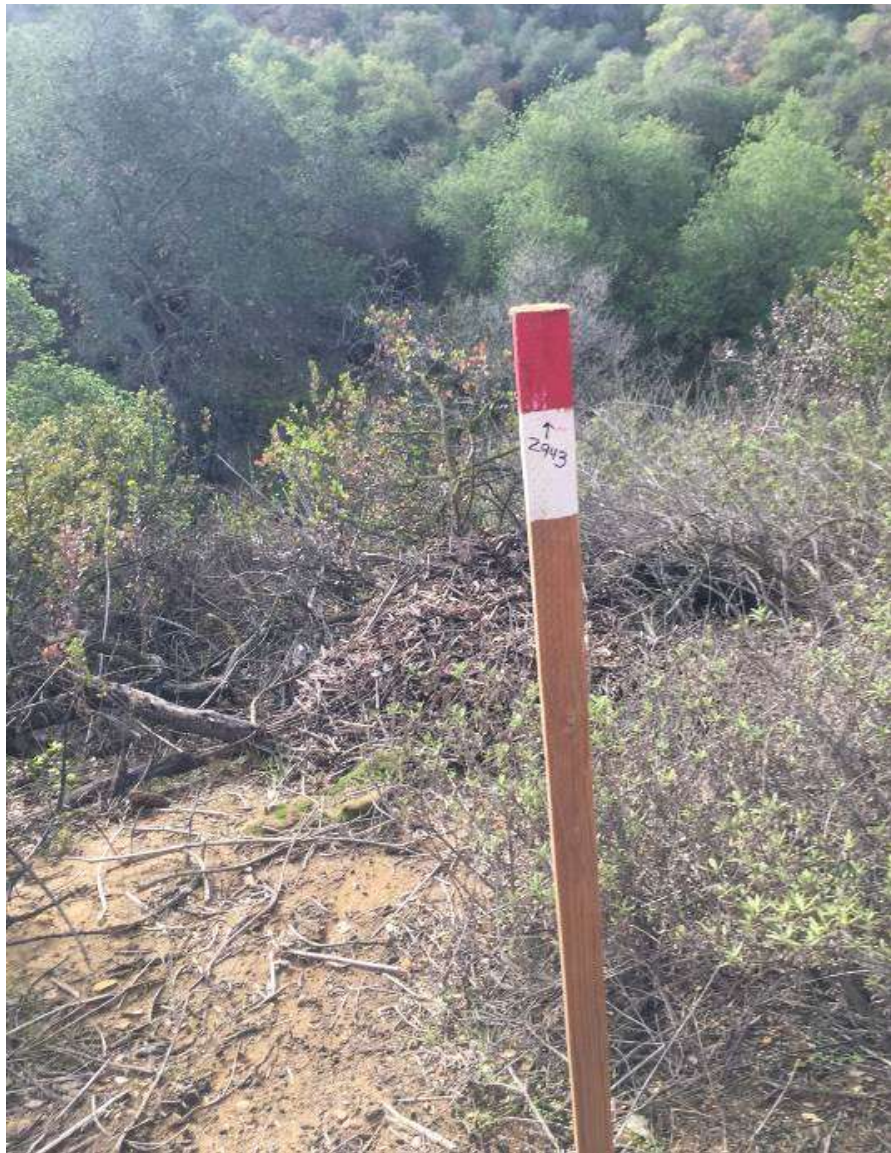
5. On Segment 8, Phase 1, offsite sedimentation from recent rains was observed at five locations at WSS M55-T2/M56-T1. Distances of sedimentation were observed to be between 22 and 200-feet offsite of the work area. Four out of these five instances impacted adjacent San Diego woodrat middens (see Figure 7).

Figure 7: Offsite sedimentation into adjacent San Diego woodrat middens near Tower M55-T2, Segment 8, Phase 1. (Photo courtesy of FRED)
