PROJECT MEMORANDUM

ANTELOPE TRANSMISSION PROJECT, SEGMENTS 1, 2 AND 3A

To: John Boccio, Project Manager, CPUC
Justin Seastrand, Project Manager, ANF
From: Vida Strong, Aspen Project Manager
Date: September 24, 2009
Subject: Weekly Report 88; September 13 to September 19, 2009

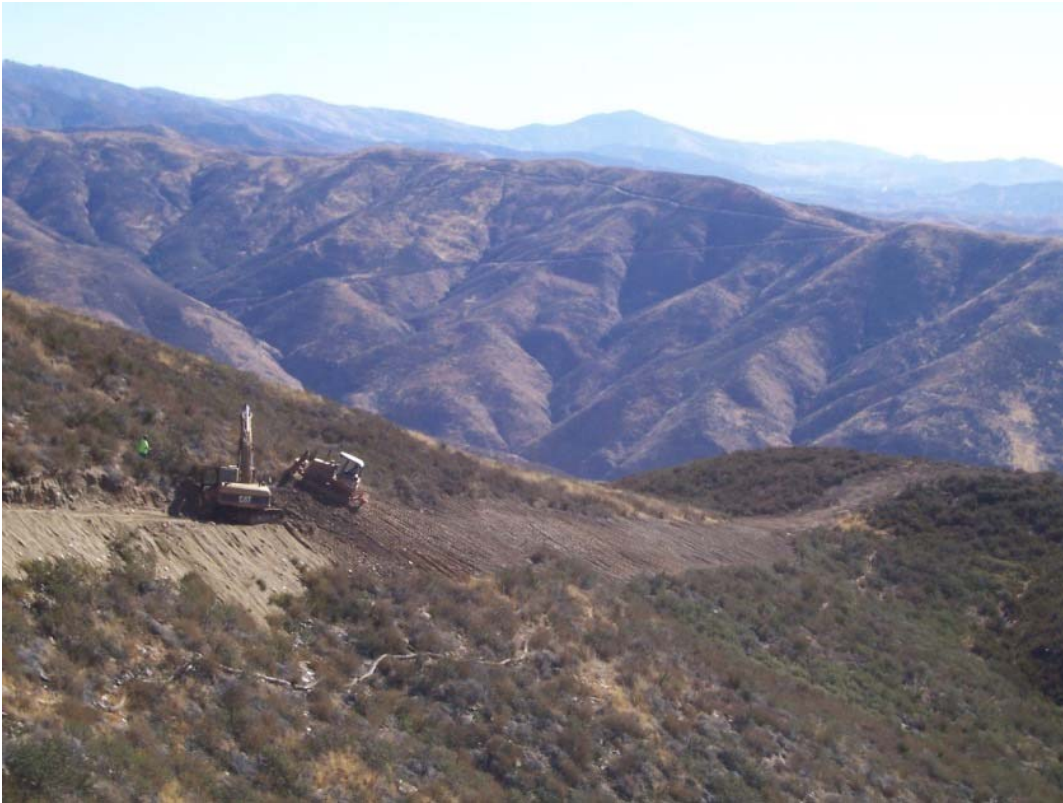
Figure 1: Road SR41 restoration on the ANF.

2. Colwell crews continued the restoration and recontouring of SR 41. The recontouring work at this location is expected to last another few weeks (see Figure 1).
3. Slope stabilization work proposed at Tower 45 was approved by the ANF during the subject week. Final design of the stabilization will depend on geotechnical boring at the slide area.

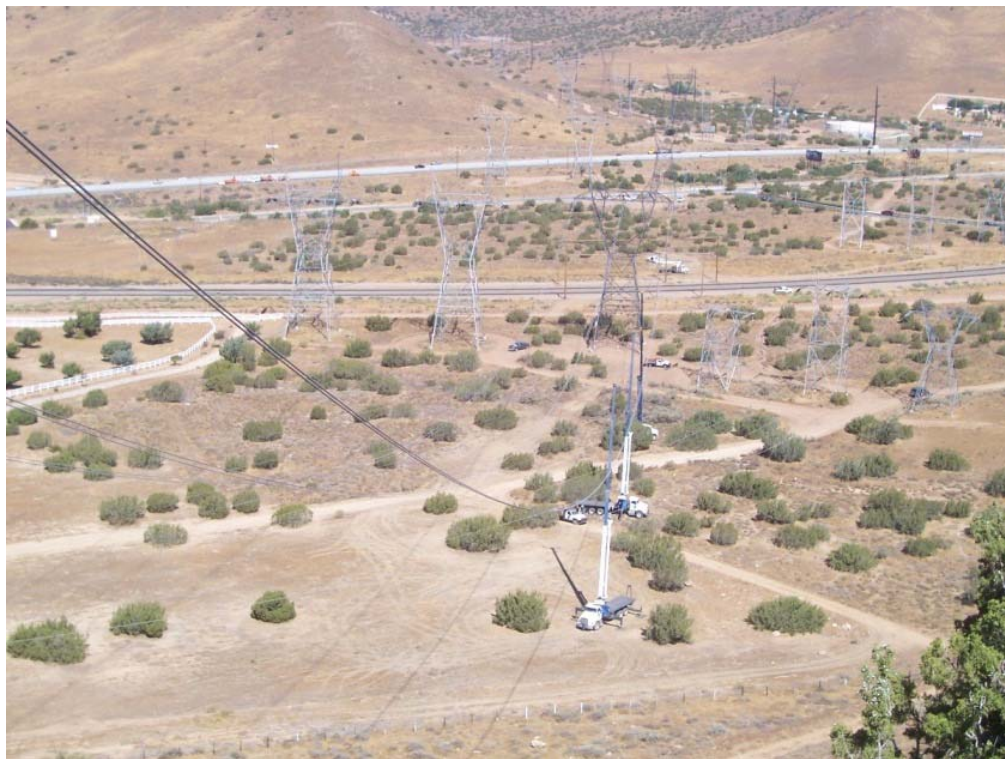
Figure 2: Wire stringing between Towers 113-115 Segment 2.

1. During the subject period, UPC crews completed clipping in and sagging between Towers 51-65 and begun conductor installation between Towers 65-76.
2. PAR crews started wire stringing activities between Towers 113-115 and VSF2-3 (see Figure 2).
3. The temporary bypass or bootleg of the 12 kV distribution line near the Vincent Substation was completed (lowering and undergrounding of the line to facilitate wire stringing).
4. Steel assembly continued between Towers 76 and 68.
5. PAR crews have completed steel assembly at Towers 1-69, 71-75, 80, 82, 84, 85, 92, 94- 115, VSF1-VSF5.
6. Wire conductor installation (wire stringing, clipping in, and sagging) has been completed between Towers 1-51, 105-113, 110-113, and VSF1-VSF5.

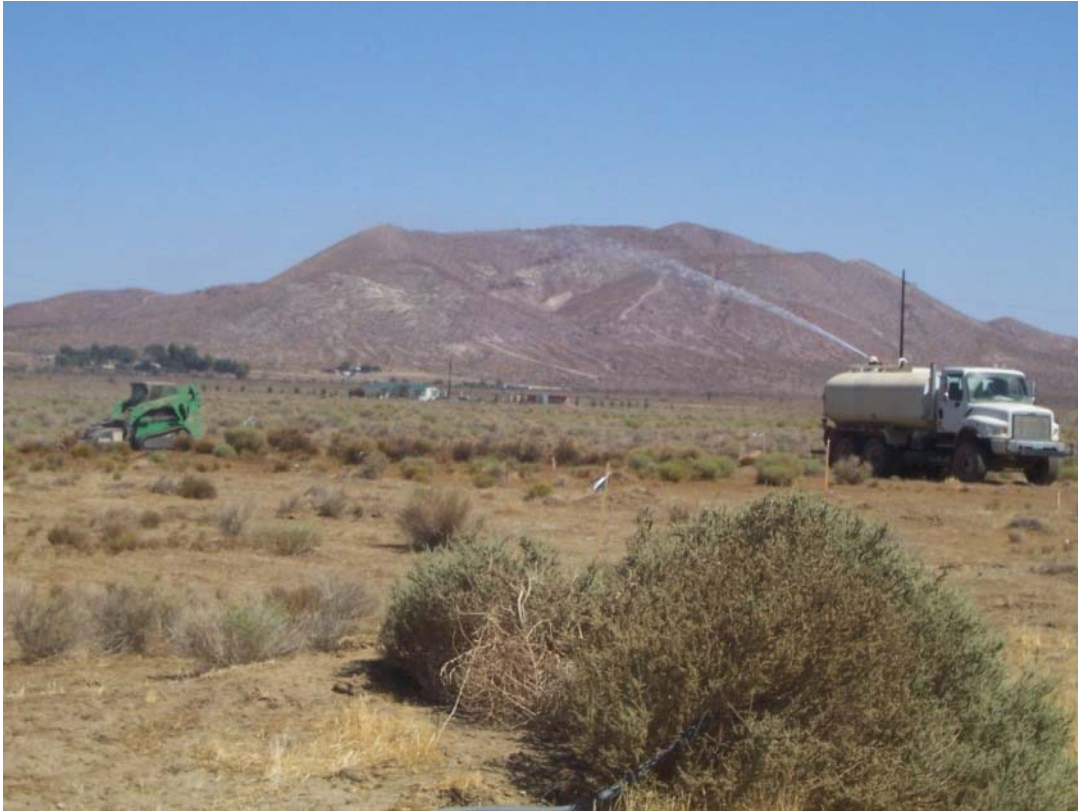
Figure 3: Vegetation removal Tower 52 Segment 3A.

2. Vegetation clearing began at Towers 49, 50, and 51 (see Figure 3).
3. Tower 52 was drilled and the steel cage was installed at Tower 53.
4. PAR crews continued assembly of lattice towers in Segment 3A.

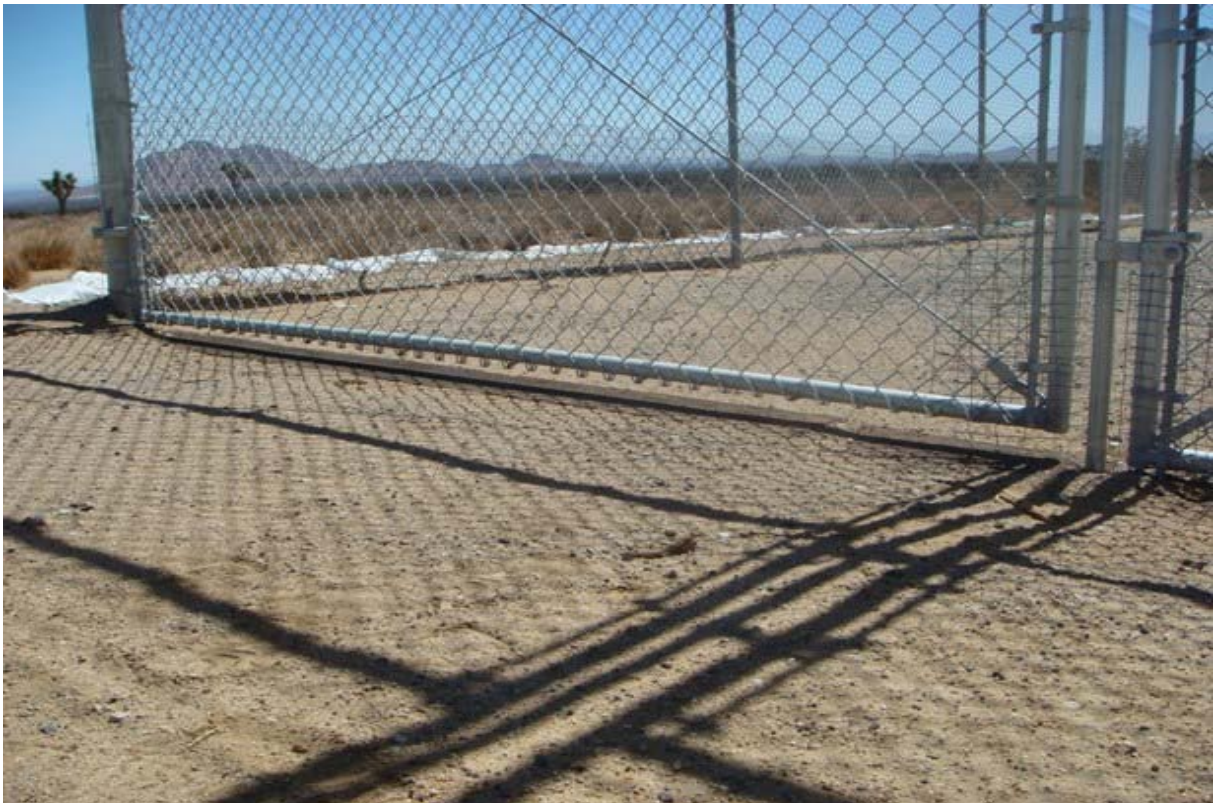
1. During a site visit to the Windhub Substation, the CPUC EM noticed that a gate installed on the east side of the property did not have tortoise fencing installed. There was a small gap visible under the gate, which could allow small tortoises into the substation property (see Figure 4). A straw wattle was previously being used as a barrier, but was not in place at the time. SCE was reminded to address the gap in the fence to comply with tortoise fencing requirements.

Figure 4: Gap under the fence on the east side of the Windhub Substation.
