PROJECT MEMORANDUM DELTA DPA CAPACITY INCREASE SUBSTATION PROJECT

Subject: Weekly Report #14: December 9, 2007 – December 15, 2007

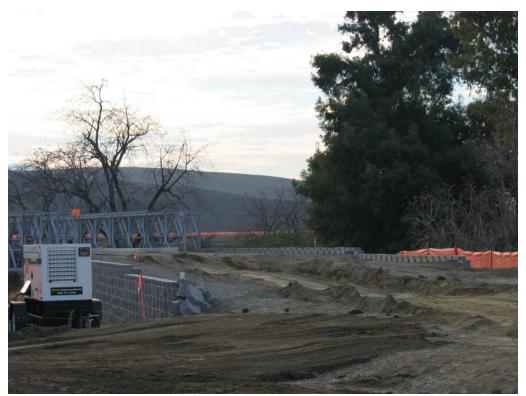
On Wednesday, at the time of the CPUC EM site visit, crews were recompacting an area on the north side of the bridge approach where the soil had not stayed compacted (see Figure 1). Guard rails along the bridge still need to be installed.

Figure 1 – Recompacting soil on north side of bridge over Sand Creek, December 12, 2007.

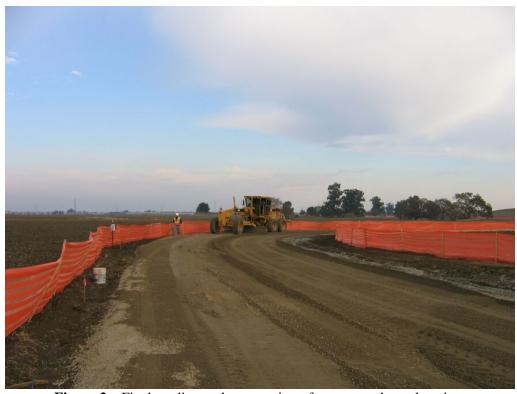
On Tuesday, the last delivery of base rock for the access road was brought on site. On Wednesday, crews completed final grading and compacting activities (see Figure 2).

Figure 2 – Final grading and compacting of access road to substation, December 12, 2007.

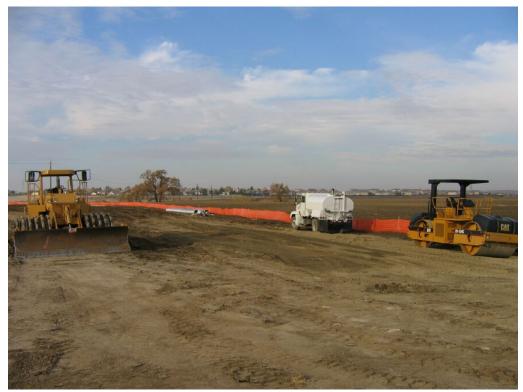
Figure 3 – Grading and compacting work at substation site, December 12, 2007.

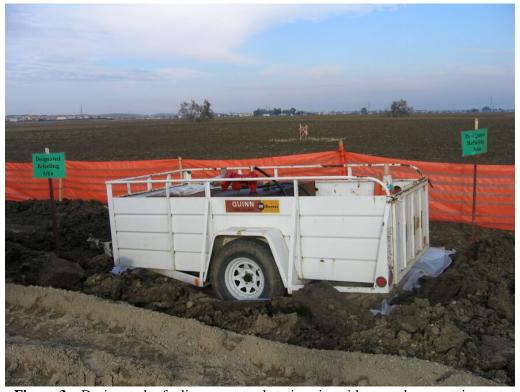
At the beginning of the week, crews continued grading and compacting the substation site (see Figure 3). On Thursday, crews began importing fill required for the substation pad. The fill was laid down in layers and then compacted. Also, a refueling area was designated in the substation site for heavy equipment. A small trailer containing a diesel fuel tank was stationed in a bermed area with secondary containment laid underneath the trailer (see Figure 4).

Figure 3 – Designated refueling area at substation site with secondary containment, December 12, 2007.
