PROJECT MEMORANDUM SDG&E – MIGUEL-MISSION 230 KV #2 PROJECT

Subject: Weekly Report #65: November 27 – December 3, 2005.

PERMANENT 230 kV INSTALLATION

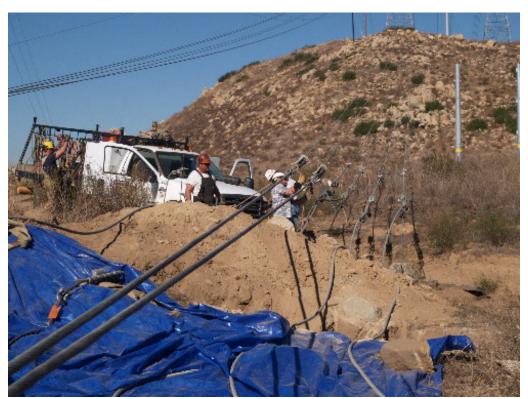
Figure 1 – A Wilson crew was set up off Camino Monte Sombra during the stringing and sagging operation.

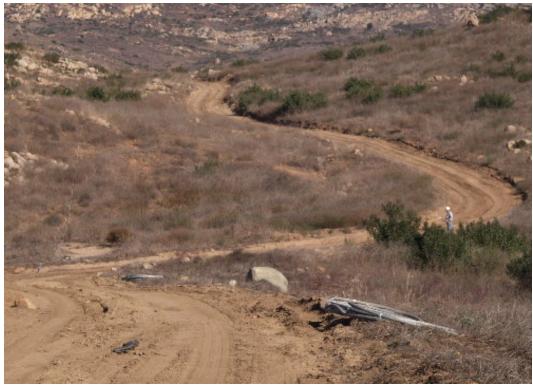
- 2. During the stringing of the last conductor on this segment on Monday, November 28th, a section of the conductor near Tower 25 touched the ground and was damaged. This approximately 1400-foot section of conductor needed to be removed and an undamaged section of conductor strung in its place. The contractor attempted to lay the damaged conductor along the road; however, due to the curve of the road and the weight of the conductor, it moved into the vegetation (see Figure 3). The Essex EI was not informed until after the incident. SDG&E notified the CPUC EM on December 28th.

Figure 3 – The damaged conductor was cut into smaller sections and rolled by hand since the reel truck was not available. Note the conductor going through the vegetation up the left side of the photograph.

- 1. SDG&E has been maintaining BMPs on the tower pads and dirt tracked onto public streets is cleaned up at the end of each day.
- 2. The off right-of-way incident with the conductor on Monday, November 28th was discussed in length during the weekly construction meeting on November 29th. Although the area impacted was CSS habitat severely degraded by fire several years ago, the area is recovering and is still protected. The conductor was cut into manageable sections and removed from the road by hand. The additional section in the habitat will be removed with the Essex EI on-site. SDG&E reminded the contractor that all work must remain in the Area of Potential Effect (APE) approved in the EIR and that the Essex EI and SDG&E need to be informed if any impacts are anticipated. In reviewing the impacts, the CPUC EM noted minor impacts to vegetation from the conductor and a small area of disturbance where the Caterpillar bulldozer left the access road. This report will serve as a written warning to keep project activities on the right-of-way and further incidents could result in the issuance of a Project Memorandum or Project Non-Compliance.

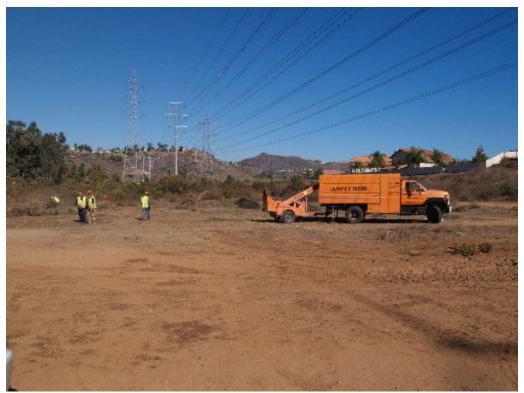
- 3. A clearing crew worked to clear the vegetation from the edges of the approved work area at the Herrick Center (see Figure 4). This crew worked on the project previously, but the Essex EI provided a refresher on the environmental training. The union rules require a gravel show up area for the workers to park personal vehicles. In order to address this issue, Wilson proposes placing gravel in the area south of the Herrick Center, adjacent to the ambrosia populations. SDG&E has been informed that only temporary impacts were address for this location in the EIR and no permanent improvements are permitted. If the gravel is placed in this location, the gravel will need to be placed in such a manner that it can be completely removed prior to restoration of the project in this area. The area of impact has increased with the laydown of construction material and equipment beyond the original dirt area adjacent to the center's parking area. Any areas outside the original dirt overflow parking area will need to be decompacted and allowed to return to their original state as part of the restoration for the project.

Figure 4 – The clearing crew worked on the edges of the approved laydown area on the east side of the Herrick Center.

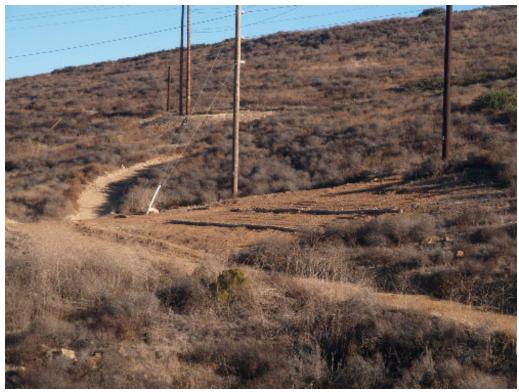
Figure 5 – The fiber rolls and water bars on the old stringing site near the Miguel Substation have been increased and improved.

3. SDG&E brought on a special crew to place, maintain, and improve BMPs on the project to prepare for the official start of the rainy season and to maintain BMPs now that it has started. The CPUC EM reviewed BMPs on the right-of-way and noted that most pads are ready for winter rains. The CPUC EM informed SDG&E that the installation of fiber rolls with thick wooden stakes breaks the nylon mesh that holds the roll together and allows the roll to float when hit with flowing water. Many of the fiber rolls from the previous winter show signs of water passing under the rolls (erosion under the rolls). A properly installed fiber roll will stay firmly attached to the ground and any failure will occur with materials flowing over the roll. It should not be possible to lift the fiber roll at any point along the run if properly installed. If chronic failure of properly installed fiber rolls is observed, another BMP may be more appropriate. During the follow-up inspection of BMPs, the CPUC EM noted that the fiber rolls in those locations visited have been secured to the ground (see Figure 5). In addition, sand bags have been used to augment the fiber rolls where needed. The Testing Engineers inspector has prepared a punch-list with BMP issues that still need to be addressed. Many of the access roads maintained by SDG&E crews not related to the project were graded dry and have been subsequently compacted to minimize erosion during use by the project.
