PROJECT MEMORANDUM PG&E - TRI-VALLEY 2002 CAPACITY INCREASE PROJECT

Subject: Weekly Report #18: January 13, 2003 – January 19, 2003

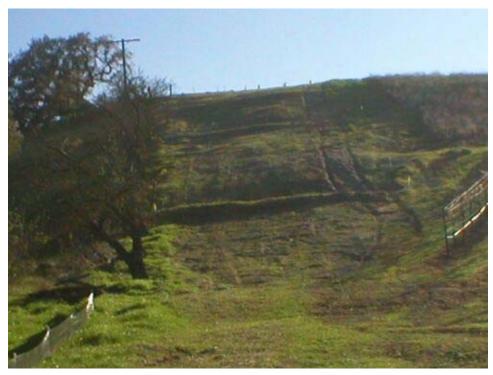
Figure 1
Erosion control installed over the trench line over a slope area is holding well. Water bars were installed and netting staked in and hydro seeded.

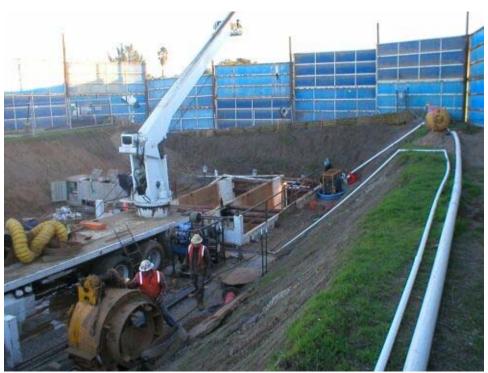
Figure 2
Arroyo del Valle northern bore pit. Note the sound wall constructed around the site.

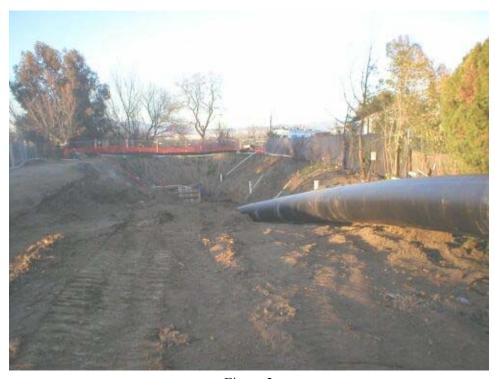
Figure 3
Arroyo del Valle southern bore pit. Note the casing which will be pulled back through the bore hole.

At the Arroyo del Valle bore, the pipe stem had been jacked under the crossing prior to the beginning of the subject week. Boring operations continued and by the end of the subject week, High Density Polyethylene (HDPE) pipe had been attached to the steel bore casing and completely pulled back through the bore hole, thus completing the first of the two bores at the site (see Figures 1 & 2). Crews continued to de-water the northern and southern pits. On Thursday, January 16, an oily sheen was seen on the northern bore pit Baker tank. De-watering was halted and samples were collected for testing. Crews continued to de-water the southern pit Baker tank.

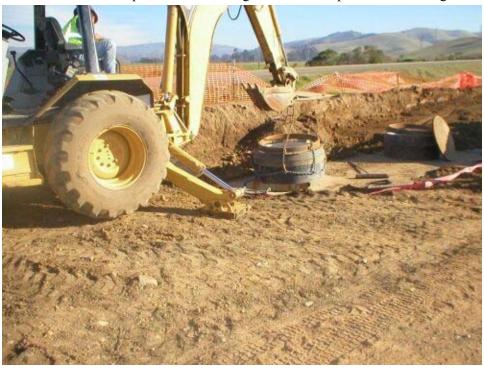
Figure 4 Vault 3A and 3B construction.
