# PROJECT MEMORANDUM PG&E – TRI-VALLEY 2002 CAPACITY INCREASE PROJECT

**Subject:** Weekly Report #13: December 9, 2002 – December 15, 2002

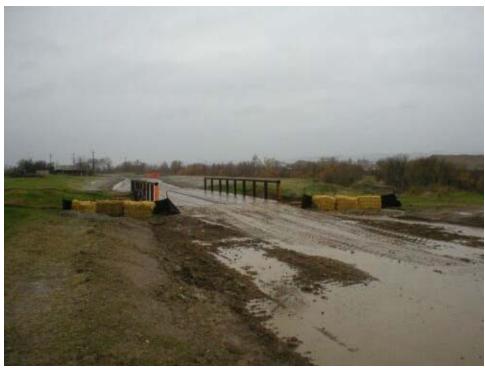
Figure 1
Additional erosion control installation near a drainage area along New Vineyard Road.

Along New Vineyard Road the contractor has completed conduit installation and backfilling. Work along New Vineyard Road is almost complete, only the vault construction and tie-ins remain outstanding. In preparation for the wet weather conditions, crews compacted and graded the road where work has been completed. Some gravel has also been laid down as cover. Excepting a few locations the grading operations have restored the Road to pre-existing conditions left by the City of Pleasanton. During the subject week silt fencing and hay bales have been placed along road to catch runoff. Additional Hay bales were placed along the drainage within New Vineyard Road to filter runoff from the roadway. During the rain events the erosion control devices were filtering runoff to a large extent. However it is inevitable that the devices will not contain everything due to the unpaved road conditions (See Figures 1 and 2).

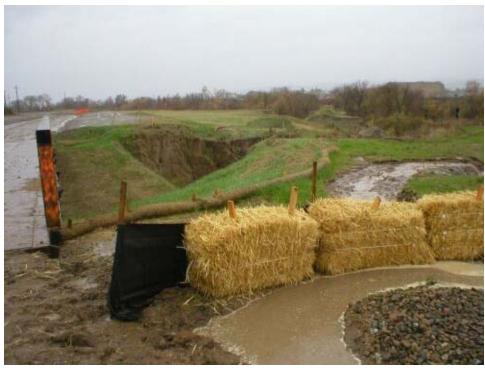
Figure 2 Closer view of additional erosion control installation near a drainage area along New Vineyard Road.

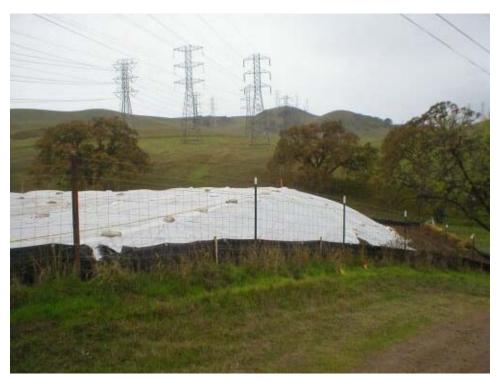
Figure 3

Transition Station site. The pad is covered with visquene, and additional hay bales have been placed around the site prior to the storm event.

At the Transition Station Site, visquene has been placed over the station pad and weighted with sand bags. Extra hay bales have been placed around the site and a stockpile of bales have been placed on the pad and covered with visquene (see Figure 3).
