California Public Utilities Commission Mitigation Monitoring, Compliance, and Reporting Program

Mira Sorrento Distribution Substation Project

Compliance Status Report: 018

November 12, 2013

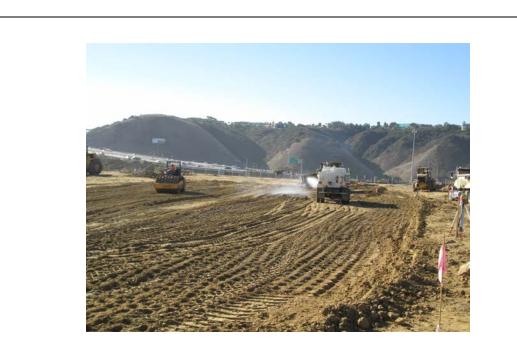
Photo 1: A water truck is utilized for dust control and compaction purposes in order to establish the final substation pad grade elevations.

Construction activities observed during this reporting period consisted of crews continued establishment of the final site grade (see Attachment A – Photo 1). Crews were also observed constructing site drainage features, including a water retention basin, that will be utilized to collect water during rain events (see Attachment A – Photo 2).

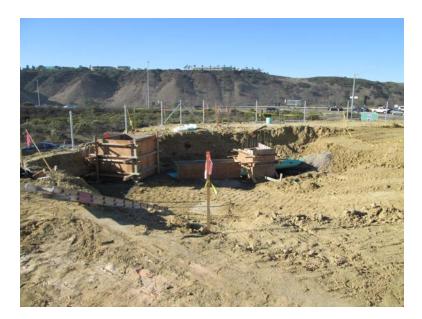
Photo 2: An excavation associated with a drainage containment basin was initiated in the southwest corner of the project site .

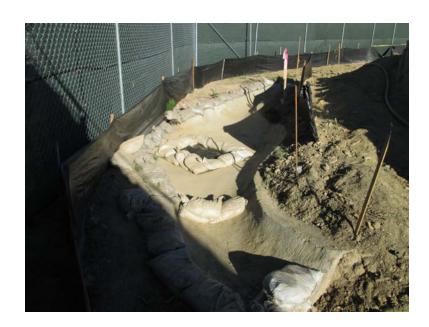
Photo 3: In accordance with APM-HYD-1, inlet protection BMP's are in place at all inlets in the work area and along Mira Sorrento Place.

minimize potential impacts to water quality. Secondary containment continues to be placed beneath equipment when not in use to prevent potential leaks from being discharged into the soil. Inlet protection BMP's, including gravel bags and filter fabric, were observed at one inlet structure within the fenced limits and two inlets offsite along Mira Sorrento Road (see Attachment A – Photo 3). Storm water control BMP's, designed to prevent silt and soil from traveling offsite, included perimeter silt fencing (see Attachment A – Photo 4). Anti-dirt tracking control BMP's, including rumble plates and a rock apron, remain at point of ingress/egress to the project site. BMP's were observed being maintained and in good working order during the reporting period.

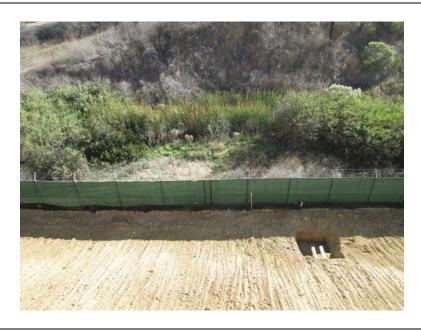
Photo 4: In accordance with APM-HYD-1, perimeter silt fencing is being utilized to protect the adjacent wetland Environmentally Sensitive Area (ESA) from silt-laden runoff.
