PROJECT MEMORANDUM PG&E ATLANTIC-DEL MAR REINFORCEMENT PROJECT

To: Jensen Uchida, CPUC
From: Vida Strong, Aspen Project Manager
Date: January 4, 2006
Subject: Weekly Report #36: December 18, 2005 – December 24, 2005
CPUC Environmental Monitor (EM): Heather Stiles

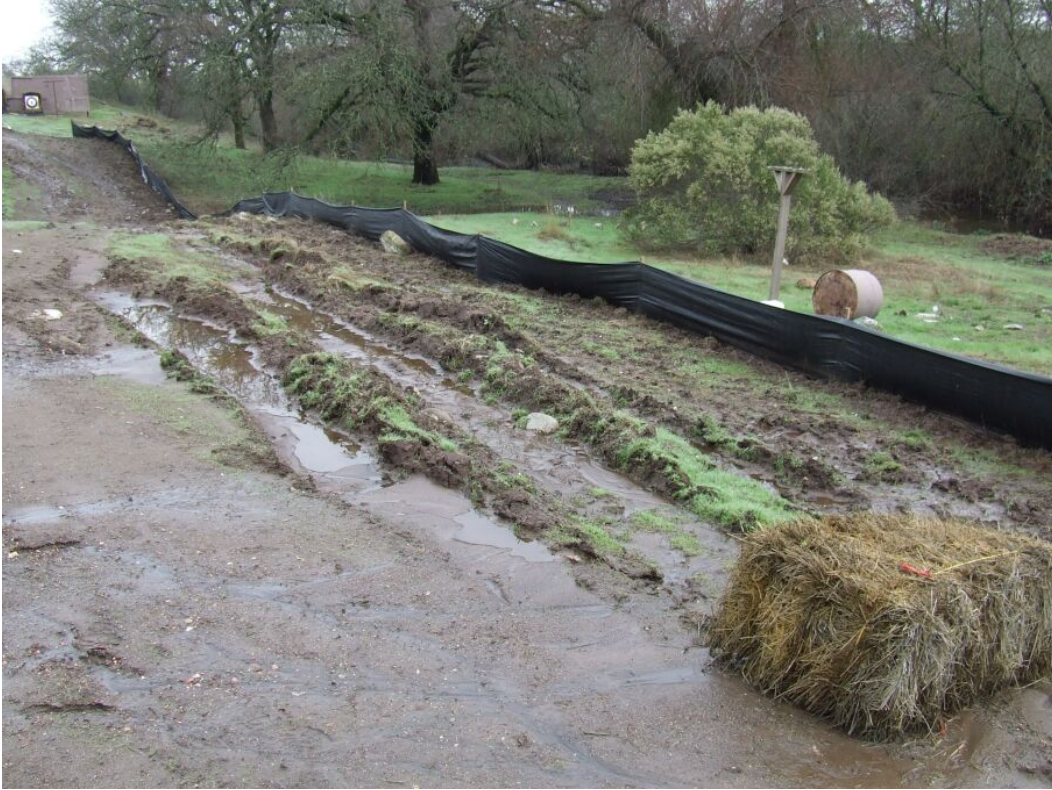
At approximately 3:45 p.m. on December 20, the crews were demobilizing between Towers #19 and #18 and a big rig crane got stuck in a two-track culvert access road next to a watery swale that likely drains into Antelope Creek. In an attempt to remove the crane, a wrecker was brought in and also got stuck in the process. A third vehicle was mobilized to pull the crane and the wrecker out of the soft mud. All vehicles were dislodged by 6:45 p.m. causing significant rutting to the two-track access road and some tire tracks were observed off of the two-track road on the embankment leading to Antelope Creek. A PG&E EI was on site and informed the crews to install silt fence parallel to the disturbed area, approximately 3.5-feet off of the two-track road on the down slope side, between Antelope Creek to prevent any potential erosion due to the rutting of the two-track road and disturbance of the embankment. Approximately 190-feet of silt fencing was installed prior to any received precipitation and no resources were damaged. Restoration of the embankment disturbance and re-grading of the rutting in the two-track road will be completed as soon as the area is not saturated. The subject area was inspected by the CPUC EM on December 23 and was determined to be adequately cleaned up and protected while the area is allowed to dry (see Figure 1).

Figure 1 – Rutted access road and erosion control measures,
December 29, 2005.

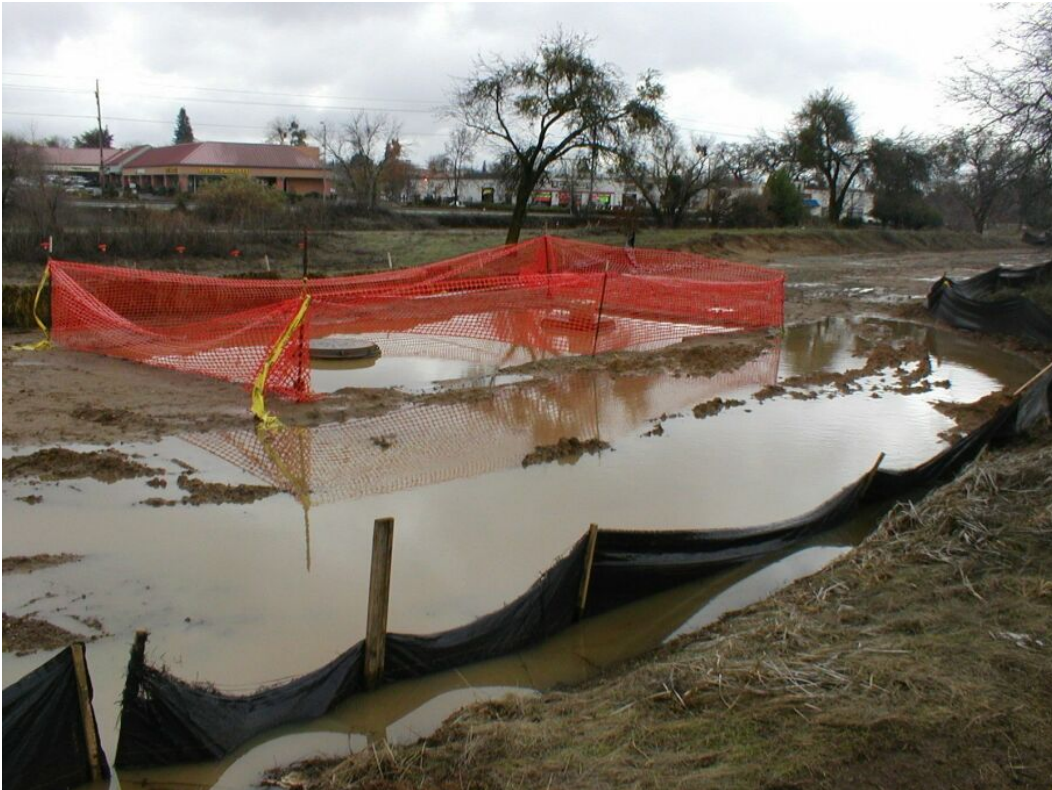
A minor problem occurred on December 20, near Vault 1. Bert Wilson instructed two laborers to drain Wetland 2 into Wetland 1. The laborers dug a trench approximately 11 inches wide, 3-12 inches deep and 18 feet long in an east-west direction toward Pacific Avenue. The trench was outside the straw bales to the north of the HDD entrance site. The trench was crossing under the yellow exclusion rope (for 13 feet

of its entire length) demarcating work area. Upon notification by the PG&E EI, the trench was backfilled by hand. Crews were reminded that Wetland 2 cannot be directly dewatered into Wetland 1 and that the topsoil needs to be preserved when any excavation occurs. In addition, the project has permission to disturb only Wetland 2. Various alternatives to dewatering Wetland 2 were discussed as well as alternative dewatering methods (i.e. using filter bags or dewatering structures). The crew opted to dewater using approximately 200-feet of hose to dewater in a vegetated area south of Vault 1. Figure 2 depicts the amount of standing water present near Vault 1 and Wetland 2.

Figure 2 – Standing water near Vault 1 and Wetland 2,
December 23, 2005.
