# PROJECT MEMORANDUM SCE TRANSMISSION PROJECTS, SEGMENTS 1 - 11

**Subject:** Weekly Report 198, November 06 to November 12, 2011

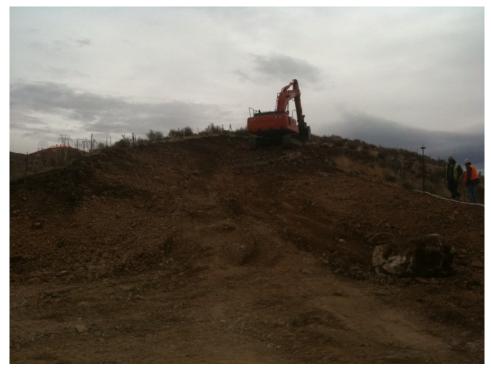
Figure 1: Cattracs grading Tower 68, Segment 5.

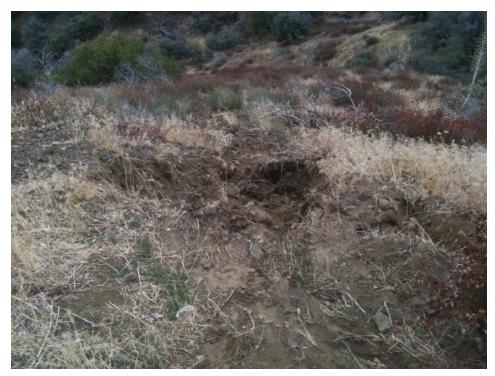
- 3. SCE submitted relevant documentation in regards to changes in paleontological resource management of Segments 4, 5, and 10.
- 4. Erosion was observed at Tower 53 on Segment 5. No BMP's were installed along the work limits perimeter (see Figure 2). The CH2MHill Environmental Monitor also observed this area and was going to address the issue.

Figure 2: Off-site erosion near Tower 53 due to lack of BMP's, Segment 5.

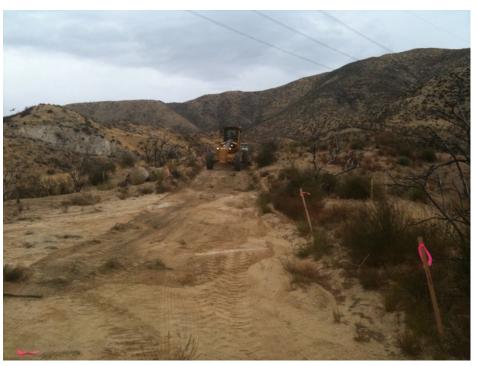
**Figure 3:** Grading access road that leads to Tower 22 in the Angeles National Forest, Segment 6A.

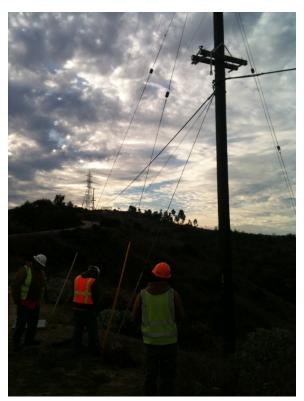
- 2. Segment 8 Telecom: Henkels and McCoy crews began the Rose Hills telecom work. Crews framed poles and hung arms on existing distribution line poles (see Figure 4).

**Figure 4:** Segment 8 Telecom within Rose Hills.

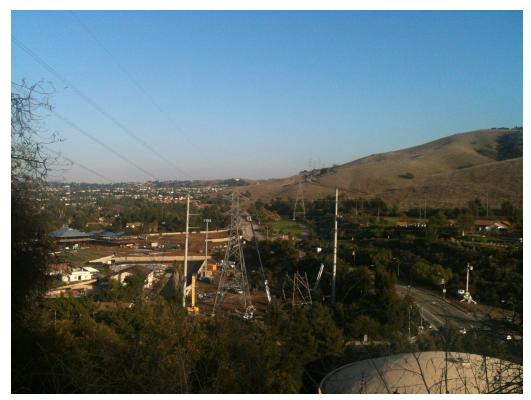
**Figure 5:** Wilson crews transfer conductor at the Fullerton Shoofly, Segment 8 Phase 4.

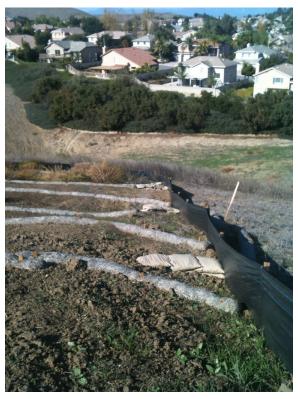
- 2. The CPUC EM checked BMPs within the City of Chino Hills after a rain event on November 7<sup>th</sup>. Fiber rolls and silt fencing were intact at all sites (see Figure 6).

**Figure 6:** Fiber rolls and silt fencing after a rain event, Segment 8 Phase 1.

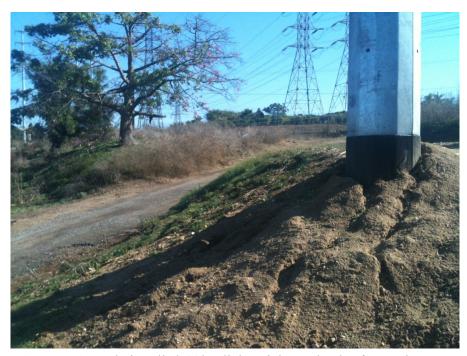
- 3. The CPUC EM spoke to SCE about the lack of BMPs at 66 kV work locations including behind Mesa Substation and within Legg Lake recreation area (see Figure 7). SCE responded that they would send a SWPPP inspector to the locations in question. The CPUC EM checked the SWPPP log located at the Huntington Yard during the subject period and the inspection had not yet been entered into the log.

**Figure 7:** A newly installed 66 kV lightweight steel pole after a rain event, Segment 7.
