**PROJECT MEMORANDUM
SCE TRANSMISSION PROJECTS, SEGMENTS 1–11**

To: Jason Coontz, Project Manager, CPUC
From: Vida Strong, Aspen Project Manager
Date: April 28, 2014
Subject: Weekly Report 323: March 30 to April 5, 2014

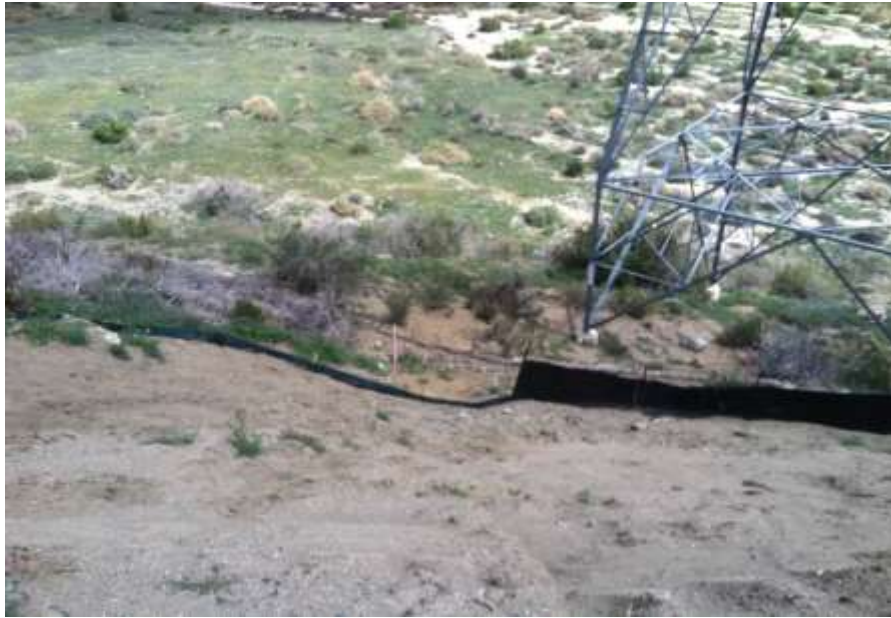
Figure 1: Erosion control devices were installed at the outstanding locations identified in the CPUC NCR, Segment 6, Tower 10. Although these devices were installed, additional work to clean up offsite erosion is still needed.

1. On March 7, CPUC Non-Compliance Report (NCR) #4 was issued after the CPUC EM reviewed portions of the Project right-of-way on non-ANF lands following weekend storms and found that deficiencies noted in Project Memorandum #10 remained. In addition, failed and/or inadequate BMPs lead to multiple sediment discharges outside of project defined work limits, including into Jurisdictional Drainages. NCR #4 documented the findings and outlined the detailed corrective actions necessary for SCE to enact in order to bring the Project into compliance. A Corrective Action Plan was submitted to the CPUC on March 19. As required by NCR #4, the Corrective Action Plan needed to be implemented no later than April 1, 2014. Follow up by the CPUC EMs on April 1 indicates that the necessary repairs to BMPs have been made, but offsite sedimentation clean-up in some areas remain (see Figures 1 and 2).

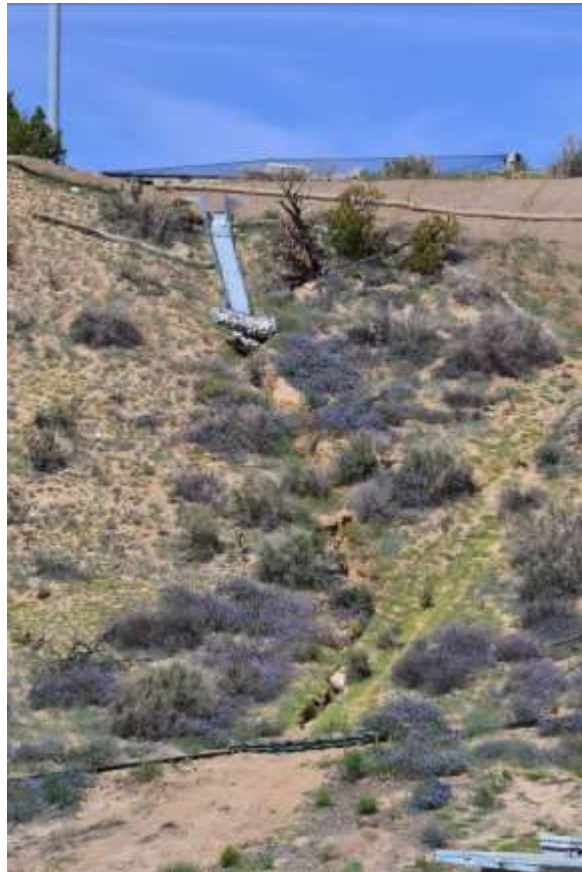
Figure 2: BMPs were installed surrounding the work area for Tower 1, Segment 6.

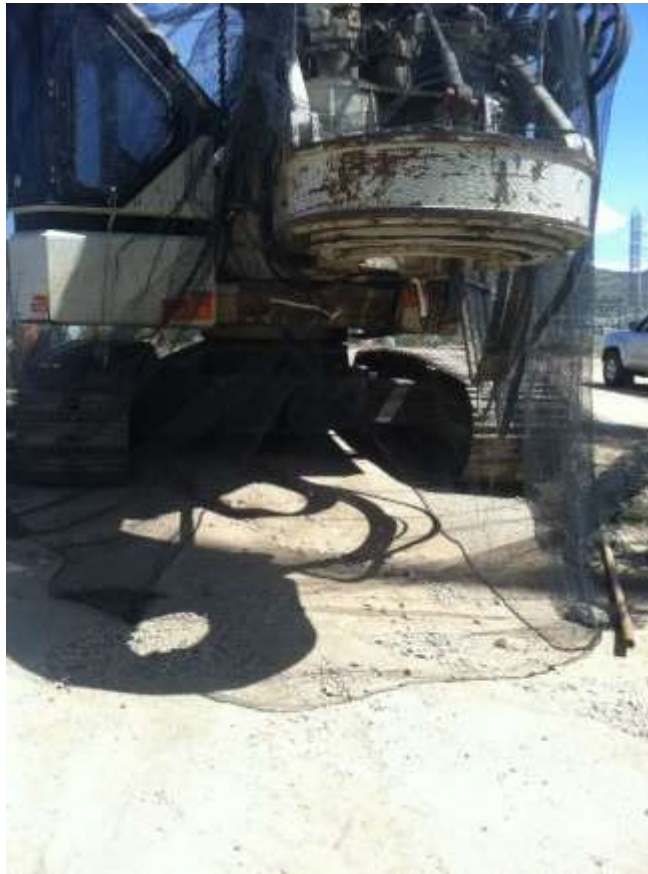
6. The CPUC EM found bird deterrent netting placed over TRTP equipment with large open gaps creating an entrapment concern for birds and other wildlife (see Figure 3). SCE was notified of the location.

Figure 3: Bird deterrent netting draped over a crane with large gaps, SCE was notified of the concern.

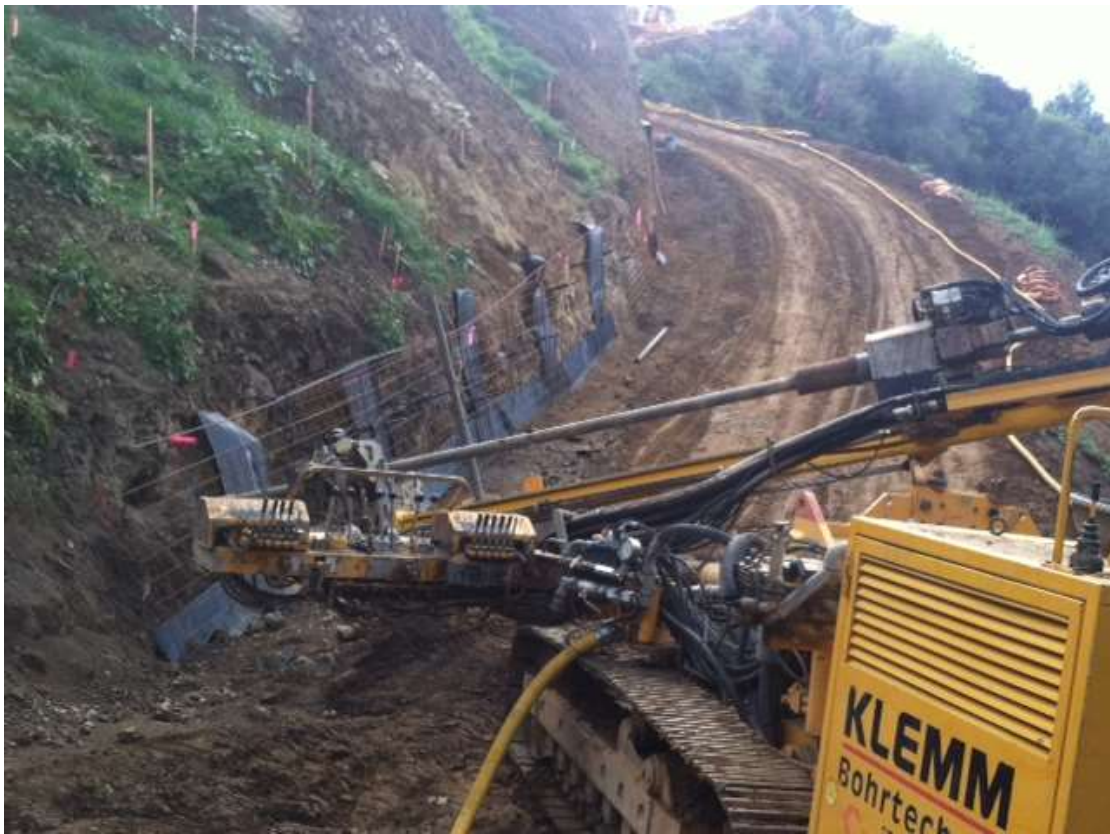
Figure 5: Soil nail wall installation at Tower M27-T3 in Duarte, Segment 7.

3. BMPs were installed/maintained at various locations.
4. Union Construction crews continued road grading, Hilfiger and soil nail wall excavation and installation, soil export, and BMP maintenance and installation at Tower M27-T3 (see Figure 5).
5. Foundation installation occurred at Tower M27-T2.
6. Assembly activities were conducted at Towers M29-T4, M31-T4, M32-T2, M32-T4, M34-T3, M34-4, M35-T3, and M35-T4 (see Figure 6).
7. Wire stringing operations to correct conductor sag continued between Towers M36-T1 and M36-T4.

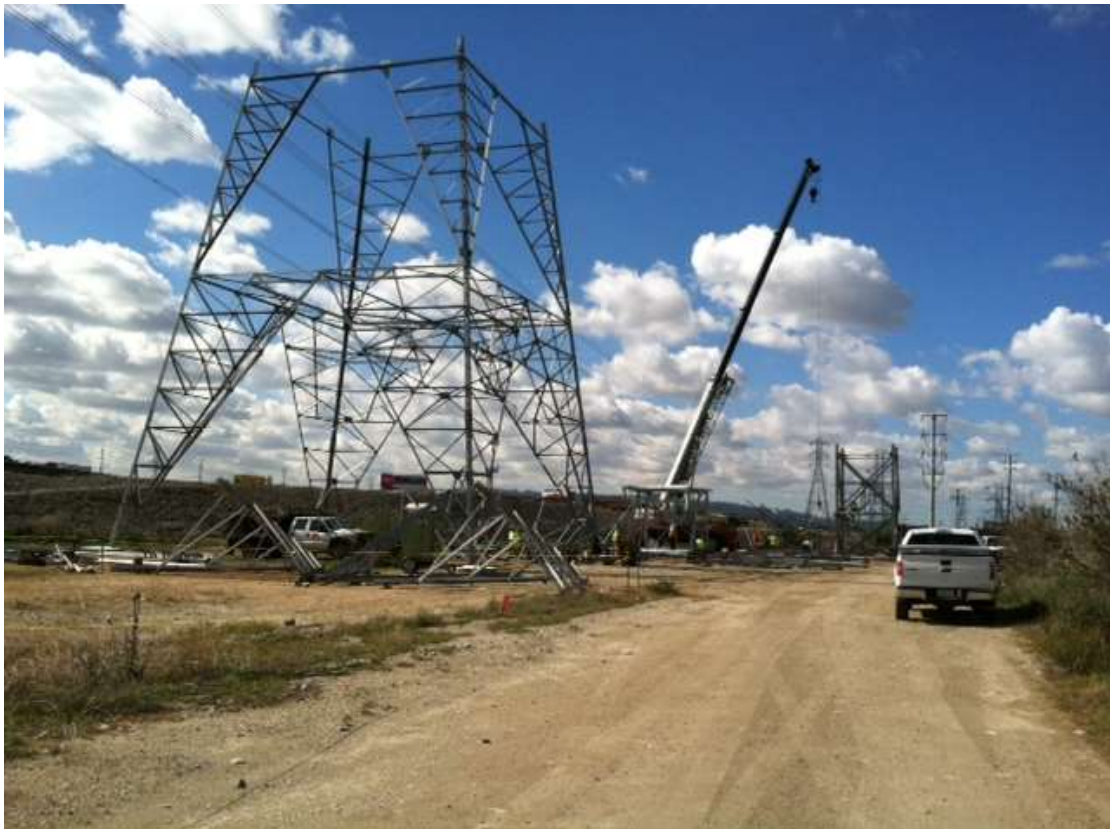
Figure 6: Tower assembly at Tower M32-T4, Segment 7.

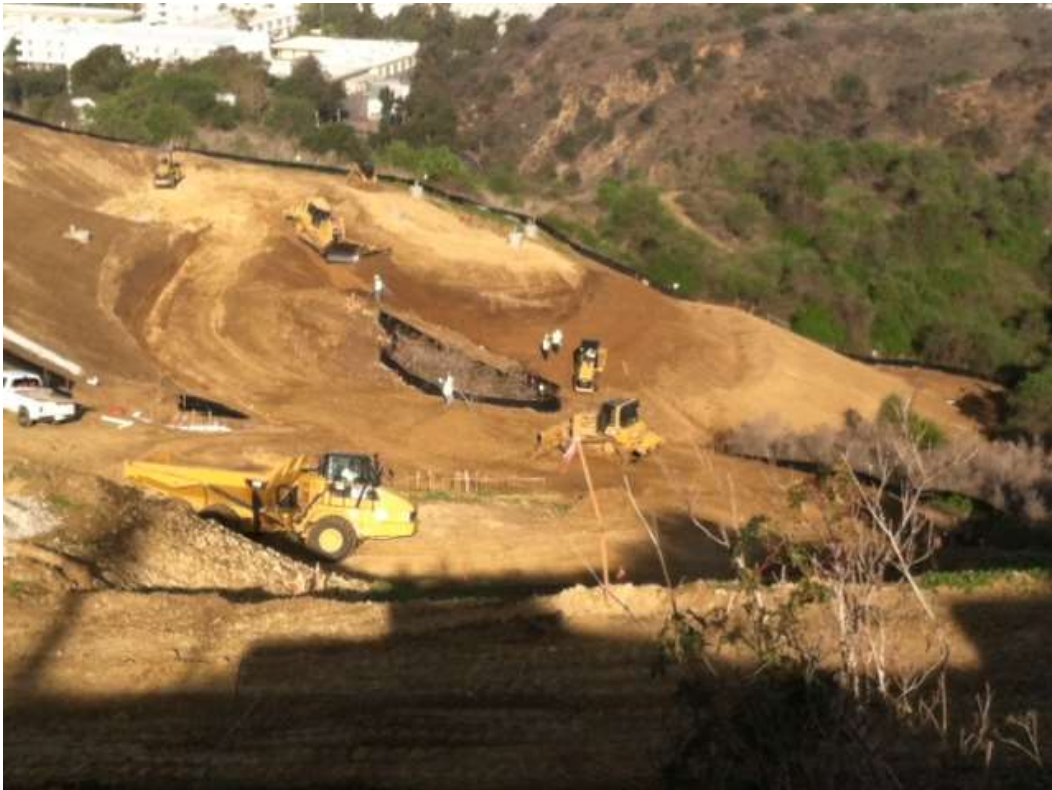
Figure 7: Patriot Construction crews grading access road and tower site at M43-T3, Segment 8.

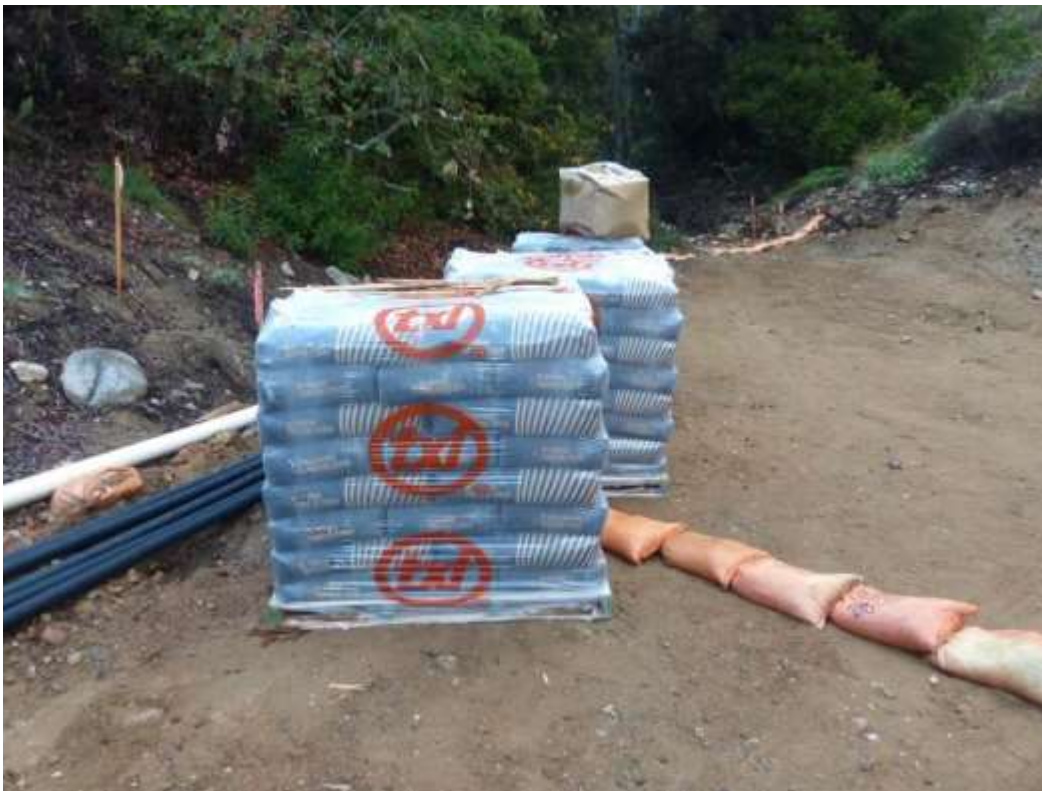
4. On April 1, the onsite Biological Monitor observed pallets of concrete and drilling equipment staged by the contractor in Jurisdictional Drainage (JD) ID 7-3-S-1 on the access road to Tower M27-T3 during a predicted rain event on Segment 7 (see Figure 8). The materials were staged within the approved disturbance limits of the site. The contractor was informed that no materials could be stored in that area. SCE has indicated they would potentially pursue approval in the future to store materials in this location.

Figure 8: Materials stockpiled within an Environmentally Sensitive Area (jurisdictional drainage) during a rain event at Tower M27-T3, Segment 7. Photo courtesy of FRED.

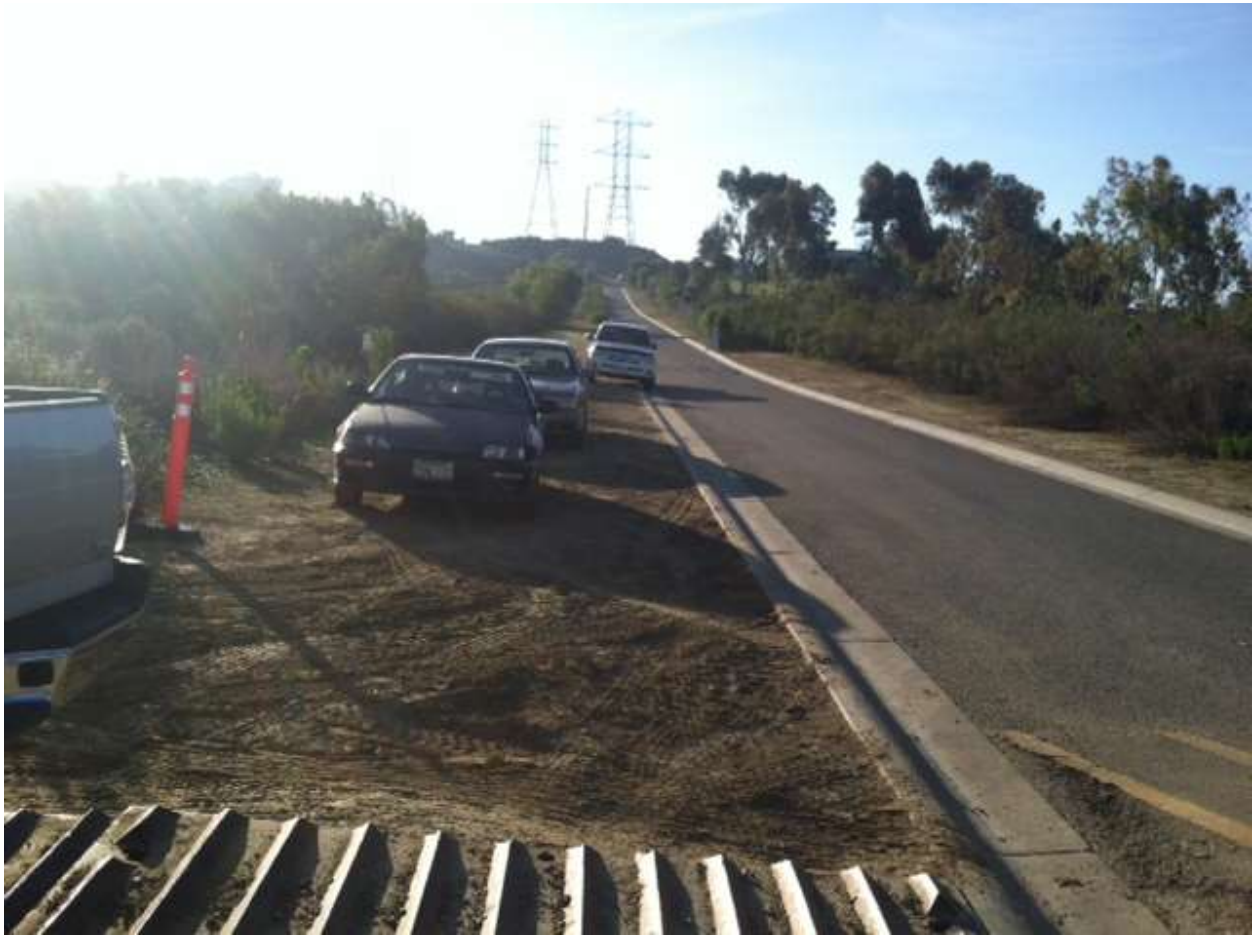
8. On April 3, the CPUC EM observed vehicles parked near Tower M44-T1 in an unapproved area that is mapped as California gnatcatcher habitat (see Figure 9). The CPUC EM informed the onsite Biological Monitor and SCE Environmental Coordinator. SCE recorded the observation as an incident in FRED.

Figure 9: Unauthorized crew parking near Tower M44-T1, Segment 8.
