Existing Condition - Transmission line corridor within San Timoteo Canyon adjacent to residential image type.
 Photograph taken 1/22/04 at 2:13 pm using a 50mm focal length.

Figure 5-7

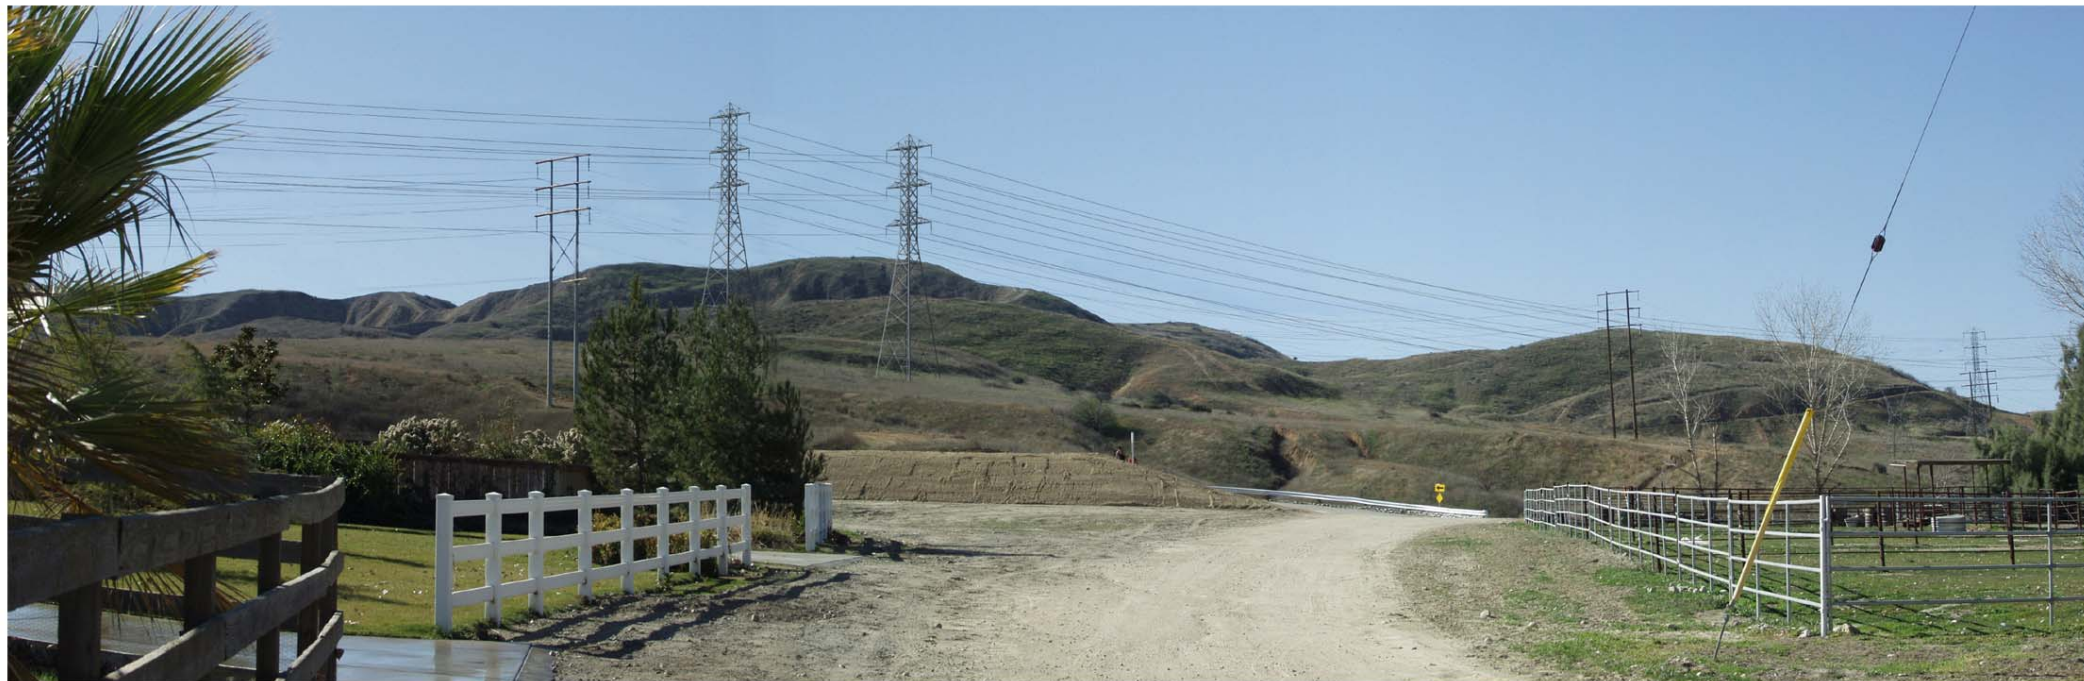
Simulation - Transmission line corridor with two 230kV single-circuit lattice towers removed and proposed 230kV double-circuit lattice steel structure transmission line.

This image is most accurately viewed at a distance of approximately 11 inches from the page to match the actual field of view.
