## **PROJECT MEMORANDUM PG&E JEFFERSON-MARTIN 230KV TRANSMISSION PROJECT**

**To:** Billie Blanchard, CPUC  
**From:** Vida Strong, Aspen Project Manager  
**Date:** August 1, 2005  
**Subject:** Weekly Report #27: July 18, 2005 – July 22, 2005  
**CPUC Environmental Monitors (EM):** Jody Fessler and Jenny Slaughter

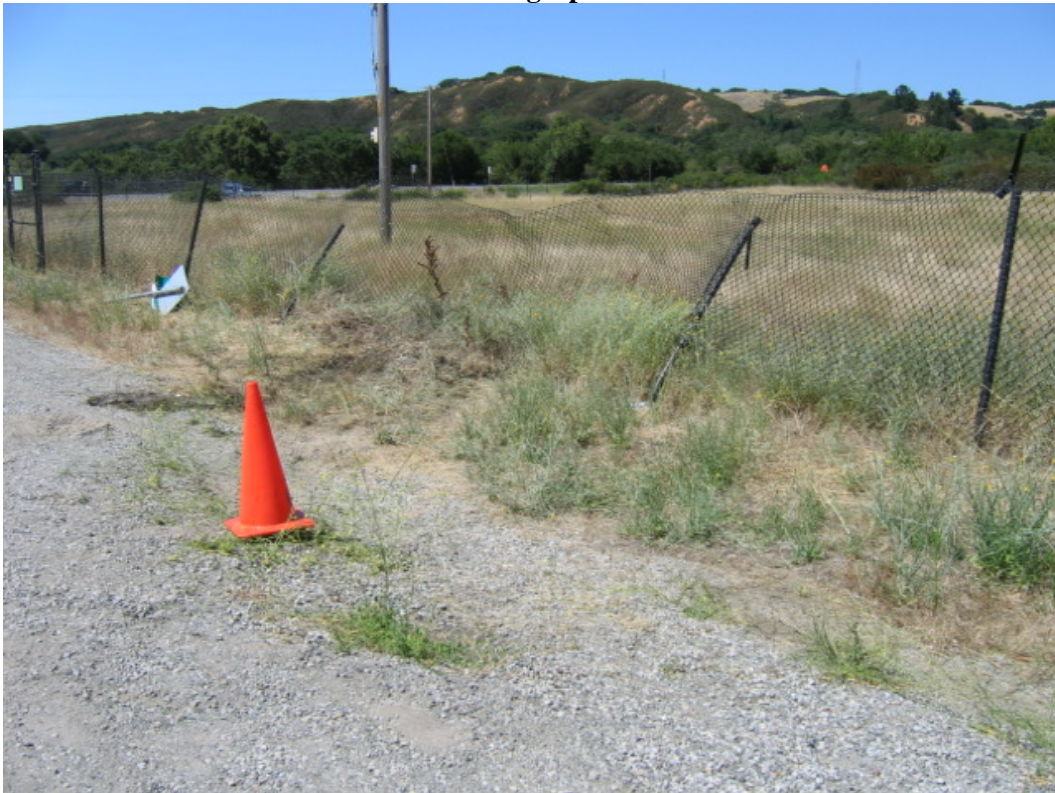
No non-compliances were issued by PG&E's EIs for Segment 1. One Non-Compliance Report was issued by the CPUC EM for off right-of-way damage caused by the accident on July 18<sup>th</sup> during cable pulling operations near Manhole #3. A truck hauling the cable on a trailer was staged on the road and rolled off the east side of the road because the parking brake was not set and hit some vegetation and a section of the SFPUC Watershed fence. A section of vegetation measuring 10-feet by 20-feet was damaged and the truck spilled approximately 16-gallons of oil and coolant in the area. The impacted soil was removed on Wednesday, July 20<sup>th</sup> (see Figure 1).

**Figure 1** – Damaged vegetation and SPUC fence from accident on, Segment 1, July 18, 2005

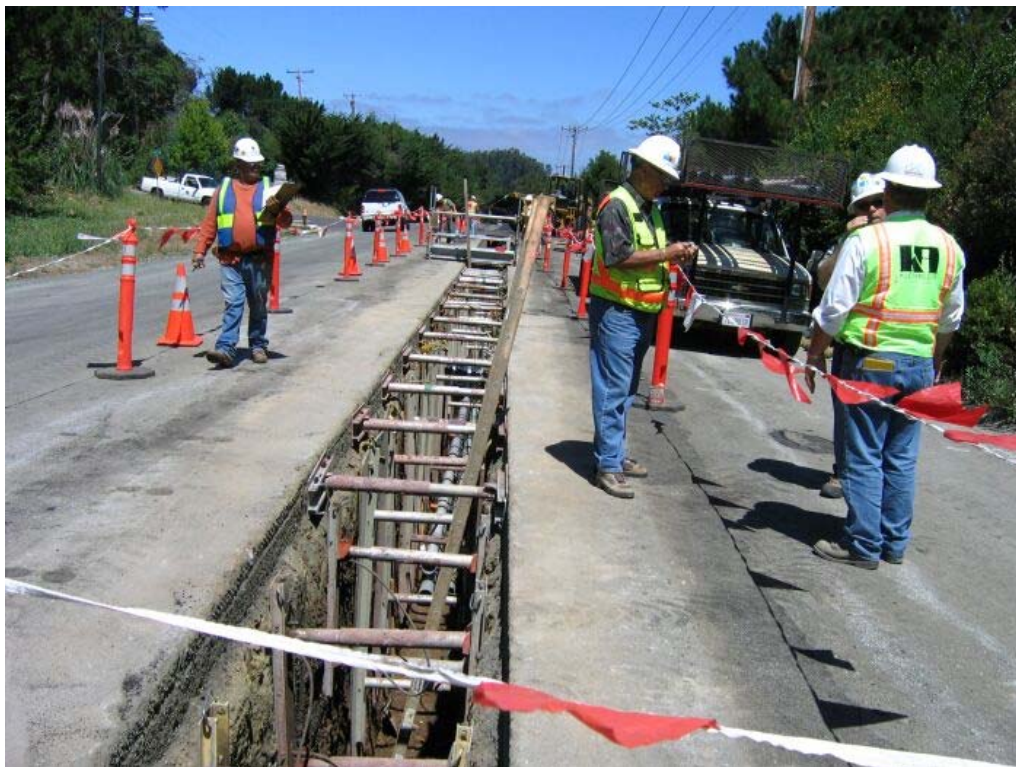
1. On July 18<sup>th</sup>, trench excavation continued on Skyline Boulevard between Manholes #34 and #33 (see Figure 2). The trench was excavated throughout the week, conduit installed, and cement slurry poured over the conduit. Trench depth is between 11 and 15 feet deep in this location. Approximately 705 linear feet of conduit was installed in the trench during the week. Paving was done on Friday in this area (see Figure 2).

**Figure 2** – Crews installing conduit on Skyline Boulevard south of Manhole #34, Segment 2 Underground, July 21, 2005

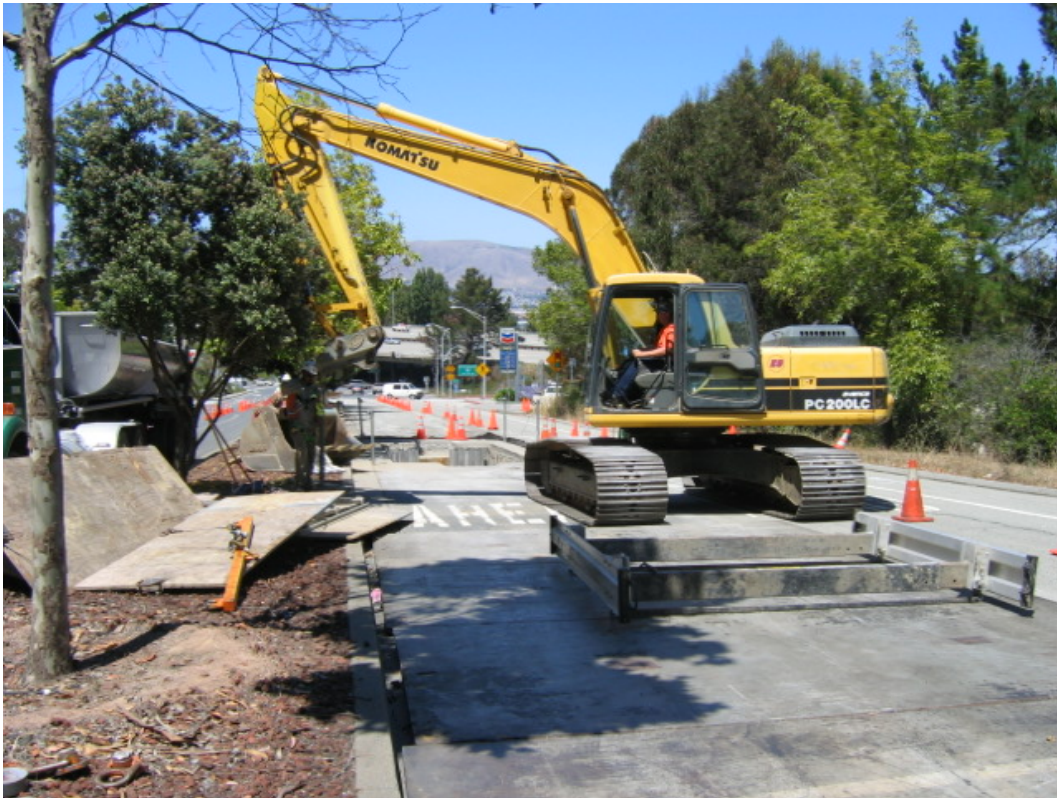
2. A manhole crew continued to work along San Bruno Avenue during the subject week. Manhole #42 was excavated and shored, and pea gravel was placed in the bottom of the pit (see Figure 3). The manhole vault was set on Friday and the area backfilled with cement slurry. The manhole pit was plated at the end of each day with steel plates.
3. Traffic controls were set up around the work areas. Traffic controls included signs, cones, and flaggers to help direct traffic around the construction sites.
4. Crews continue to use their staging yard under Highway 380 just east of Huntington Avenue.

**Figure 3** – Excavation of Manhole #42 along San Bruno Ave, Segment 3, July 20, 2005.

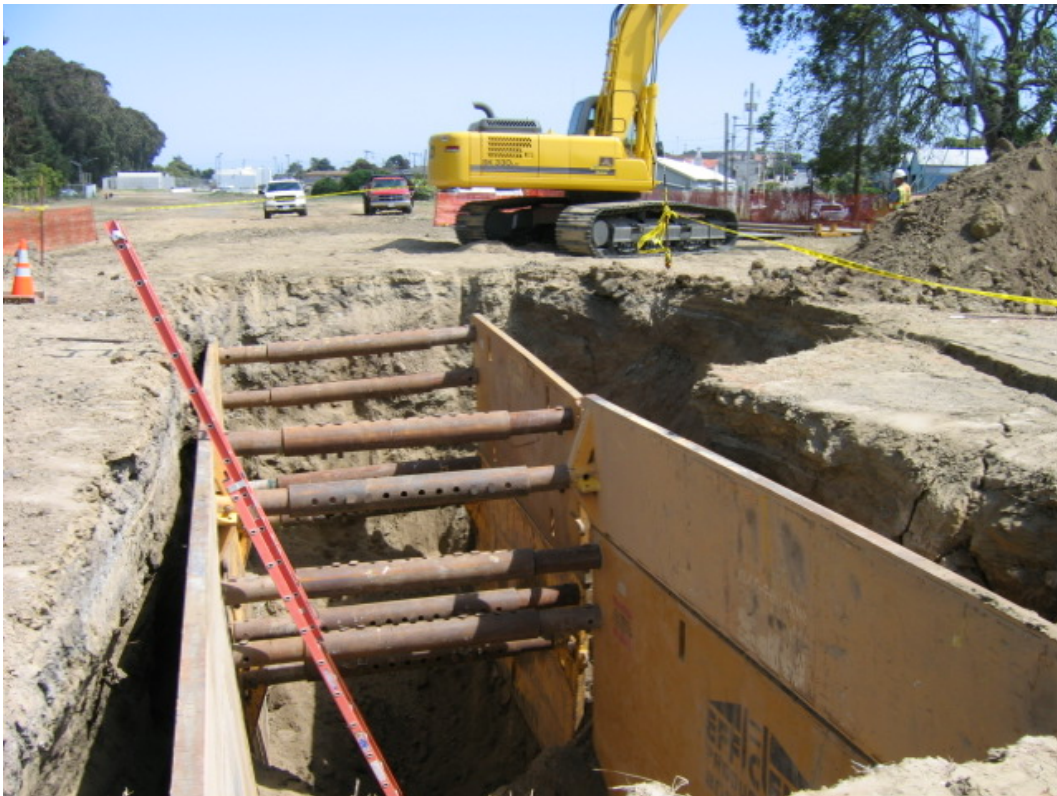
3. Work began at the entry bore pit on the south side of 12-mile creek, within the BART right-of-way (see Figure 4). Crews had continual problems with cave-ins at this location and worked throughout the week on excavating and shoring the pit. Bore crews are expected to begin the crossing on July 27<sup>th</sup>.

**Figure 4** – Crews working at the entry bore pit on the south side of 12-Mile Creek, Segment 4, July 20, 2005

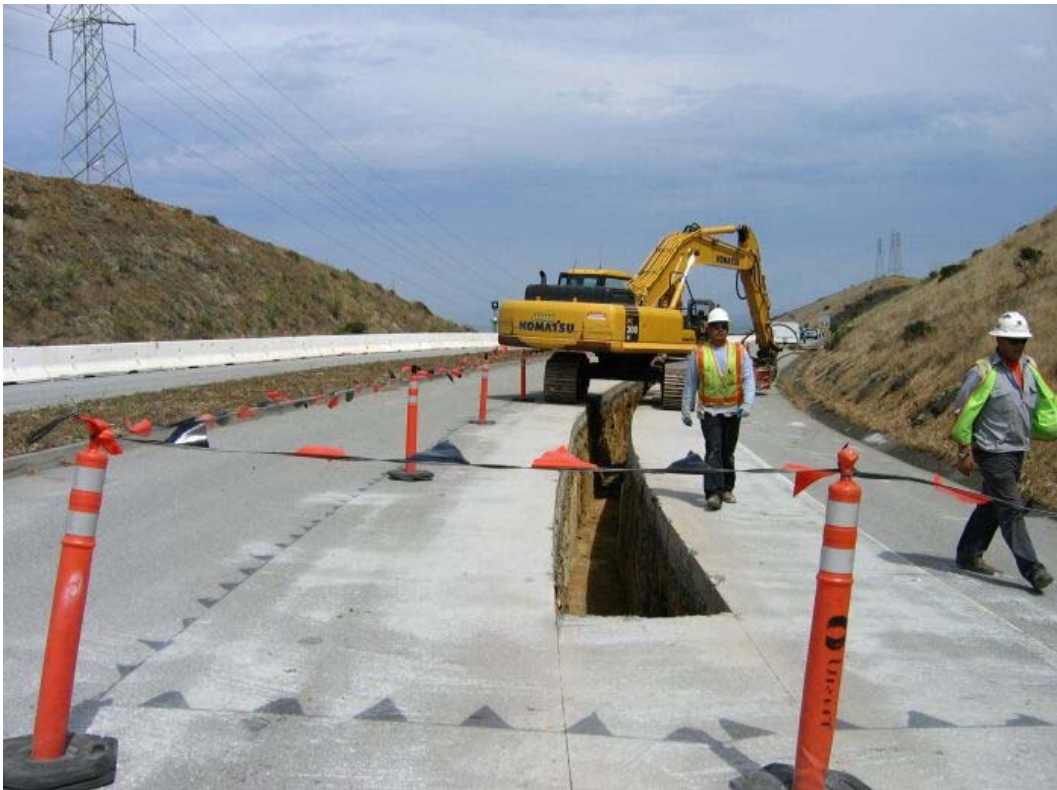
2. Trenching operations along Guadalupe Canyon Parkway in the City of Brisbane began during the week (see Figure 5). A rock trencher has been approved for use by the City; however, the contractor has not been able to secure one for the project yet. Saw-cutting, trench excavation, and conduit installation occurred during the week.

**Figure 5** – Crews began trenching operations on the east side of San Bruno Mountain on Guadalupe Canyon Parkway, Segment 5, July 20, 2005.
