PROJECT MEMORANDUM SDG&E – MIGUEL-MISSION 230 kV #2 PROJECT

To: Jensen Uchida, CPUC
From: Vida Strong, Aspen Project Manager
Date: October 20, 2004
Subject: Weekly Report #11: October 10, 2004 – October 16, 2004
CPUC Environmental Monitor (EM): Christopher Meyer

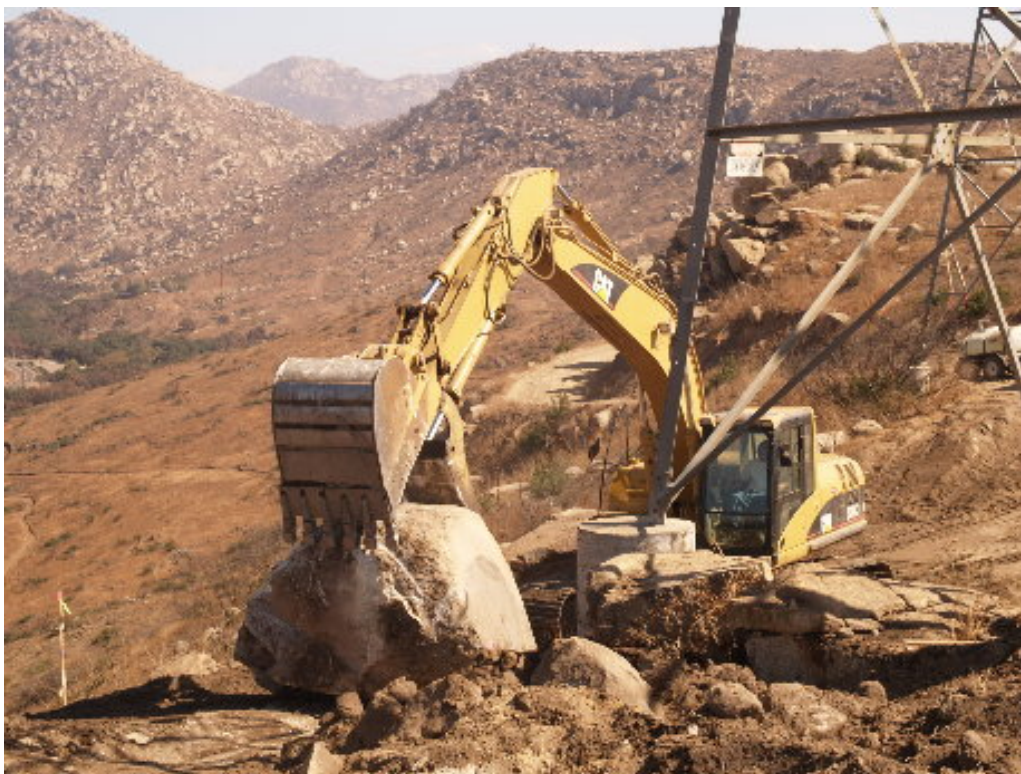
Figure 1 – The grading crew worked carefully to move large boulders at Tower Site 1180 without allowing spoils or rock to roll off the ridge line.

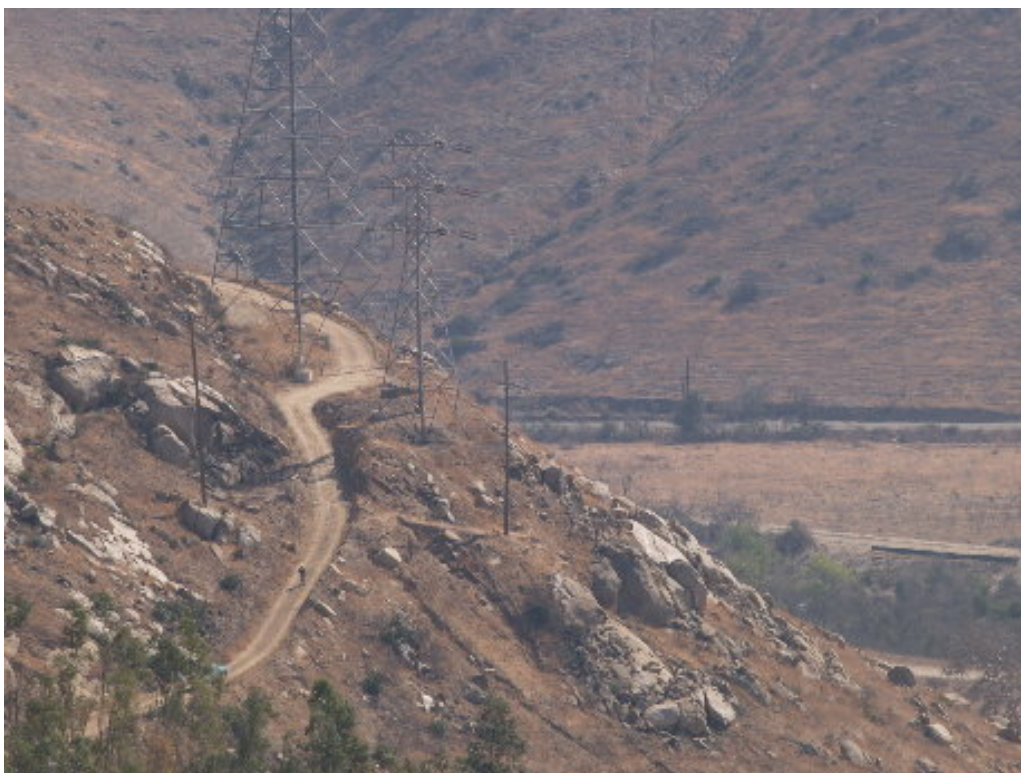
The grading crew worked at Tower Site 1180 during the subject week. The site is at the summit of a ridgeline and cannot be reached by the water truck or other heavy on-road vehicles due to the slope and condition of the road. A loader was used to move the excess spoils and rock to a location on the road accessible to the 6-wheeler dump truck. A trailer mounted water tank was used to control fugitive dust at the pad location. An operator worked with an excavator to move large boulders off the pad site prior to grading (see Figure 1). The operator took care to avoid rolling the boulders down the steep slopes on either side of Tower Site 1180. Representatives from SDG&E reviewed engineering changes at Tower Site 1160. No grading work took place at the location during the subject week (see Figure 2).

Figure 2 – The construction contractor reviewed engineering changes at Tower Site 1160.

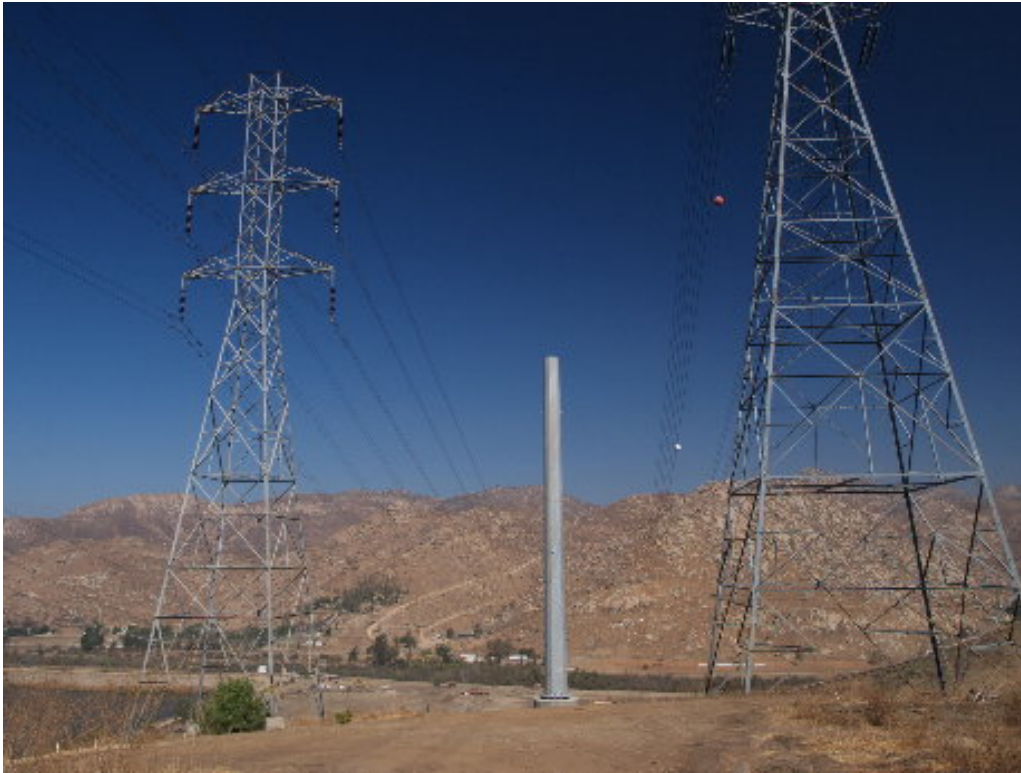
The PAR crew worked to erect the bottom section of the towers along the northern section of the project during the subject week. The drilling operations left many sites with loose soil in the proposed crane locations. The sites will have to be re-compacted before the crane for tower erection can be set up. The crew raised the lower section of the towers at Site 635 during the subject week (see Figure 3). The crew did not work during the last portion of the week to allow the other crews to prepare more locations and clean the loose spoils from the drilling operation from the crane pads.

Figure 3 – The PAR crew erected the lower section of the pole at Tower Site 635.

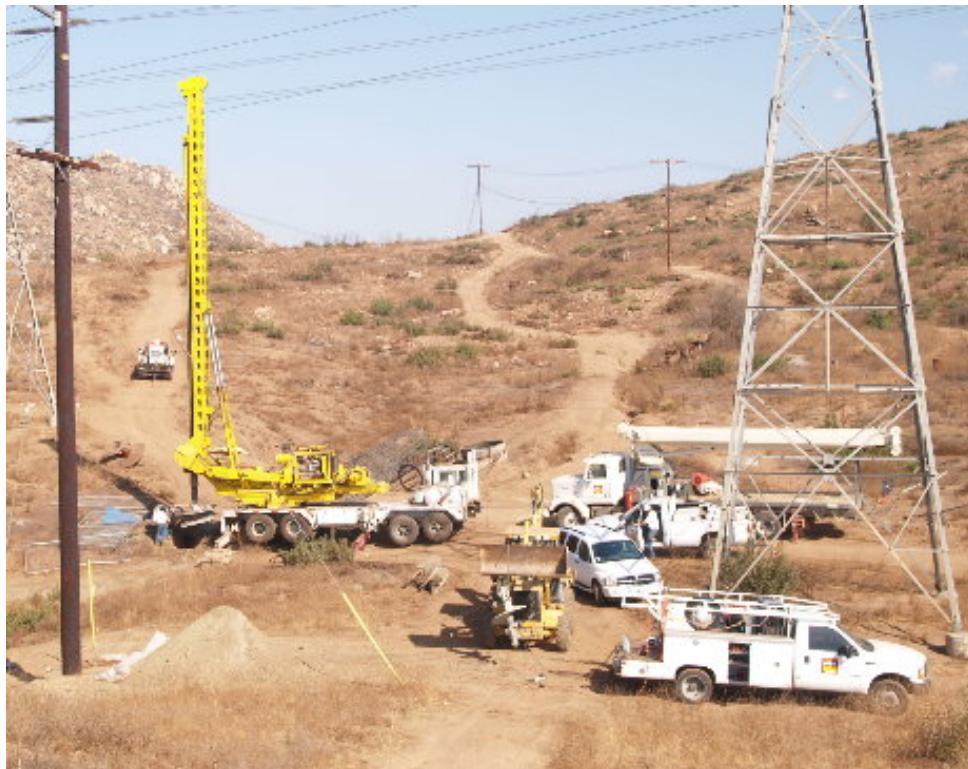
A drilling crew worked at Tower Site 842 in very hard rock (see Figure 4). The drilling machine had to be anchored to the support truck to minimize swaying during the drilling. The crew repaired the gate on the access road after several hand tools and smaller materials were stolen from the site.

Figure 4 – The drilling crew worked in hard material at Tower Site 842.

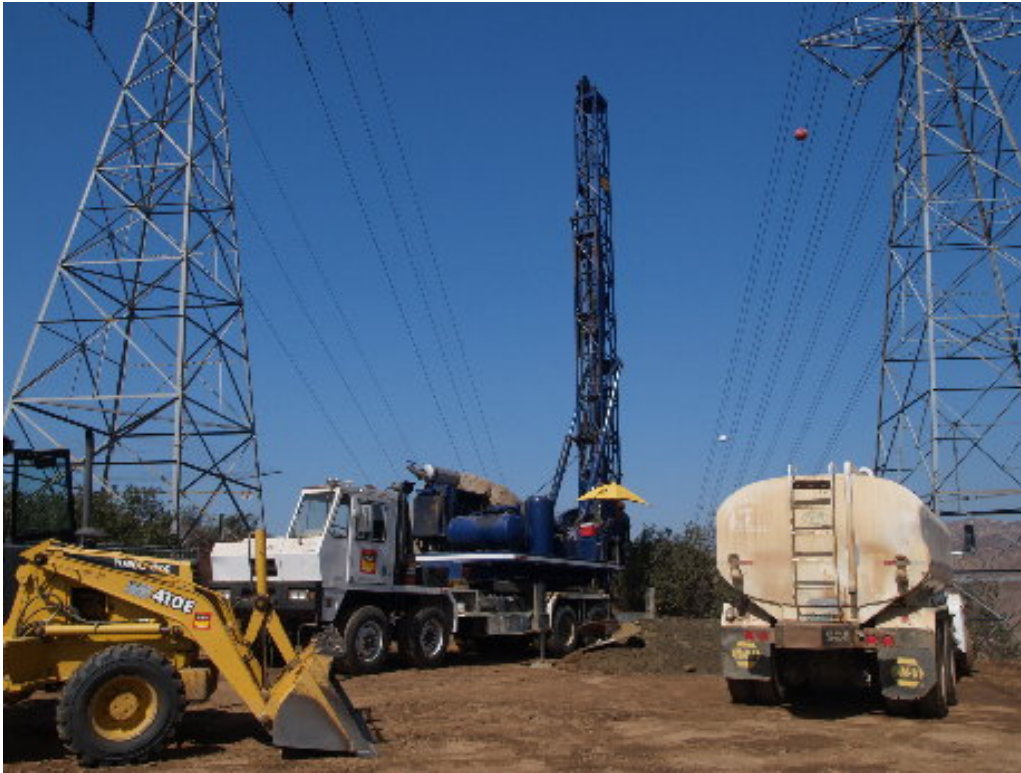
The other drilling machine worked in equally hard bedrock on Vista Rodeo (see Figure 5). The drilling machine was set up near several houses and the crew is required to be off the road by 7:00 pm. No noise complaints have been received despite the loud drilling due to the hardness of the bedrock. The operation was briefly stopped to allow a mechanic to address an oil leak on the drilling machine. Several sites throughout the project are on hold until blasting plans can be developed and implemented.

Figure 5 – The second drilling crew worked near houses at the tower site on Vista Rodeo.
