PROJECT MEMORANDUM SDG&E – MIGUEL-MISSION 230 kV #2 PROJECT

To: Jensen Uchida, CPUC
From: Vida Strong, Aspen Project Manager
Date: November 2, 2004
Subject: Weekly Report #13: October 24, 2004 – October 30, 2004
CPUC Environmental Monitor (EM): Christopher Meyer

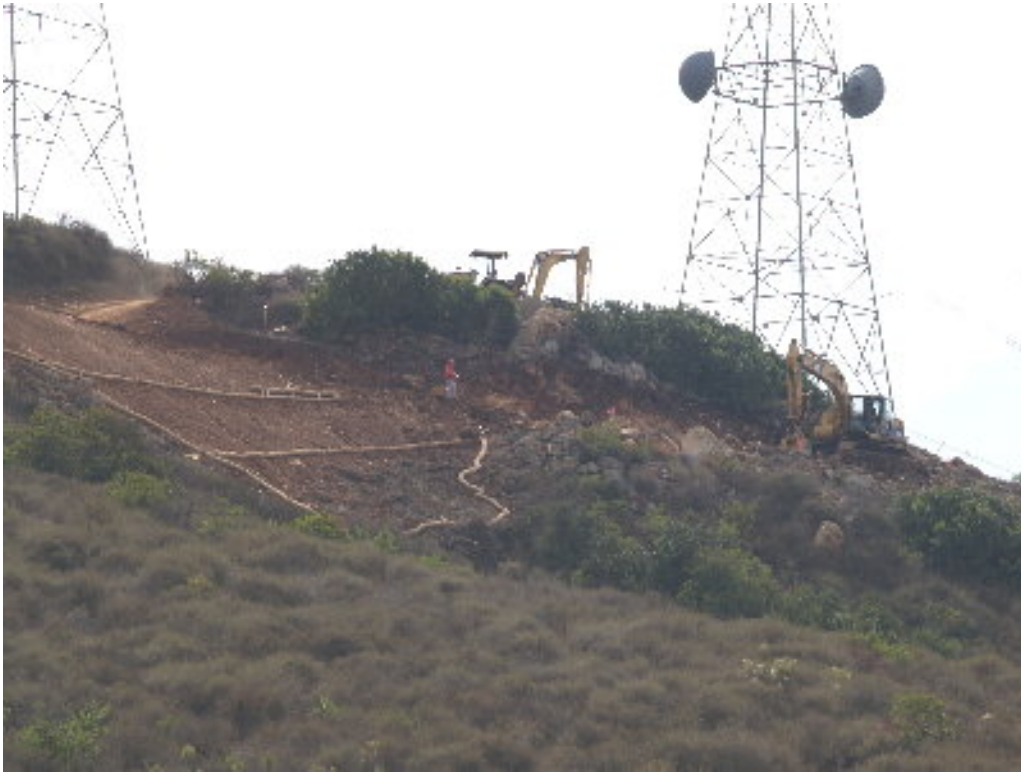
The grading crew worked to remove spoils and rock from Tower Site 80 before additional rain made the access road unsafe for the rubber-tired dump trucks. An operator worked with an excavator to move the soil and rock off the pad site and load it into trucks for removal from the right-of-way (see Figure 1). The access road to the tower locations in the area was rough after the recent storms and is not passable when wet. A crew worked at Tower Site 151 repairing erosion damage from the storms and improving the BMPs (see Figure 2). The rains that started on October 27 halted any additional repair work due to the saturated soils and restricted access. The pads cannot be properly compacted if the water content in the soil is above approximately 13 percent.

Figure 1 – The grading contractor returned to Tower Site 80 to remove spoils while the access roads were passable. The straw waddles were installed at too steep an angle.

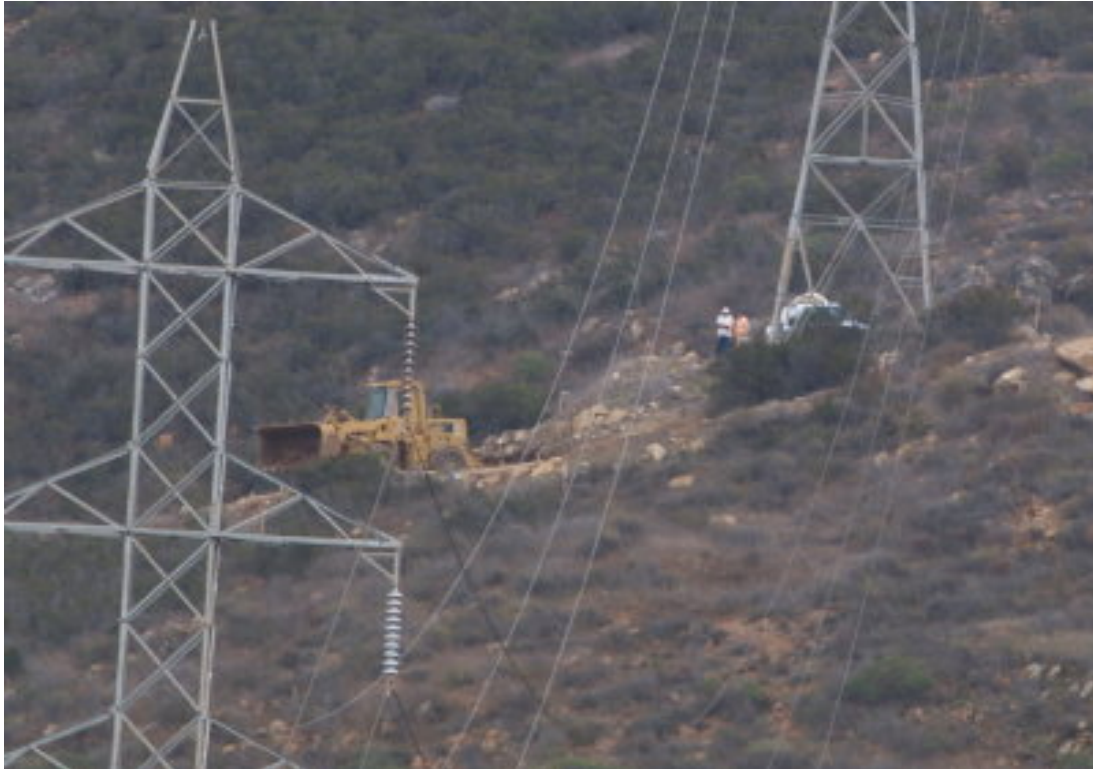
Figure 2 – A grading crew worked to repair storm damage and improve BMPs at Tower Site 151.

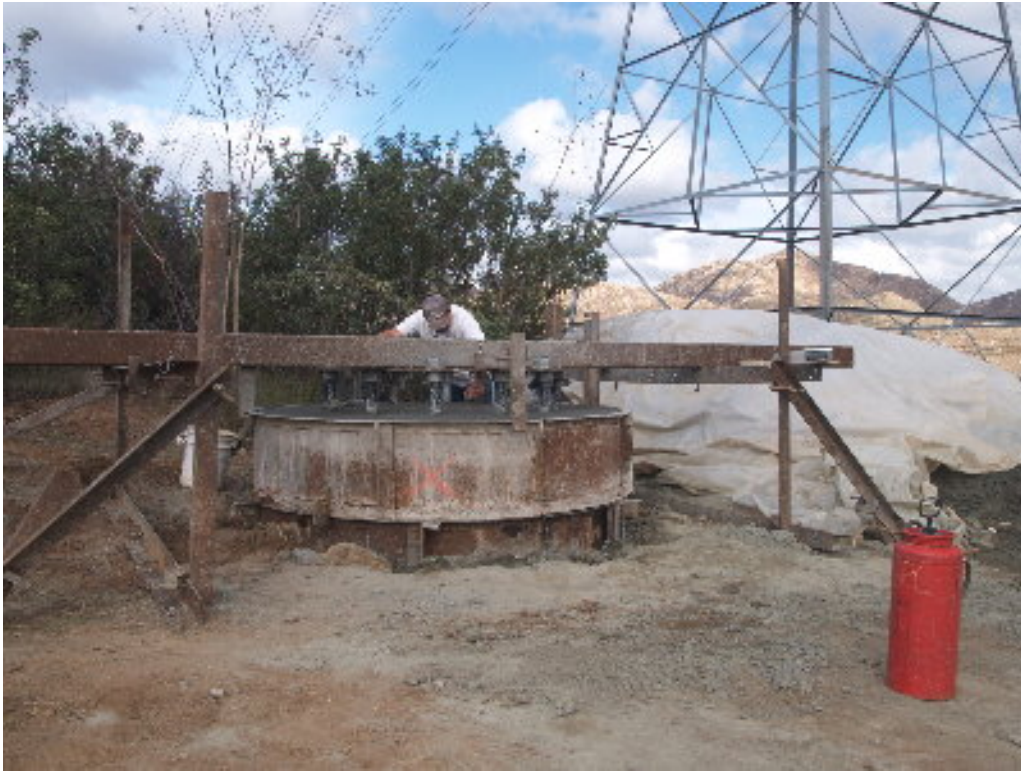
Concrete was poured at Vista Rodeo and a worker finished the surface of the foundation by hand (see Figure 3). The arms have been attached to the towers and the upper sections are on-site at Site 925A for the work during the weekend outage approved in Variance Request #6 (see Figure 4).

Figure 3 – The drilling crew finished the foundation at Vista Rodeo and a worker finished the foundation surface after the concrete pour.

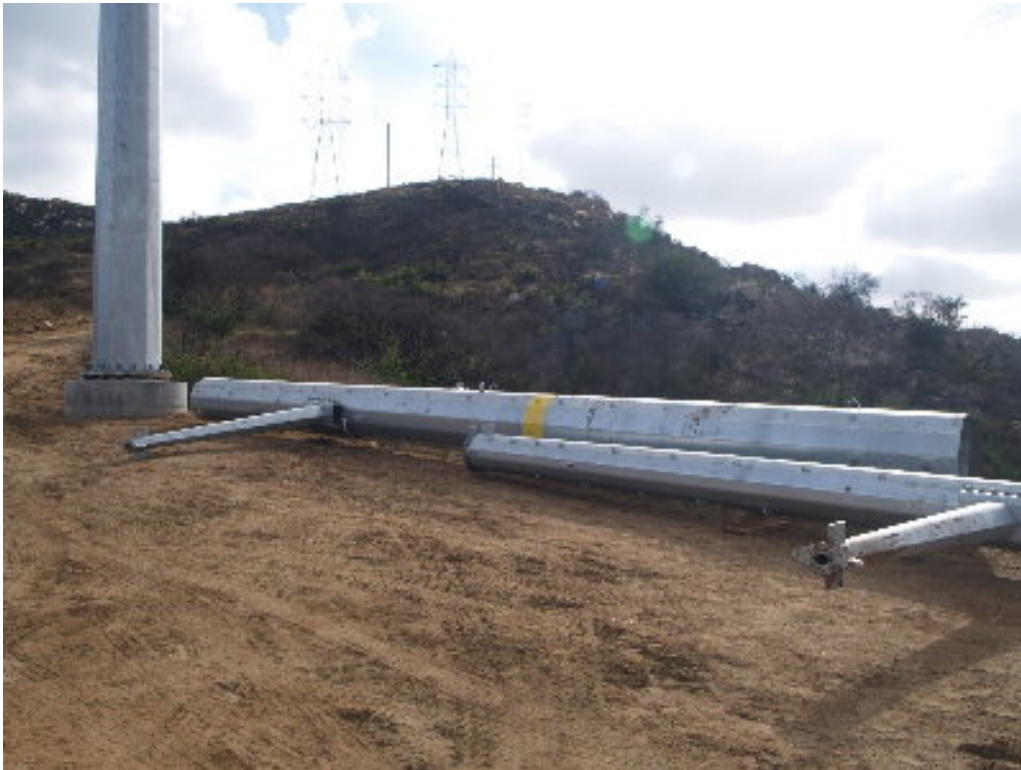
Figure 4 – The upper sections of the poles at Tower Site 925A are on-site for raising during the weekend outage covered in Variance Request #6.

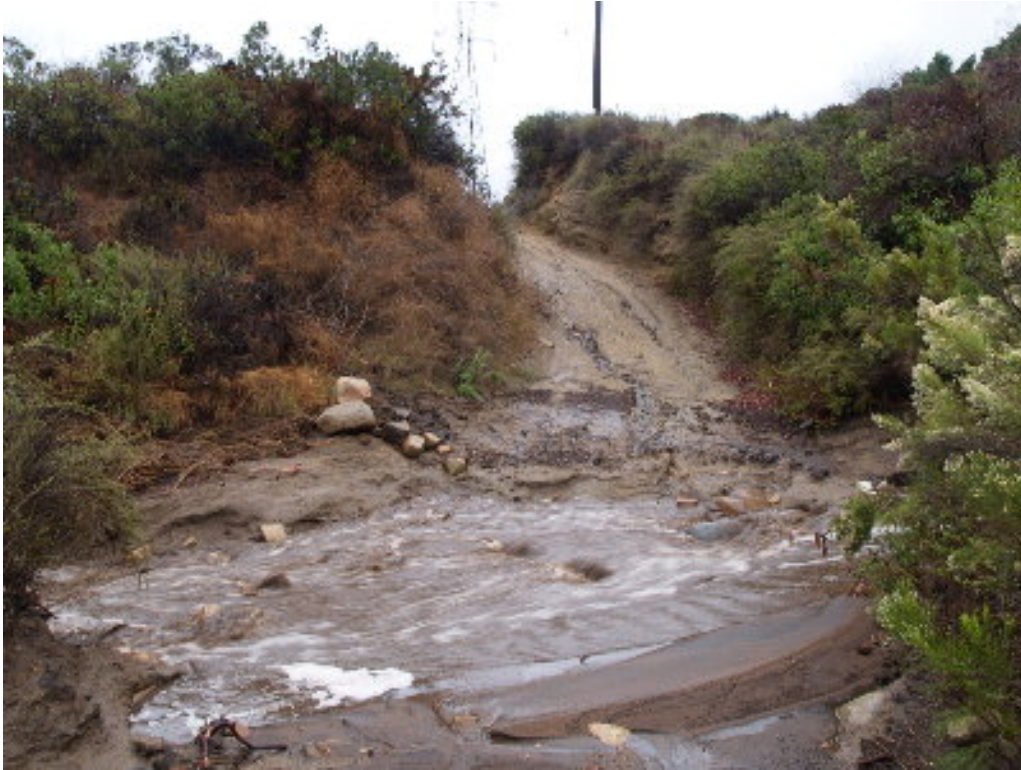
The CPUC EM noted that the contractor did not have adequate time between the storms to address many of the SWPPP issues from the previous week. Many of the water bars installed by the operations crews have failed and the access roads are not passable. In some areas, the access roads are both eroded and subject to significant off-site drainage (see Figure 5). The water bars on the steep access road to Tower Site 440 were completely washed away, resulting in sediment on the public road and into the adjacent storm drain (see Figure 6).

Figure 5 – Both erosion on the access roads and drainage from the surrounding hillsides made access impossible in some areas.

The CPUC EM spoke with SDG&E about the BMP concerns following the site visit. SDG&E will be working to address the issues and modify the procedures to avoid future erosion and sedimentation problems.

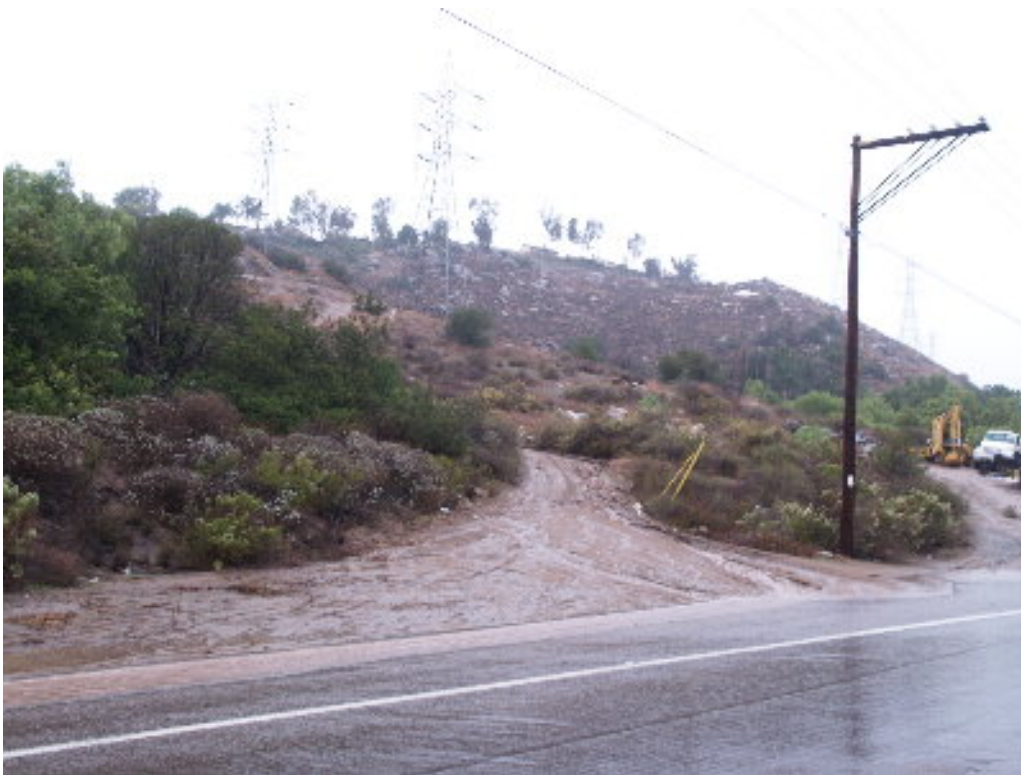
Figure 6 – The water bars at Tower Site 440 were completely washed away and sediment flowed onto the public right-of-way and into the storm drain.
