PROJECT MEMORANDUM SDG&E – MIGUEL-MISSION 230 kV #2 PROJECT

To: Jensen Uchida, CPUC
From: Vida Strong, Aspen Project Manager
Date: February 1, 2005
Subject: Weekly Report #26: January 23, 2004 – January 29, 2005
CPUC Environmental Monitor (EM): Christopher Meyer

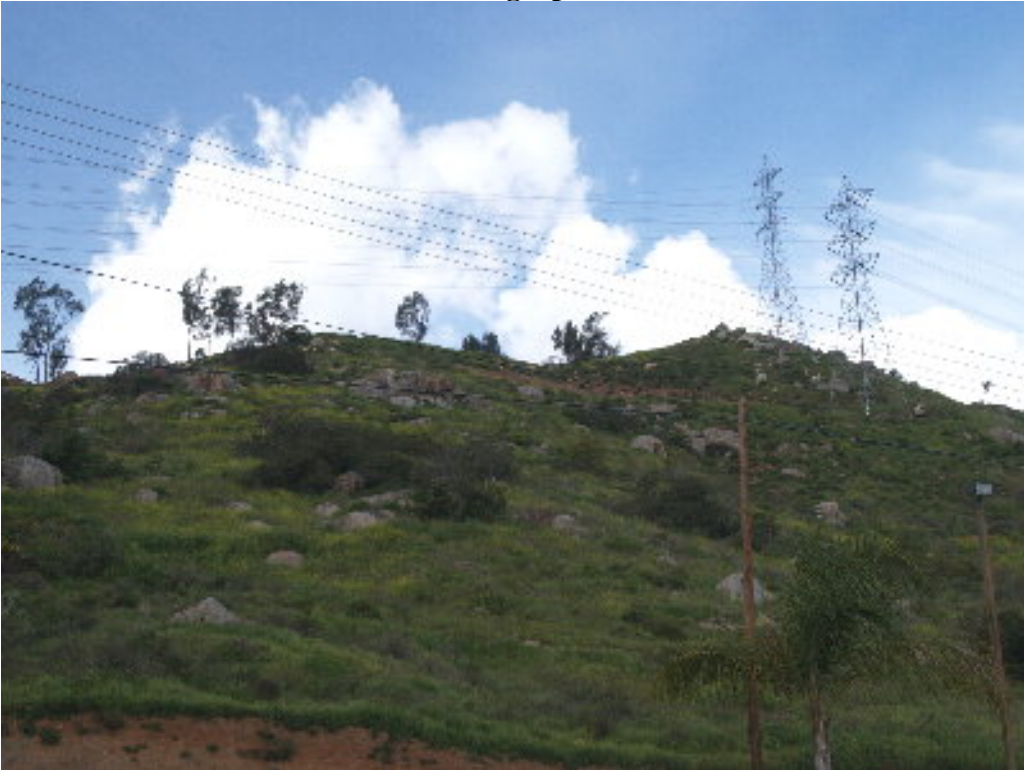
Figure 1 – No work occurred at Pole Locations 481 or 493 during the subject week.

The CPUC EM met with the local property owners, a representative of a San Diego County Supervisor, and the SDG&E Project Manager and the transmission engineer to review site conditions at Tower Sites 481 and 493 on January 26. The in-field meeting was in response to the second letter from local residents and the County Supervisor received by the CPUC Project Manager with complaints about the pole location. The CPUC EM stayed after the field meeting to answer property owner questions and concerns. The CPUC EM verified that the location where the pad grading and foundation drilling have been started match the location in the project documents (Figures 2-2 and 4-10 in the Environmental Impact Report). The major concern of the local property owners, beyond the location of the poles, was notification and public involvement in the process. Aspen has obtained a list of the local property owners and is checking the names against the property owners list provided by SDG&E and the list of Scoping Meeting participants. A summary of the field meeting was provided to the CPUC via email following the meeting. Property owners blocked access to this section of right-of-way on January 27 and SDG&E is pursuing a court order to gain access to the pole location. The incident was covered by the local print and television news services. No work was scheduled at the location the remainder of the week (see Figure 1).

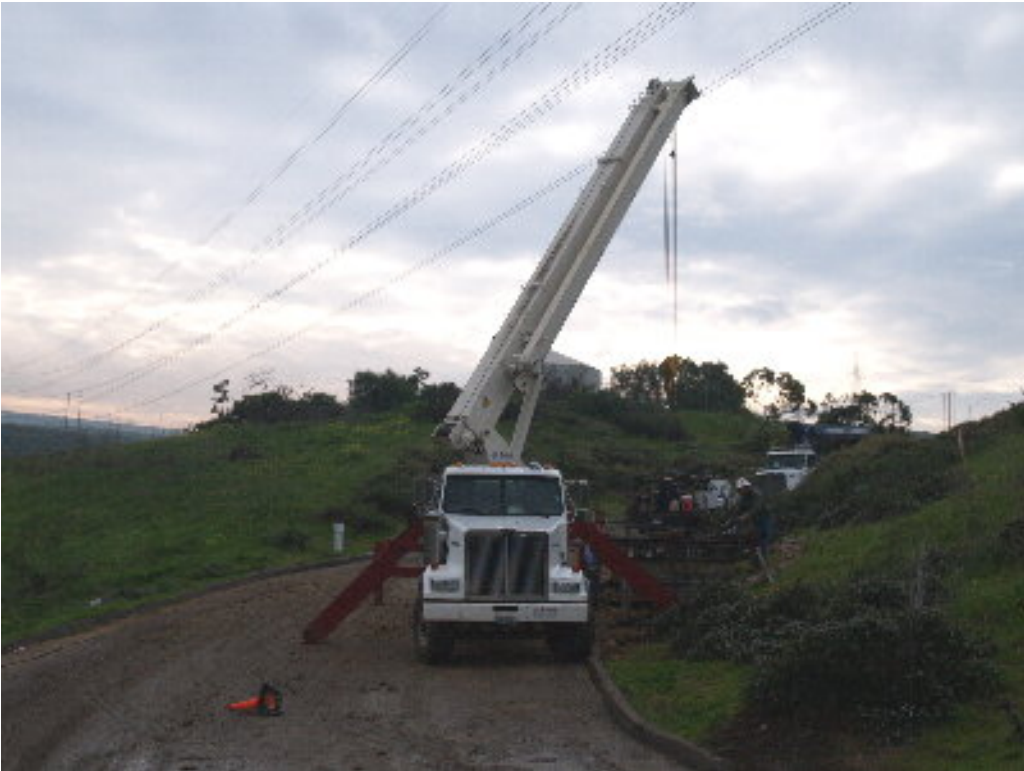
Concrete crews worked on pouring the first pole foundation leaving the Miguel Substation (see Figure 2). The light rains early in the week caused significant mud issues on the asphalt access road adjacent to the foundation. Material left on the road from cleaning out the excavation has spread out, leaving the road extremely slippery. This material needs to be cleaned from the road to prevent the sediment from entering the adjacent drainages.

Figure 2 – The concrete crew placed concrete outside the Miguel Substation.

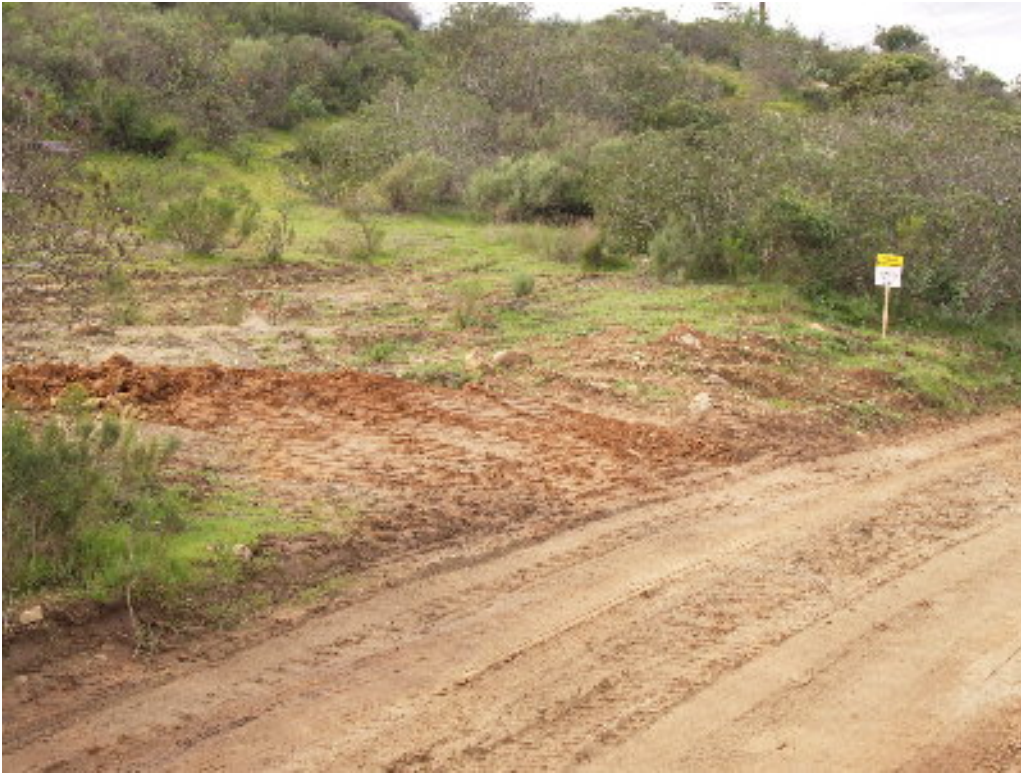
Access to some portions of the right-of-way was not possible due to the recent rains. A crew attempted to access Pole Site 181 and became stuck on the muddy access road. The crew left the right-of-way during the recovery process (see Figure 3). The impact was in a previously disturbed area and no vegetation was impacted, however the crew was informed of the access road restrictions. The EI reviewed the impacts and added an additional sign to remind crews to remain on the approved access roads.

Figure 3 – A crew left the access road after becoming stuck in the mud on the way to Pole Site 181.

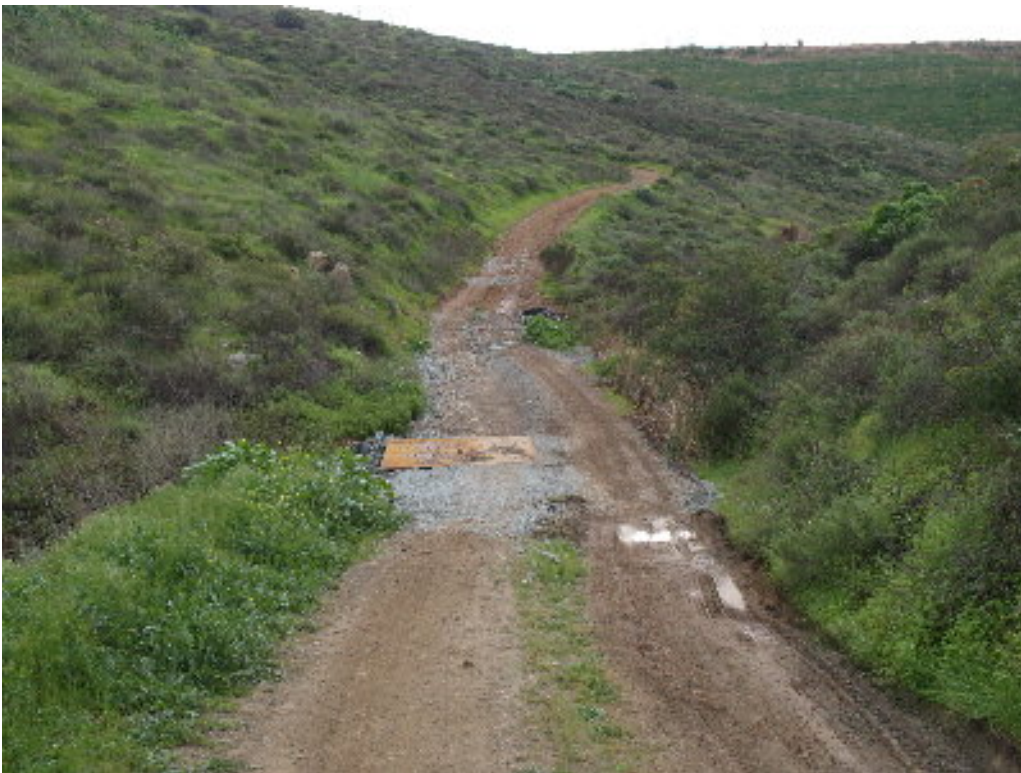
A steel plate was placed over the small drainage in the road to provide safe access to Pole Sites 10 and 20 (see Figure 4). The CPUC EM and SDG&E are reviewing the requirements for access over ponded or flowing water. Silt fencing was correctly placed around the spoils at Pole Site 20 (see Figure 5).

Figure 4 – One plate was placed on the access road to Pole Sites 10 and 20 to allow safe passage over the cut.

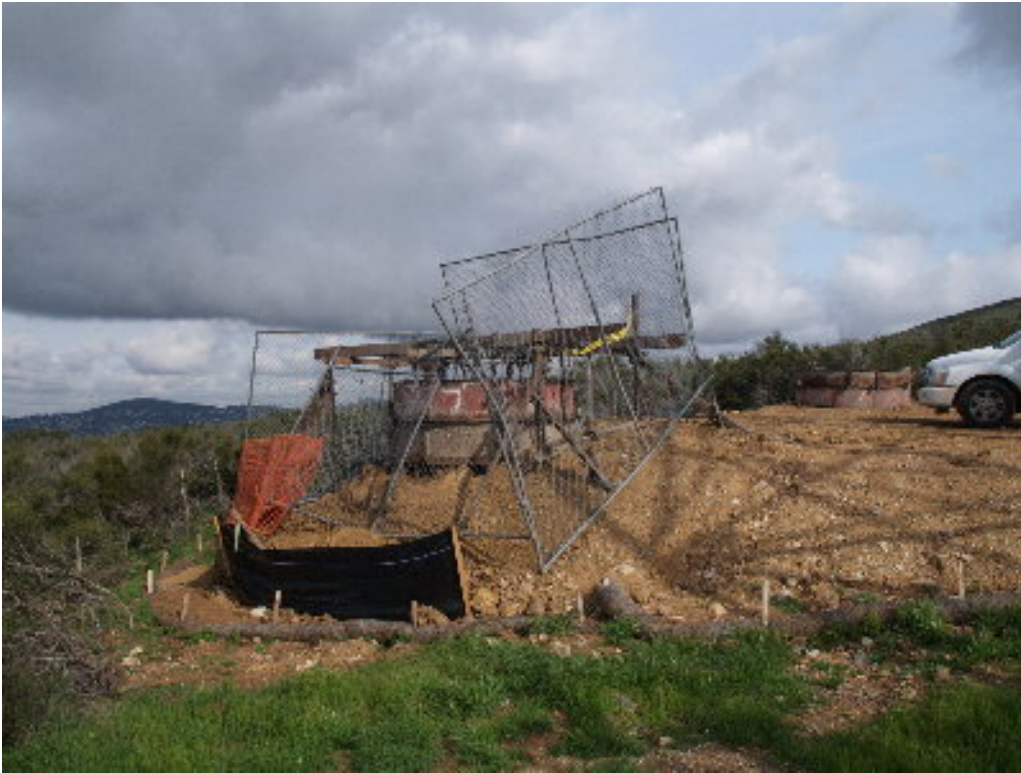
Figure 5 – Upon completion of the excavation, silt fencing was placed correctly at Pole Site 20.
