PROJECT MEMORANDUM

SDG&E – MIGUEL-MISSION 230 kV #2 PROJECT

Subject: Weekly Report #50: July 31 – August 6, 2005.

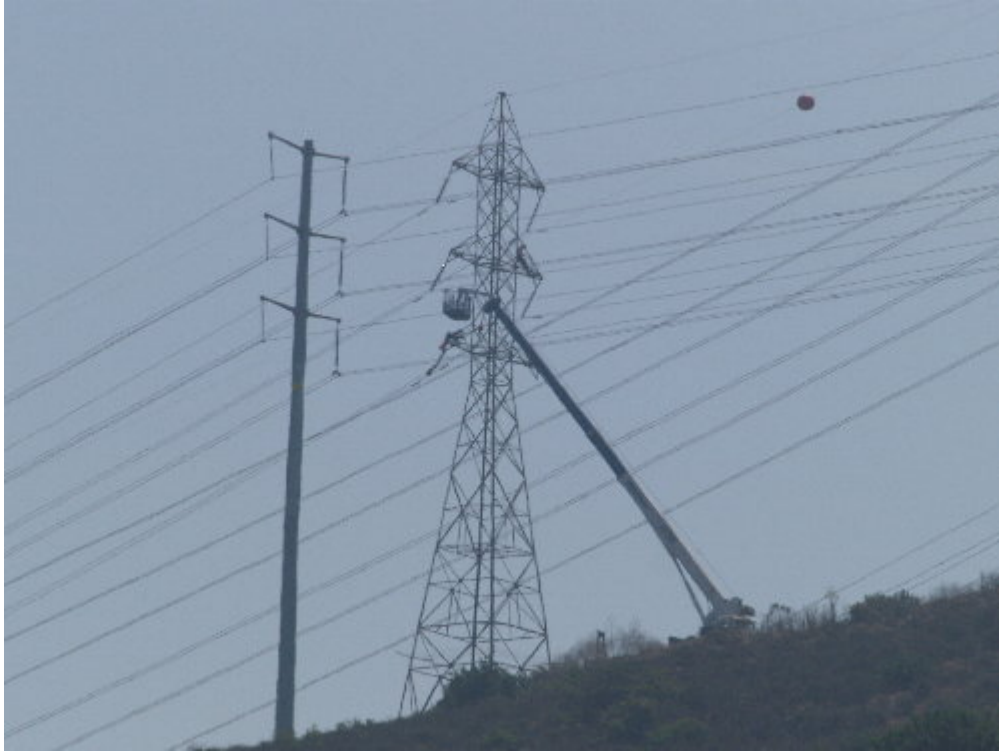
Figure 1 – The Wilson crew worked in the Sweetwater area dropping conductor from towers that will either be modified or replaced by steel poles.

1. Wilson Construction continued work on dropping existing conductor and dismantling towers that will be replaced by steel poles. Crews dropped the existing conductor in two sections during the subject week, from Towers 40 to 43 and Towers 50 to 65 (see Figure 1). The crew was working above Sweetwater during the site visit. The old conductor was reeled onto spools and removed from the sites. Another Wilson crew was working to dismantle a lattice tower directly adjacent to a residence during the site visit, and a total of three lattice towers were removed during the subject week (see Figure 2). The crews used a crane to lower sections of the tower and then further dismantled the sections on the ground for removal from the site. The crew appeared to be taking care to minimize disturbance to the resident and his property.

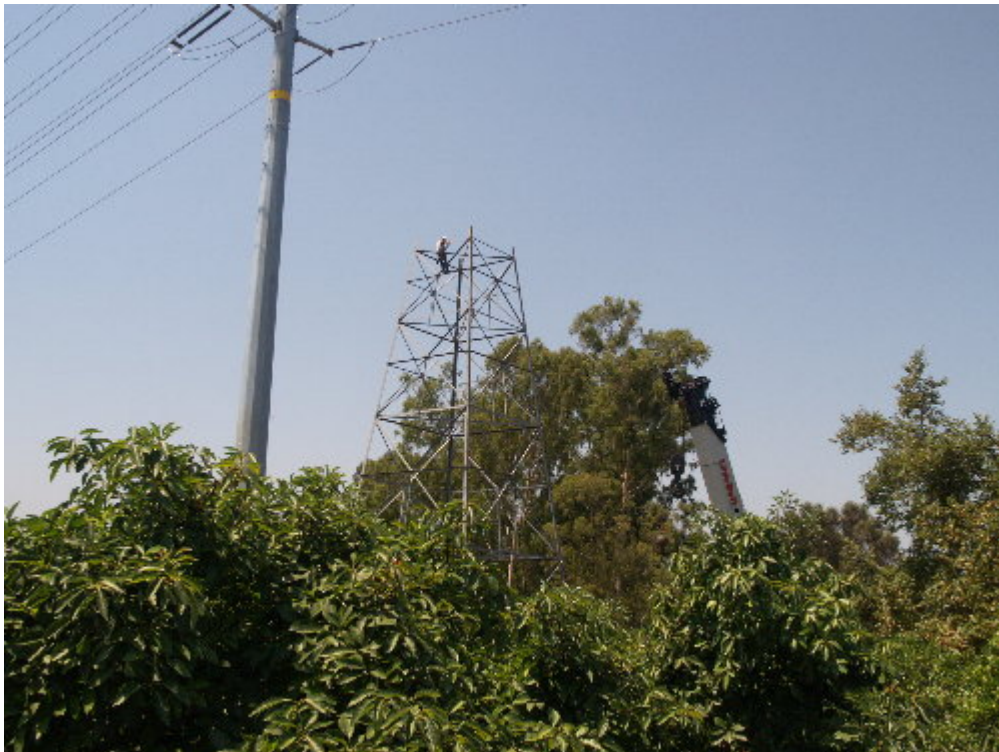
Figure 2 – Wilson Construction has dismantled several towers in preparation for drilling.

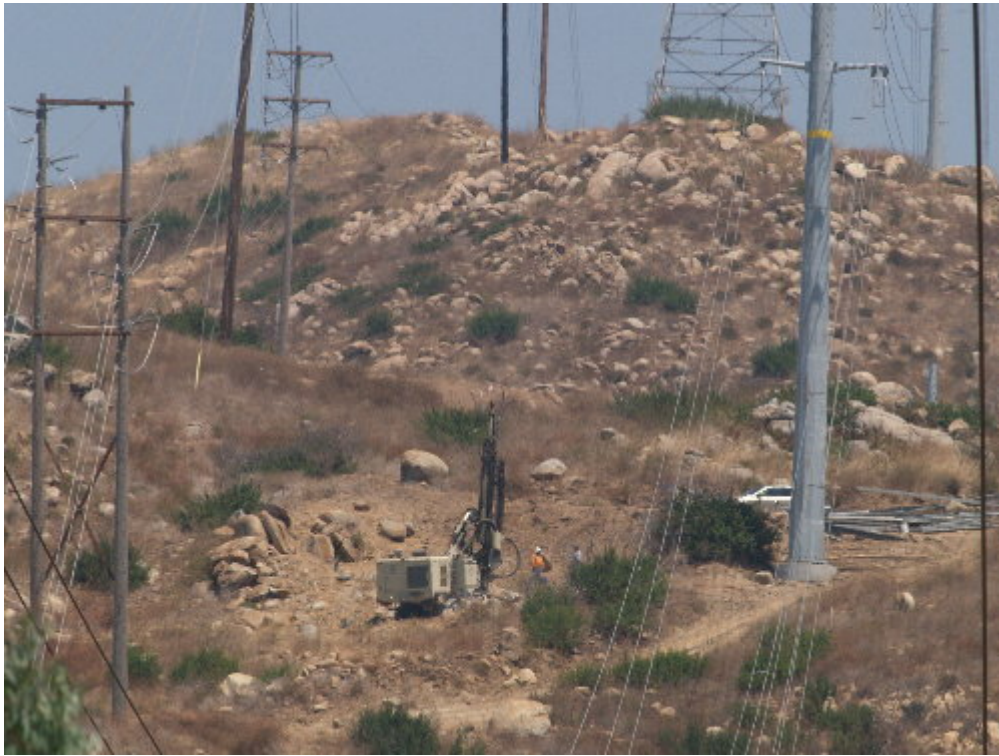
Figure 3 – A drilling subcontractor worked east of Hillsdale Street to test for rock with a small-diameter drill head.

2. A subcontractor was brought onto the project to test new pole locations for rock in order to prepare a blasting plan (see Figure 3). The crew used a core-drilling machine to test several places within the planned excavation for rock. If rock was discovered, the operator continued drilling multiple holes in preparation for eventual blasting. The crew worked east of Hillsdale Road during the site visit.
3. The Tri-State Drilling crew completed excavating the foundations for the new steel poles at Tower Sites 17 and 19 and the foundations were poured during the site visit (see Figure 4).

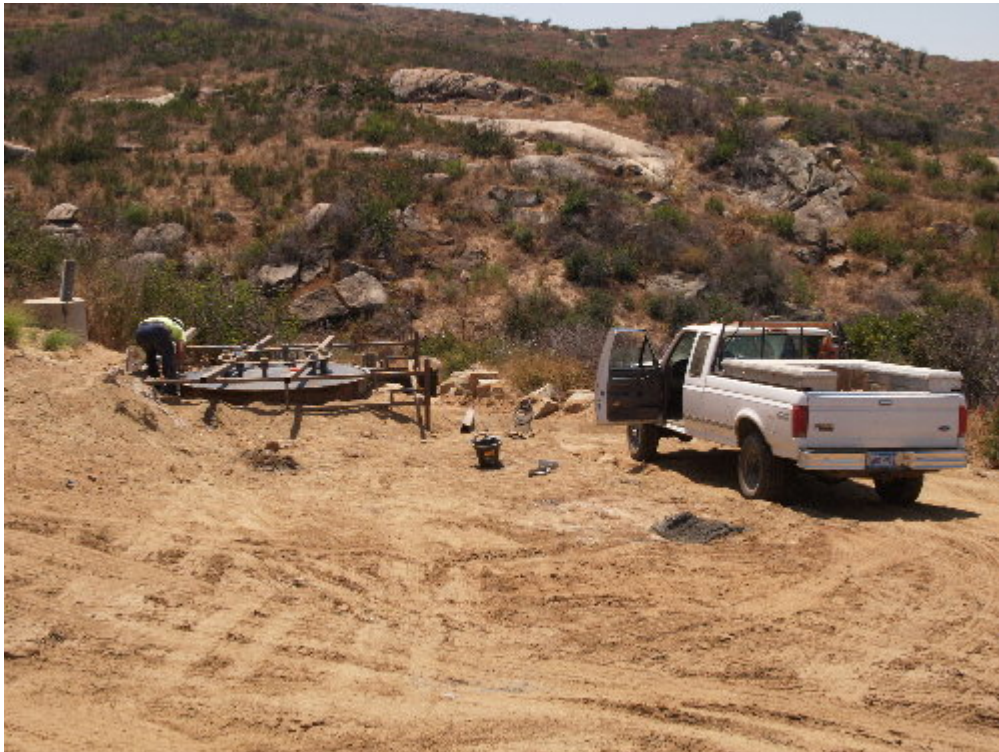
Figure 4 – Tri-State Drilling crews poured the foundations for new steel poles. An inspector from Testing Engineers was on-site.

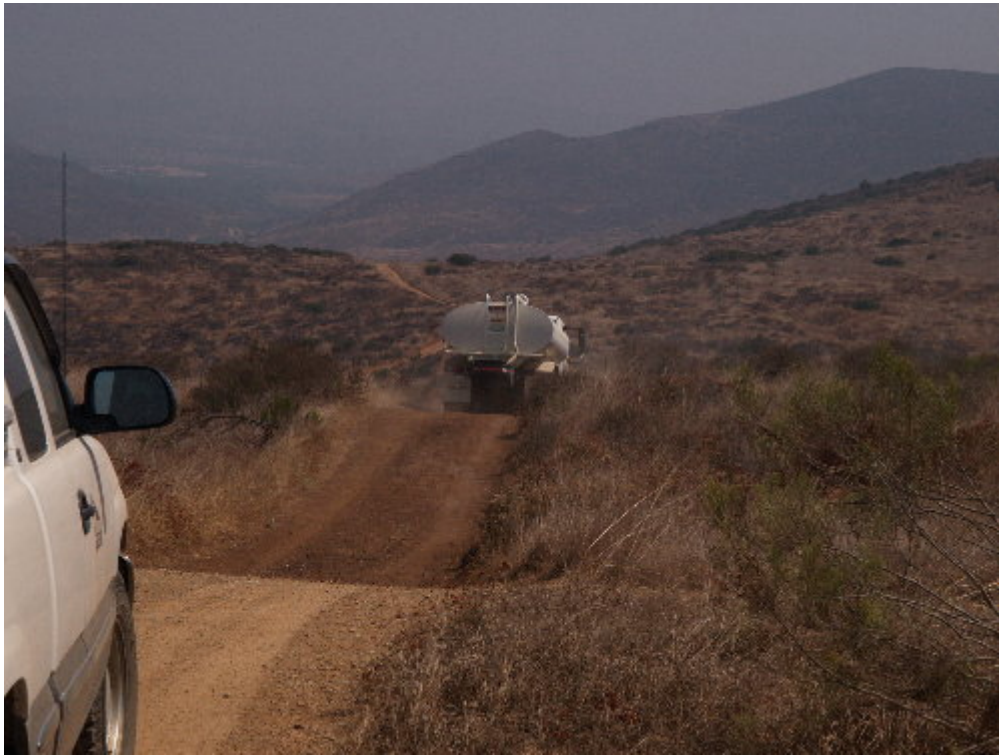
Figure 5 – A water truck worked to control dust in the Sweetwater area.

The Essex EI was on-site with the crews and worked ahead with the foreman to identify sensitive areas. A water truck was used to keep dust down on the access roads during the site visit, as well as for safety in case of fire (see Figure 5).

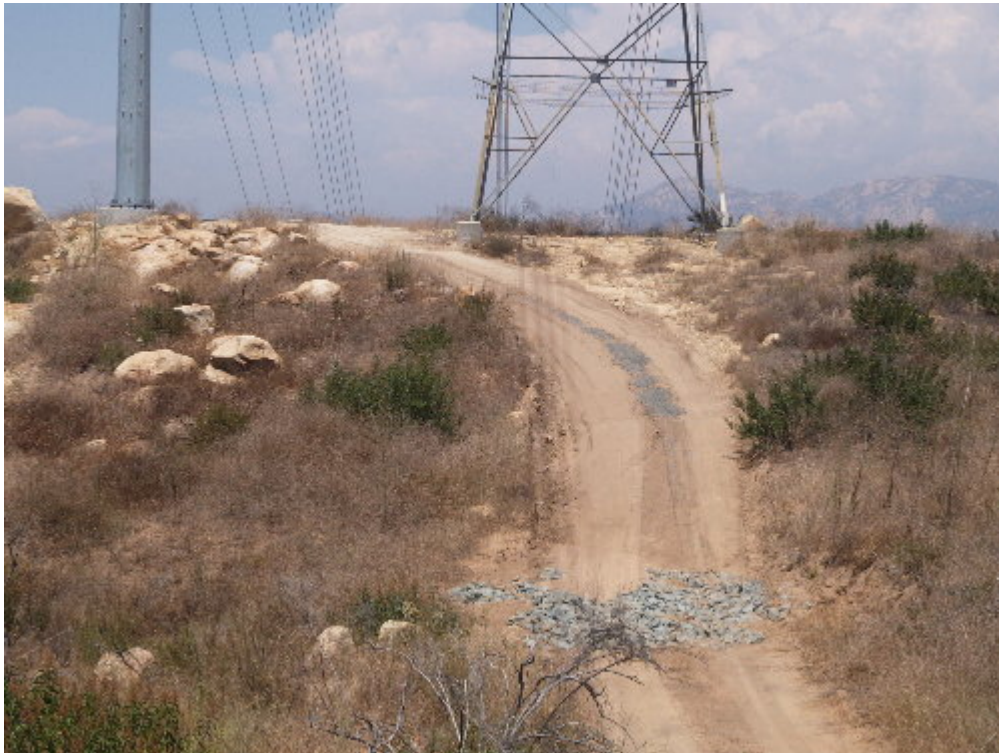
A small concrete spill was noted on a steep access road near Tower Site 16 where a concrete truck took the wrong road (see Figure 6). The spill was minor and no environmental resources were threatened. The Essex EI was aware of the problem and had already contacted the contractor to clean up the concrete. It is not uncommon for concrete to spill out of trucks that are full during travel on steep roads.

Figure 6 – A minor concrete spill near Tower Site 16. Note that the dip at the lower spot in the road is rock placed to control erosion, not concrete.
