## **PROJECT MEMORANDUM PG&E NORTHEAST SAN JOSE TRANSMISSION REINFORCEMENT PROJECT**

**To:** Roosevelt Grant, CPUC  
**From:** Vida Strong, Aspen Project Manager  
**Date:** February 20, 2003  
**Subject:** Weekly Report #38: February 10, 2003 – February 16, 2003  
**CPUC Environmental Monitor (EM):** Jody Fessler

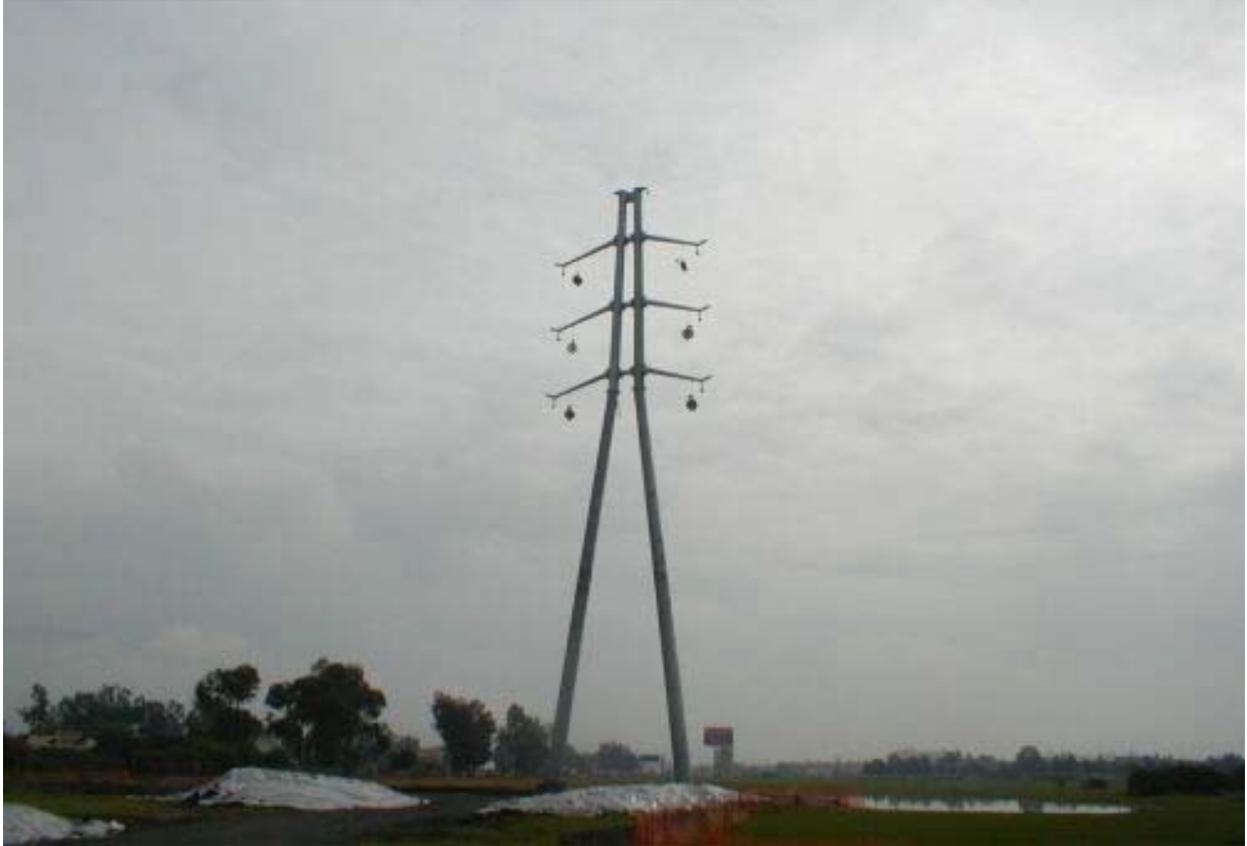
The CPUC EM conducted a site visit of pole structures #1(a) and (b) in the morning. The poles are erected and half of the arms are connected. Pole structures #2, #3, #4, and #5 (see Figure 1) are fully erected and the arms are also all connected, as well as the temporary travelers. The CPUC EM noted that these sites were neat and clean. On the Catella Property (pole #5) the silt fencing was well maintained.

Figure 1  
Pole Structure #5 on the Catella Property  
February 12, 2003

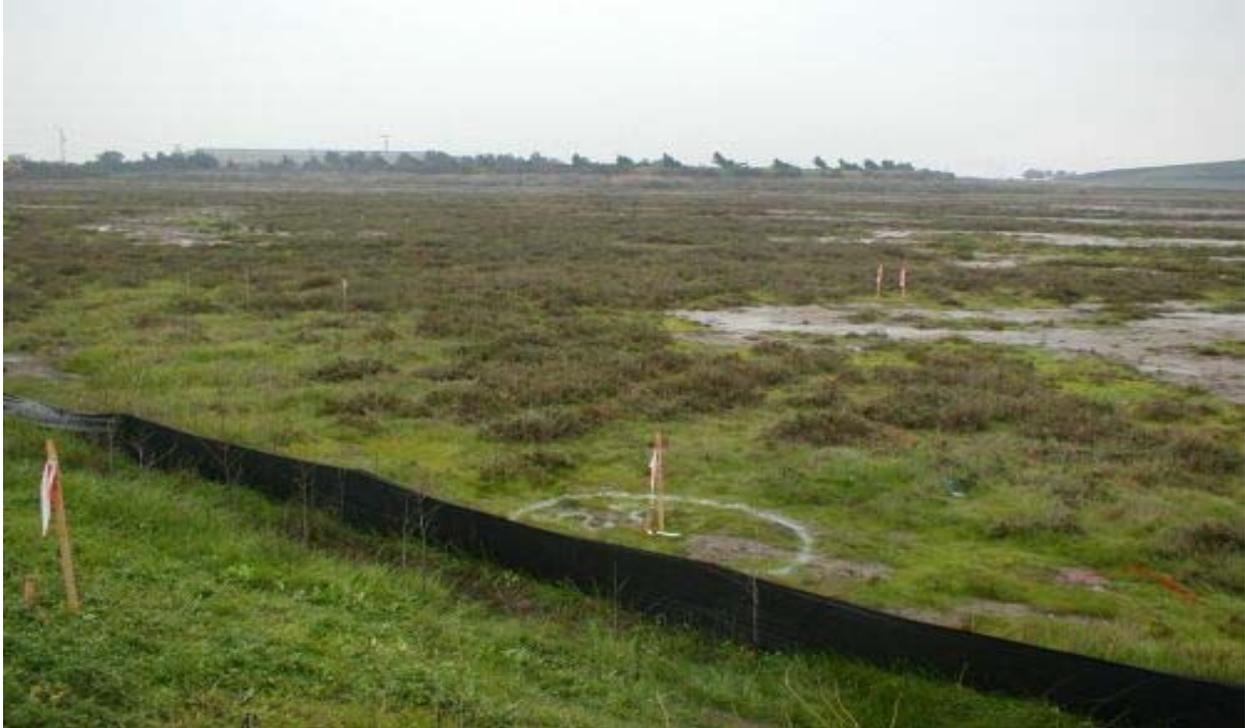
Later in the afternoon, the CPUC EM conducted a site visit of the King & Lyon's property where poles #11, #12, and #13 will be placed. The CPUC EM met with the Essex Environmental Inspector (EI) at pole site #12 and discussed the work area and access (see Figure 2). PG&E and Essex have been working closely with the King & Lyon's environmental consultants in order to comply with mitigation measures and permit requirements. The final construction plans should be finished shortly and passed around for approval by the property owners as well as the Corps.

Figure 2  
Pole area #12(a) and (b) on the King & Lyon's Property  
February 12, 2003

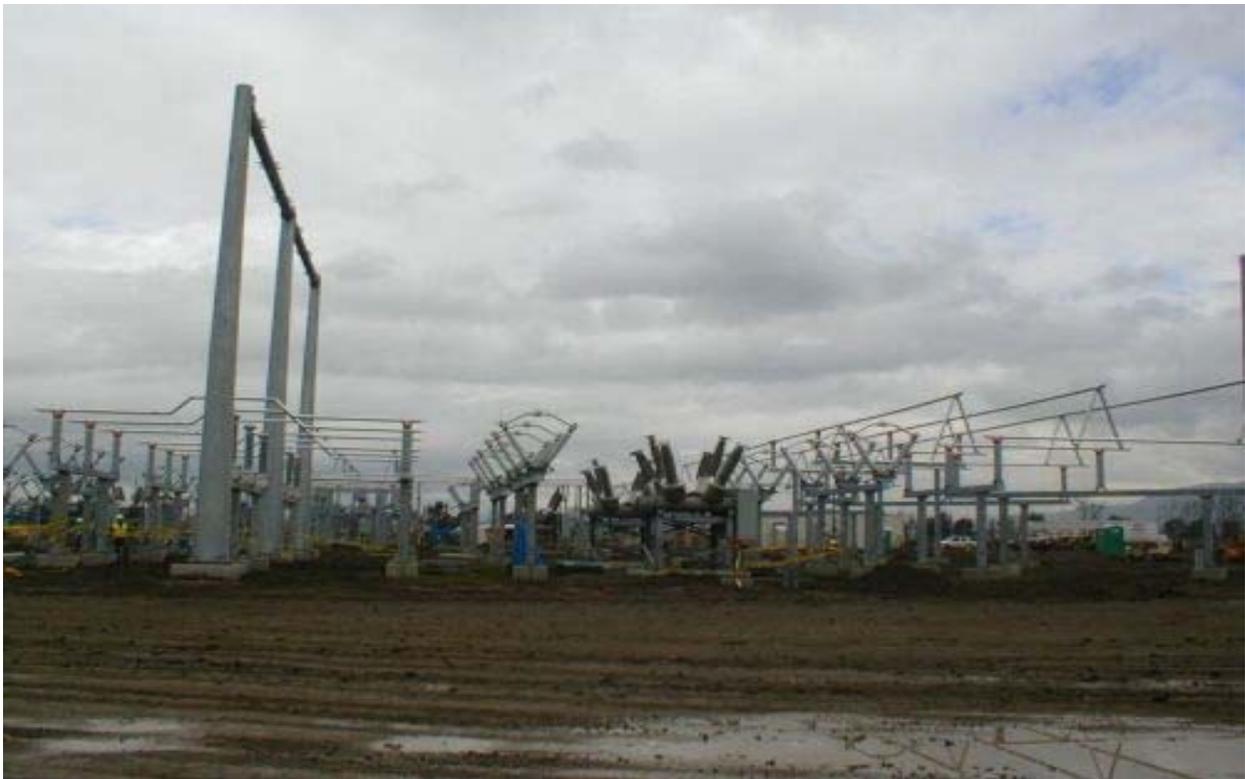
At the Los Esteros Substation (see Figure 3), separate electrical crew were working on insulators and both transformers. The CPUC EM observed that the site was neat and clean.

Figure 3  
Los Esteros Substation  
February 13, 2003
