Figure 3.14-21b
Visual Simulation
for KOP-Center-6
Southbound Upper Big
Tujunga Canyon Road
(Alternative 2, Segment 6)

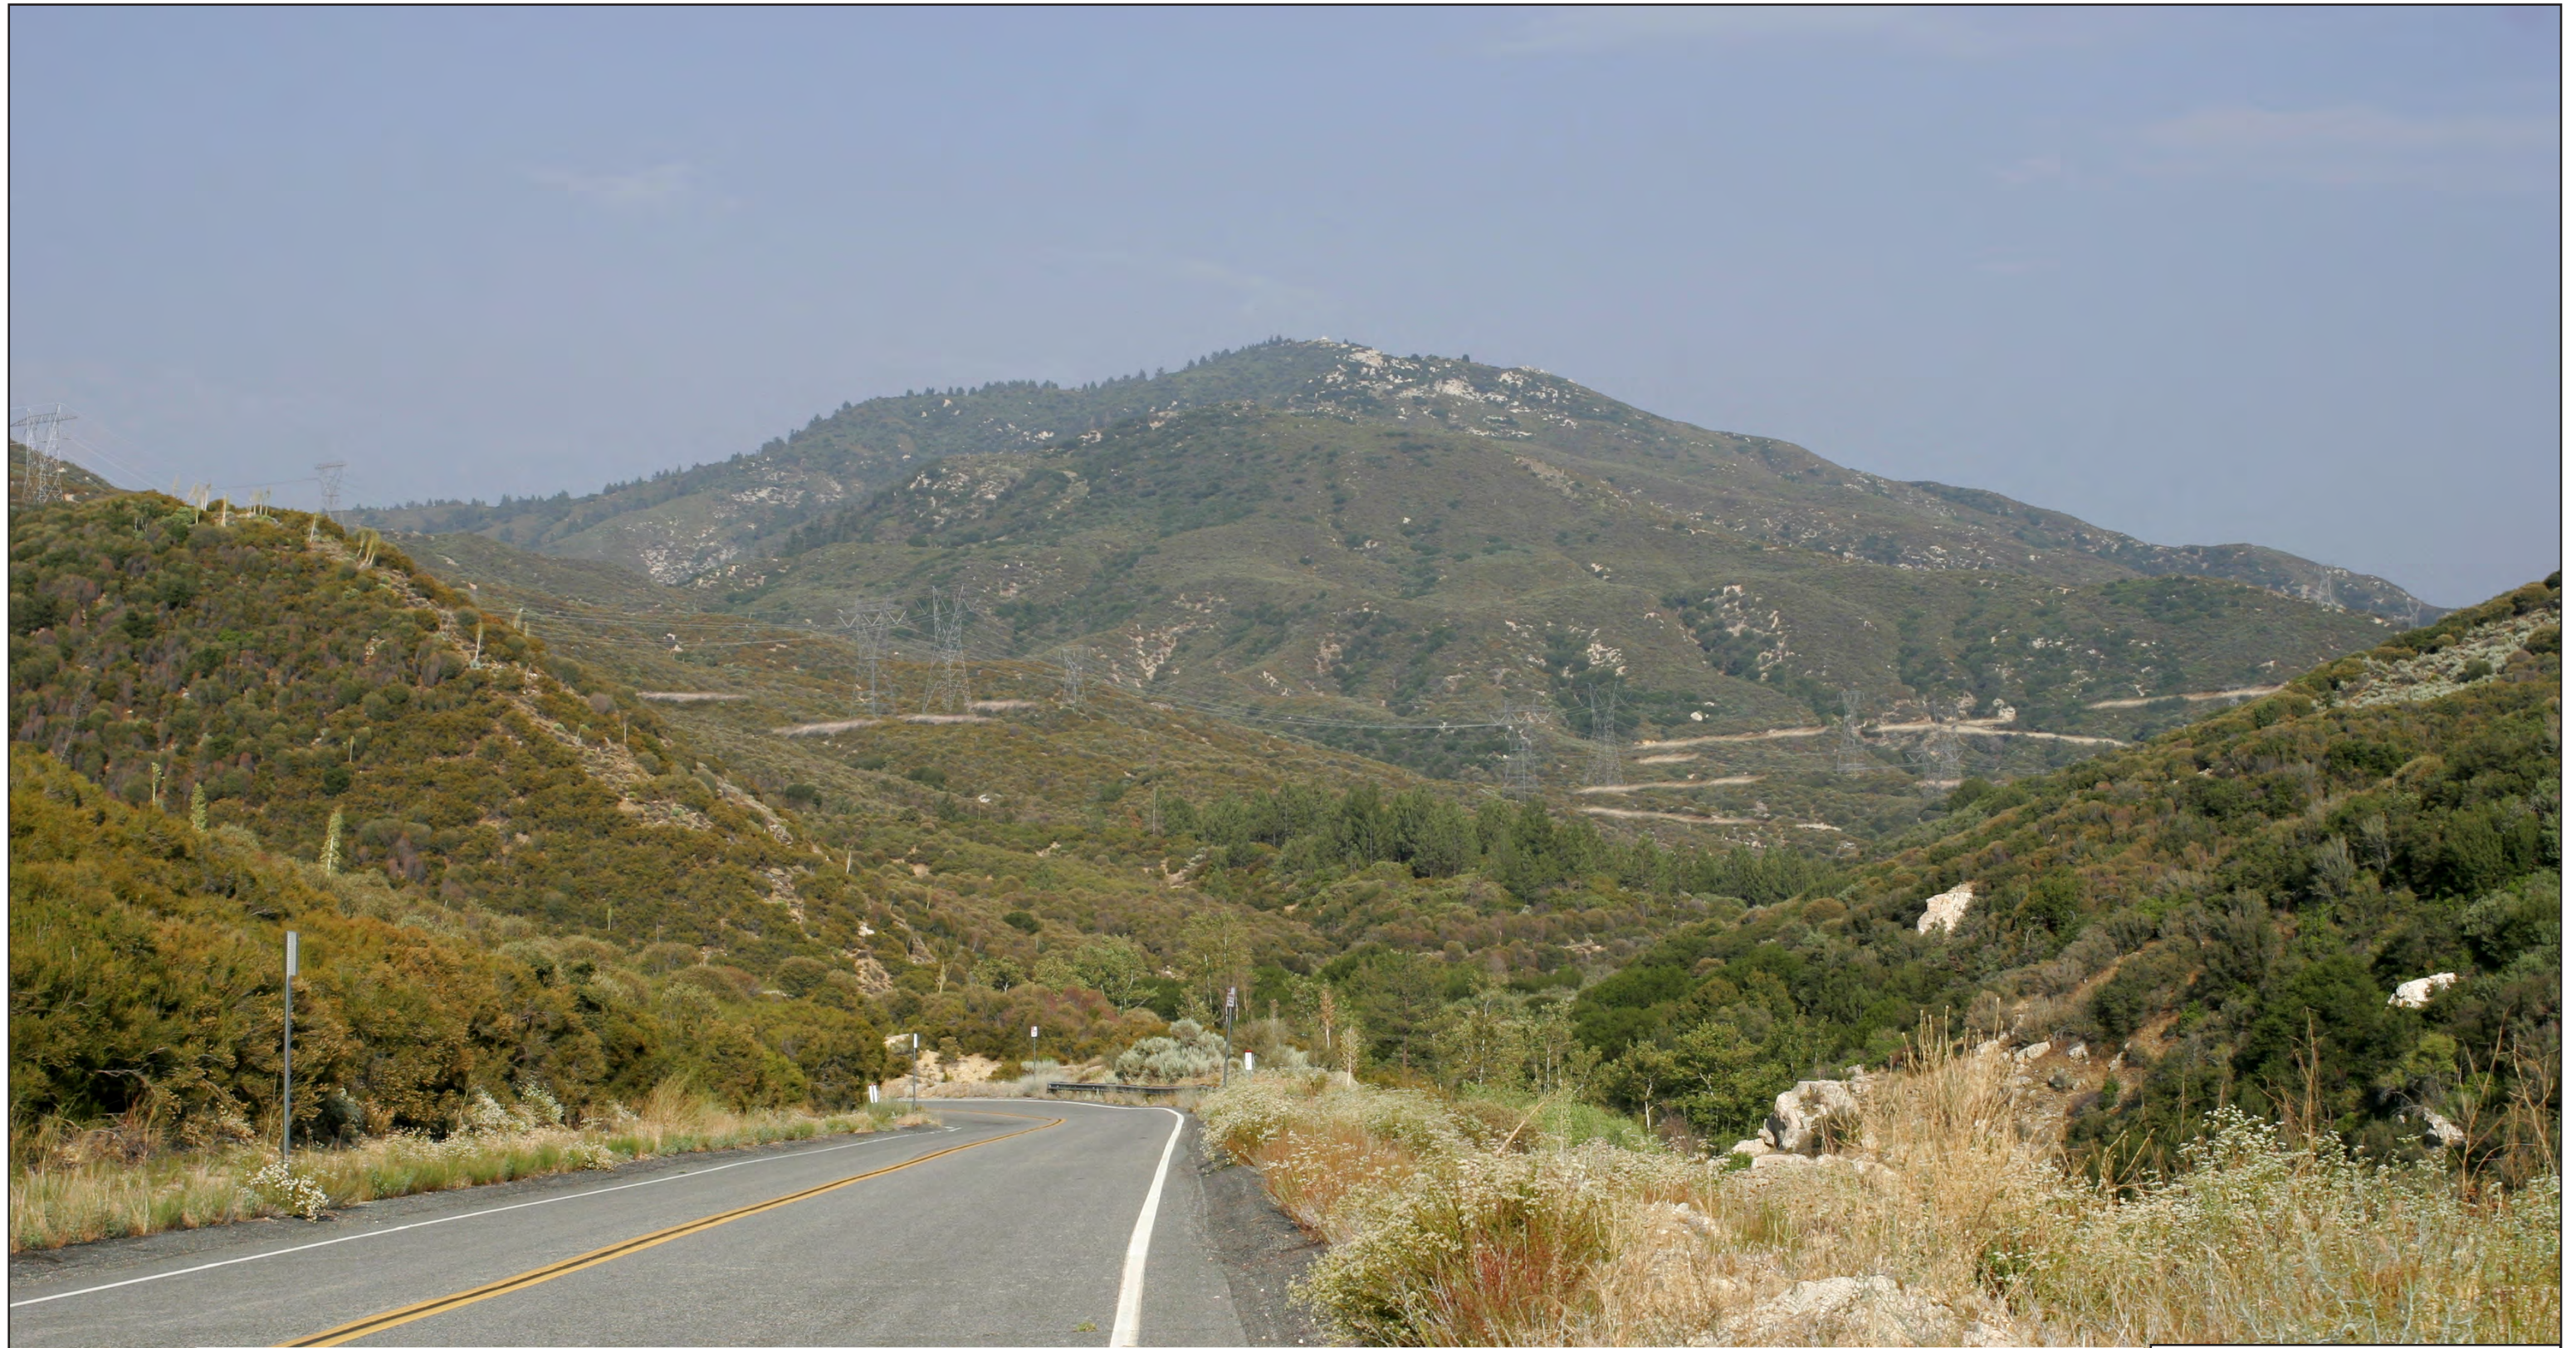
Future Scenic Integrity: High, with Areas of Very Low. The proposed Project would replace an existing 220-kV transmission line with a new 500-kV transmission in the middle of three parallel lines in this view. In this area of Segment 6, the proposed Project would construct the new transmission line using re-opened access/spur roads in this vicinity. Segment 6 transmission lines, access roads, and spur roads would be seen in the middleground, and would achieve very low scenic integrity in an otherwise predominantly natural-appearing existing landscape character. Access and spur roads are simulated based on Road Permit Plans provided by SCE in August 2008.

Adverse Visual Impacts. In the vicinity of KOP-Center-6, implementation of the Project would result in adverse visual impacts V-1, V-3, V-4, V-5, and V-7, as detailed in Table 6-1.

Mitigation Measures. Implementation of Mitigation Measures (MMs) would reduce adverse visual impacts to a certain degree, but the Project would create strong adverse contrasts of form, line, color, texture, and scale. It would continue to not meet the High SIO established for this area. MMs would include: V-1 – Clean up staging areas, storage areas, marshalling yards, access and spur roads, and structure locations on a regular periodic basis; V-2b – Treat surfaces with appropriate colors, textures, and finishes; V-3b – On NFS lands, provide restoration/compensation for impacts to landscape character and visual quality; V-4b – Slope-round and re-contour in areas as prescribe; V-4c – Avoid locating new roads in bedrock on NFS lands; V-4d – Dispose of excavated materials as prescribed.
