**Figure 3.14-75a (Revised)**  
**Existing Conditions**  
**for KOP-Center-12**  
**Cogswell Reservoir &**  
**National Scenic Bikeway**  
**(Alternative 6, Segment 6)**

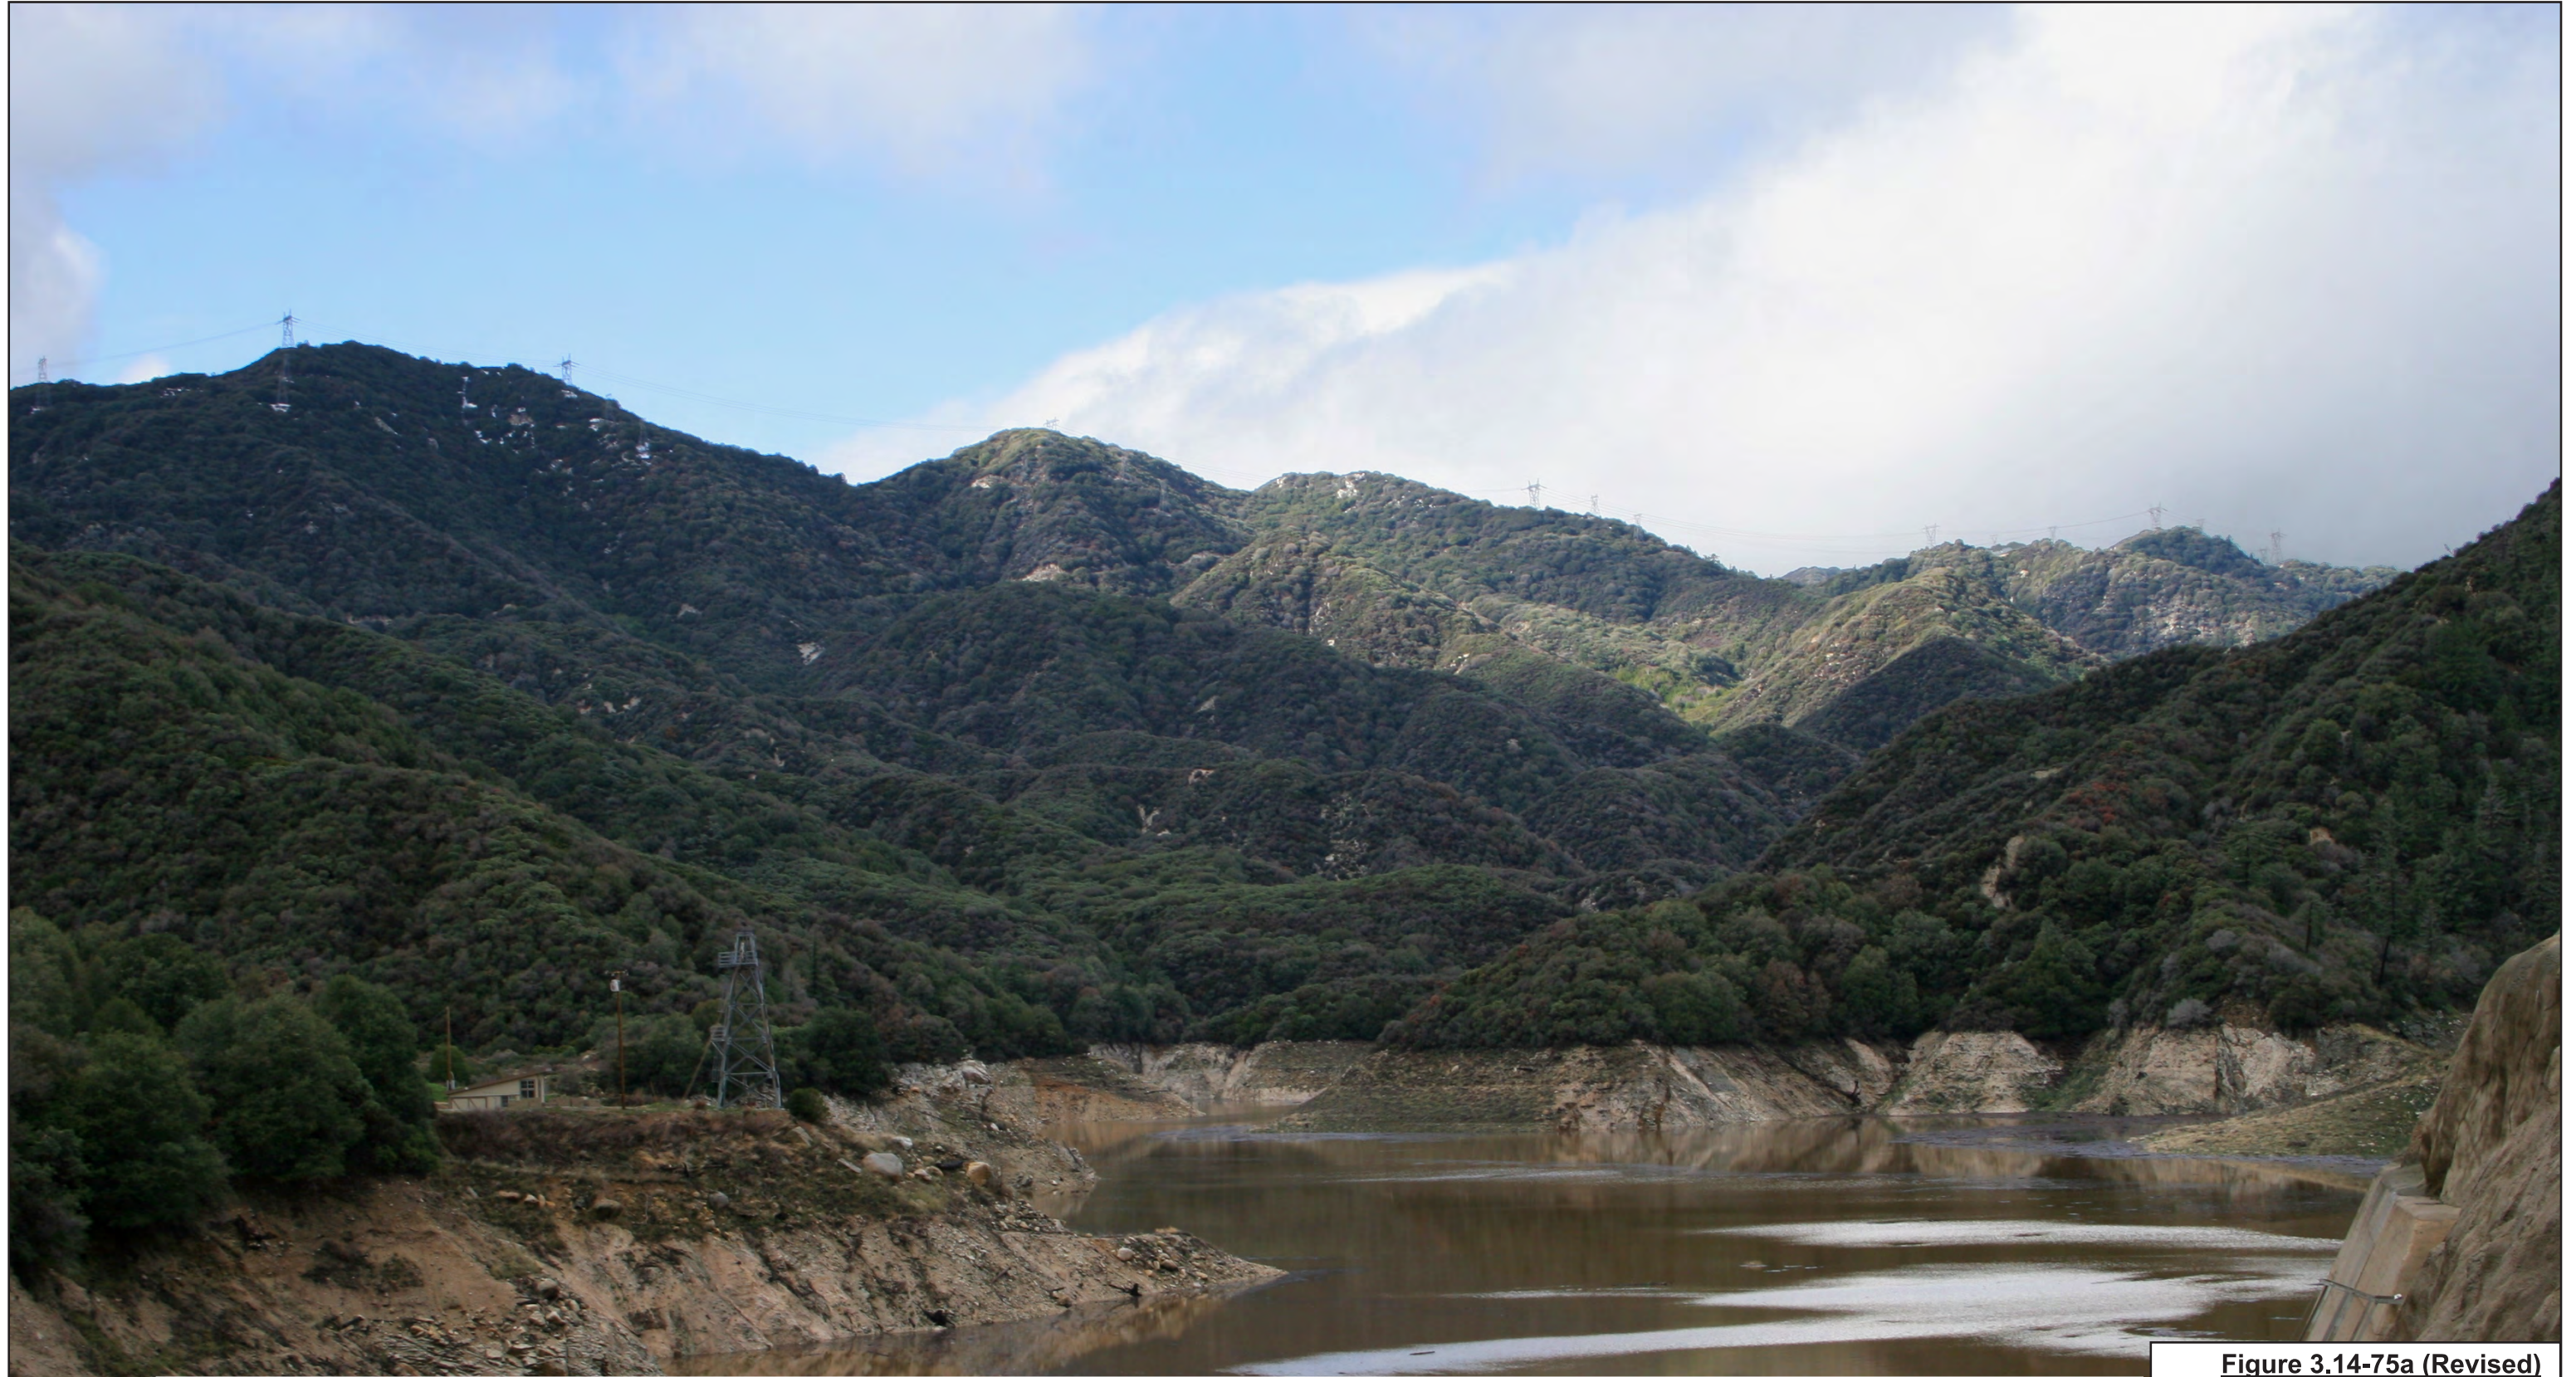
**Existing Scenic Integrity: High, with Areas of Moderate.** KOP-Center-12 is located on Cogswell Reservoir Dam, looking west. It is located at the west end of the West Fork National Scenic Bikeway next to the San Gabriel Wilderness, at an elevation of approximately 2,415 feet. Existing 220-kV and 500-kV lattice structures are visible on the skyline, as are access and spur roads cutting across the mountainside and leading to each LST. When the reservoir is full, there is no “bathtub ring” effect and scenic integrity is high for this landscape. Overall, the existing scenic integrity of this natural-appearing National Forest landscape is high, with no deviations of form, line, color, texture, or scale except for the seasonal bathtub ring at the reservoir in the foreground and existing transmission lines, access roads, and spur roads near the skyline in the middleground. These manmade features create strong visual contrasts and make the valued landscape character appear moderately altered. They detract from the otherwise high scenic integrity and reduce certain areas of this landscape to a level of moderate scenic integrity.

**Scenic Integrity Objective: High.** In the 2005 Forest Plan, the entire landscape in this vicinity is mapped as High SIO, where the management direction states that human activities should not be visually evident. Human-caused deviations may be present but must repeat the form, line, color, texture, and pattern common to the natural landscape character so completely and at such a scale that they are not evident.
