PROJECT MEMORANDUM PG&E – TRI-VALLEY 2002 CAPACITY INCREASE PROJECT

To: Roosevelt Grant, CPUC
From: Vida Strong, Aspen Project Manager
Date: October 2, 2003
Subject: Weekly Report #54: September 22, 2003 – September 28, 2003
CPUC Environmental Monitor (EM): Anne Sweet

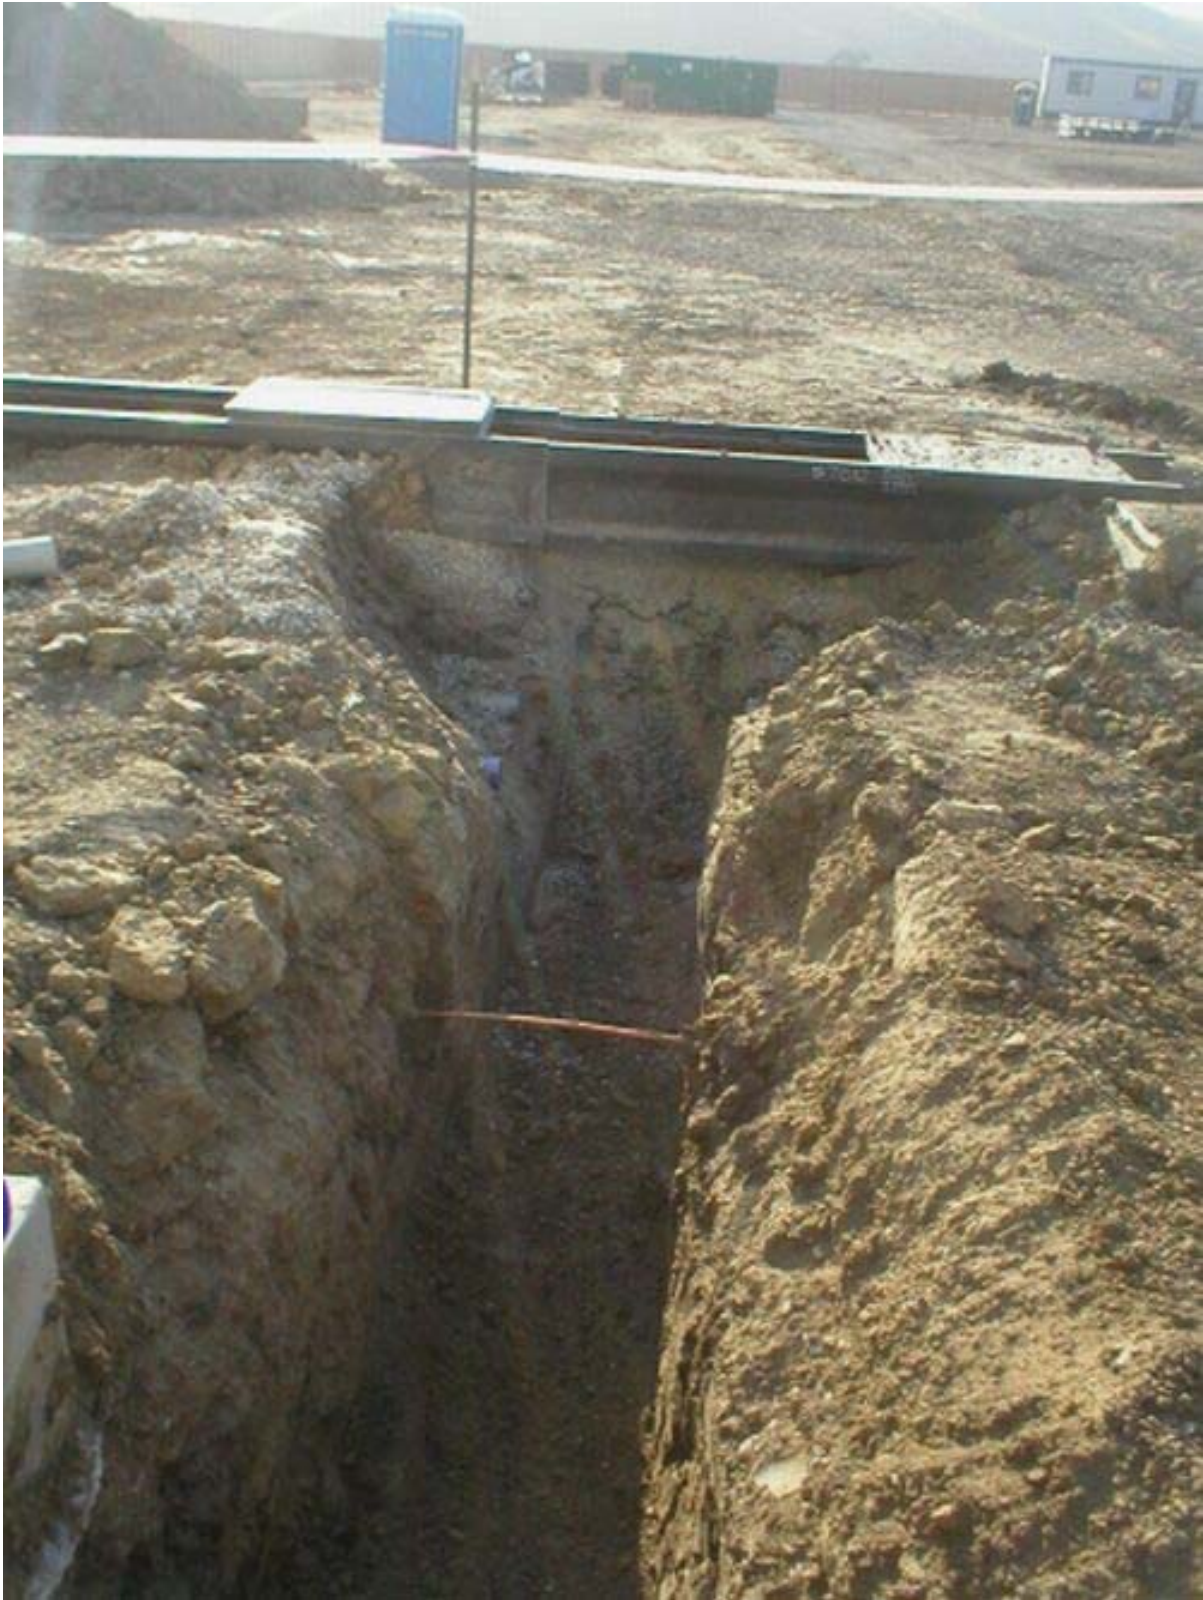
Figure 1 - Un-ramped trench at the Cayetano Substation, Phase Two.

A CPUC Project Memorandum was written when on September 24, at the Cayetano Substation, crews had left the site with a trench unramped. The project USFWS Biological Opinion Conservation Measure 27 states: *To prevent accidental entrapment of San Joaquin kit fox during construction all excavated holes and trenches will be ramped, or escape boards will be placed in the trench to allow the animals to escape...* This issue marks the second instance that a CPUC EM observed compliance failure in regard to San Joaquin Kit Fox protection requirements (see Weekly Report #53, end of work day conduit capping issue).
