PROJECT MEMORANDUM PG&E – TRI-VALLEY 2002 CAPACITY INCREASE PROJECT

To: Roosevelt Grant, CPUC
From: Vida Strong, Aspen Project Manager
Date: October 9, 2003
Subject: Weekly Report #55: September 29, 2003 – October 5, 2003
CPUC Environmental Monitor (EM): Anne Sweet

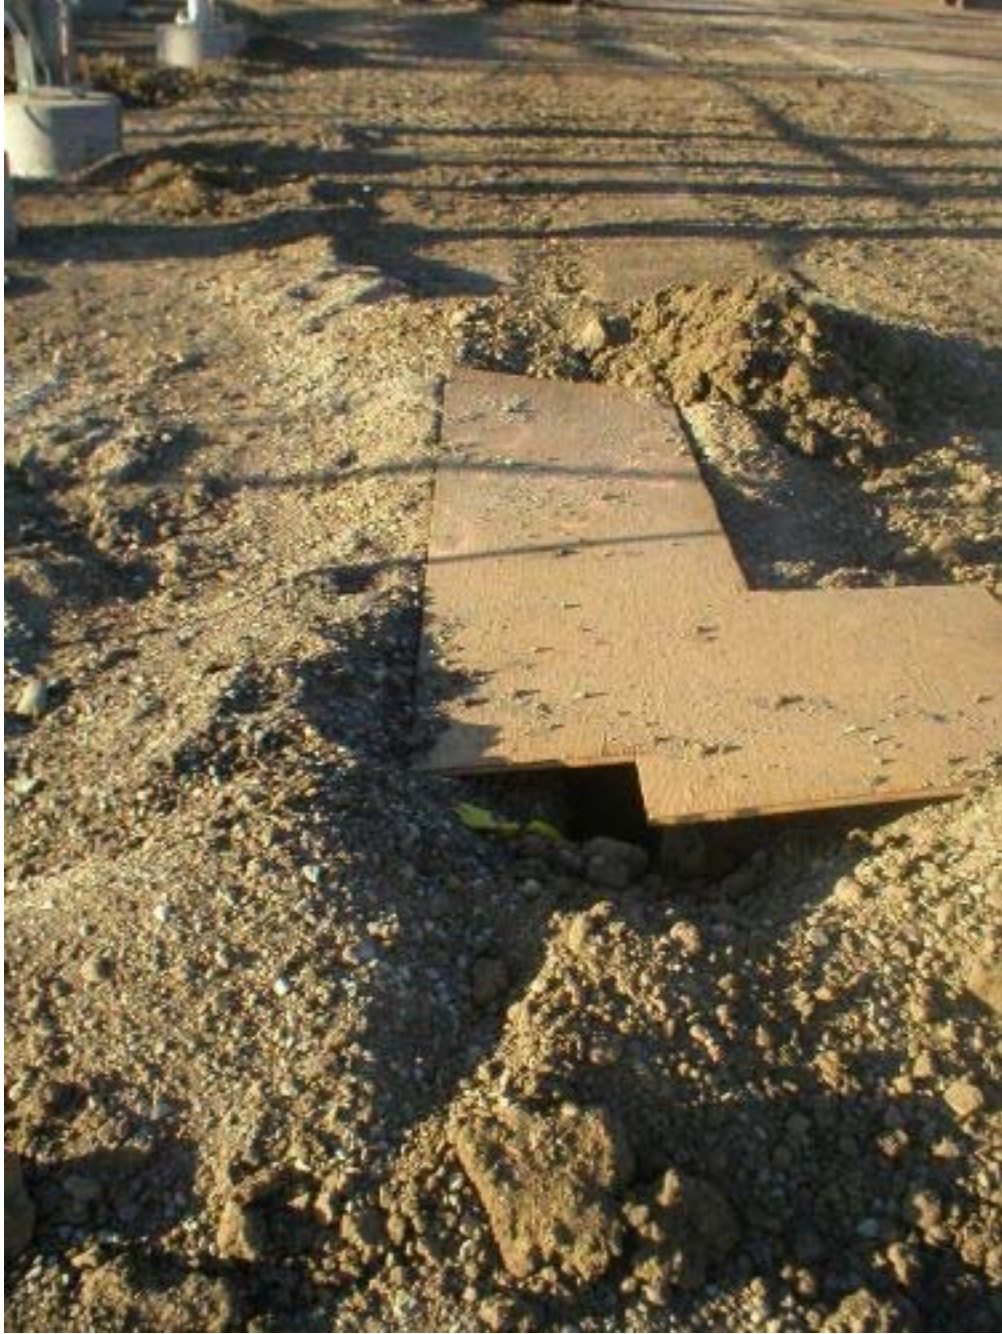
At the Cayetano Substation site, the contractor continued component structure installation. Work also continues on the fence around the perimeter of the station. Numerous trenches and holes have been excavated within the substation pad for tie-ins to the station components. An additional trailer has been placed at the back of the substation site. On September 29, the CPUC EM observed that there was a hole that was covered with plywood; however the plywood had an approximate 12" square notch cut out of the end. Thus wild life would be able to get in making the cover ineffective (see Figure 1). The Essex EI was notified.

On September 29, the CPUC EM observed that there was a hole that was covered with plywood; however, the plywood had an approximate 12” square notch cut out of the end. Thus wild life would be able to get in making the cover ineffective. The Essex EI was notified of the problem.

Figure 1 – Ineffective cover of an open hole at the Cayetano Substation, Phase Two.

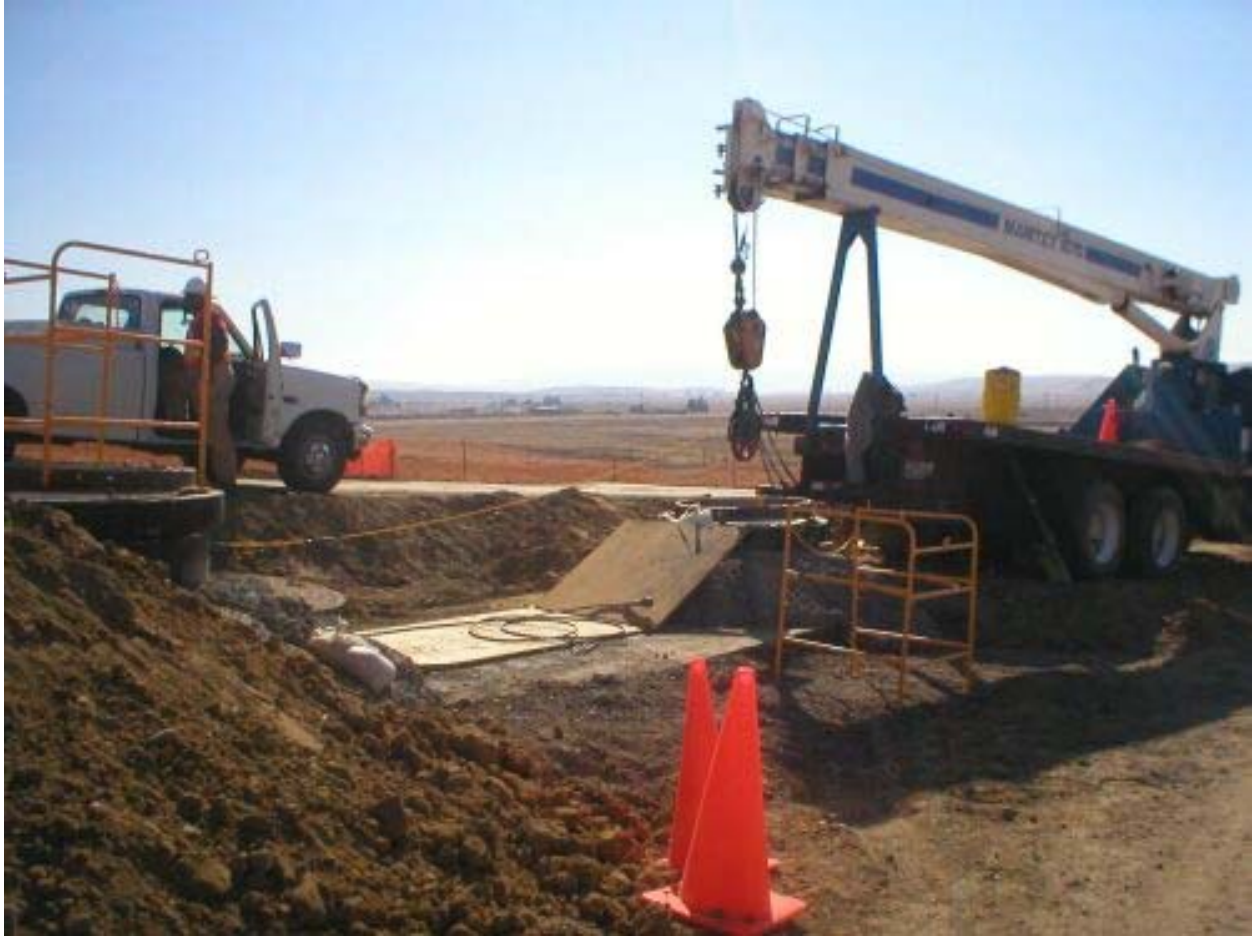
During the subject week, crews finished pulling operations between Vault DC-25 and the cable termination point structures at the Substation. Crews also pulled cable between Vaults CC-2 and DC-21 and the cable termination structures at the Transition Station (see Figure 2).

Figure 2 – Cable pulling activities at the Vault location along the access road leading to the Transition Station, Phase Two.

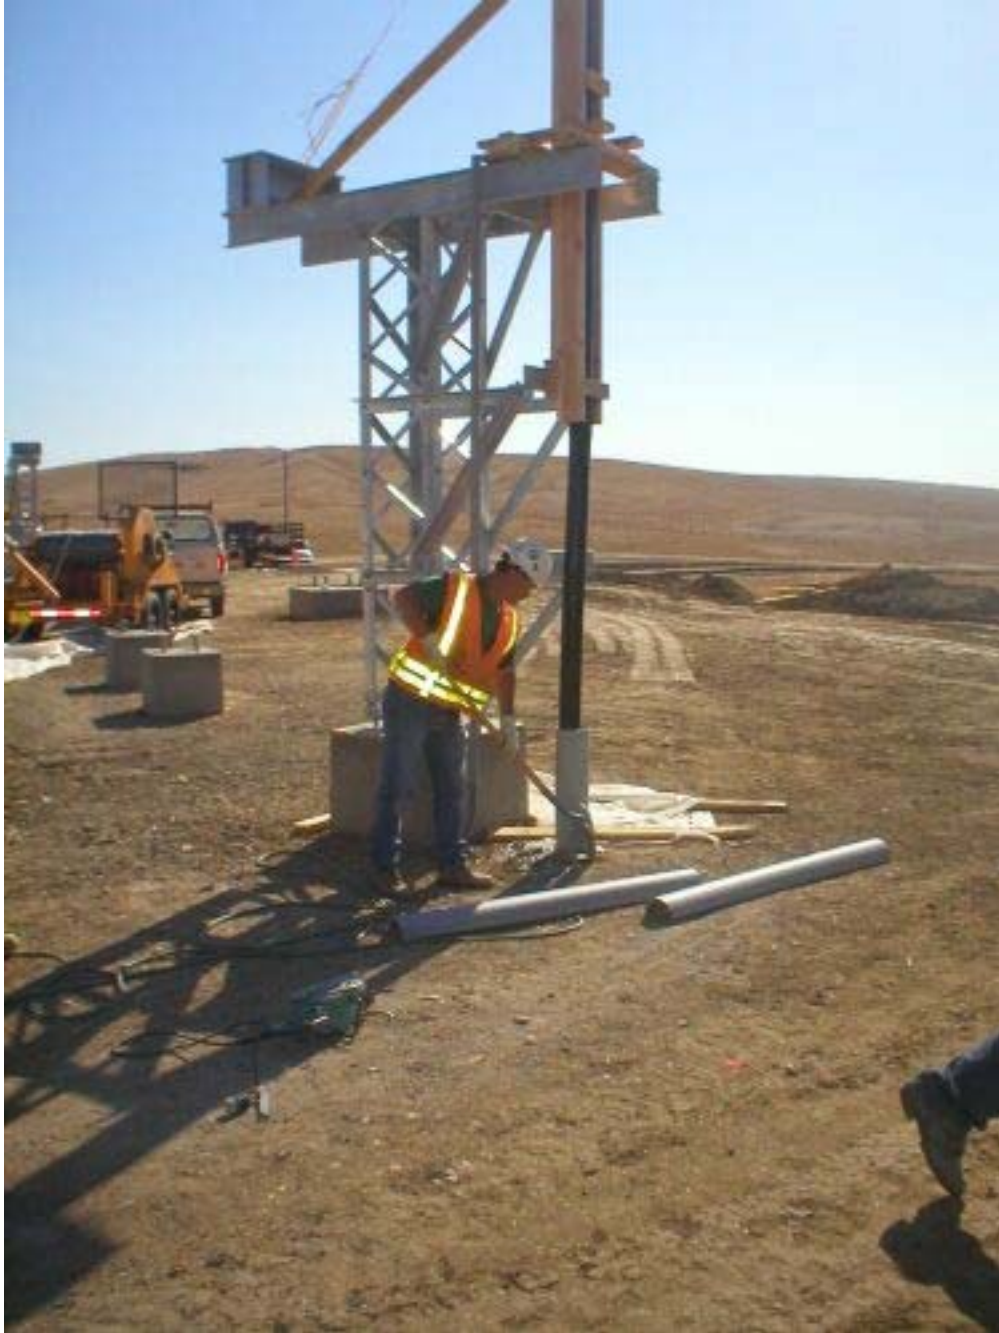
At the Transition Station, the contractor continued to pull cable to the Transition Station termination structures. During pulling operations, a spill of poly lube occurred at the structure and crewmembers promptly cleaned up the lubricant (see Figure 3). A fiber optic vault at the west side of the Transition Station was installed and trench excavated. The Essex EI reported that at the end of each workday, all open holes are being covered by plywood or ramped to avoid entrapment of wildlife.

Figure 3 – Cable pulling activities at the Transition Station. Lubricant was spilled at the site and a crewmember promptly cleaned it up, Phase Two.
