PROJECT MEMORANDUM PG&E – TRI-VALLEY 2002 CAPACITY INCREASE PROJECT

To: Roosevelt Grant, CPUC
From: Vida Strong, Aspen Project Manager
Date: October 16, 2002
Subject: Weekly Report #4: October 7, 2002 – October 13, 2002

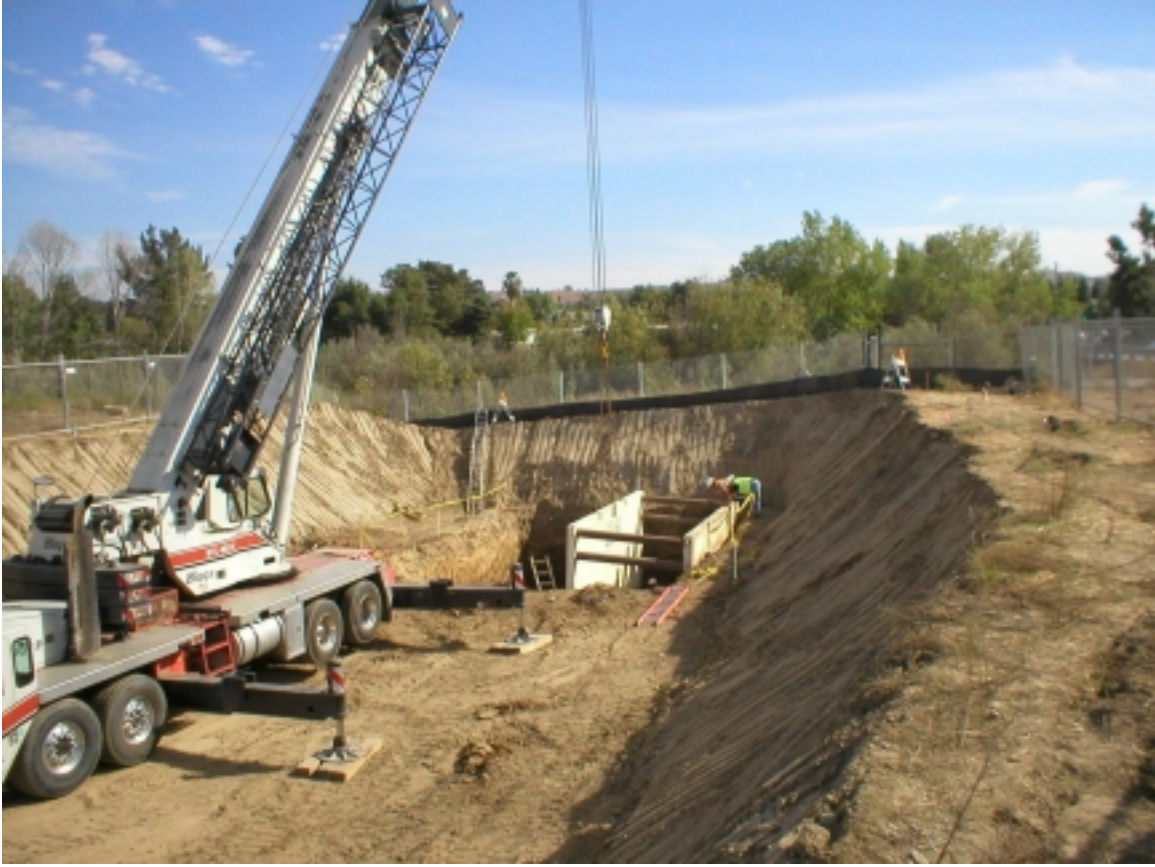
CPUC EM conducted site visit of the Arroyo Del Valle bore crossing. Crews have completed digging the bore pit on the north side of the crossing to 32 feet in depth. Crews continue to install shoring (see Figure 1).

Figure 1: Arroyo Del Valle north bore pit shoring placement.

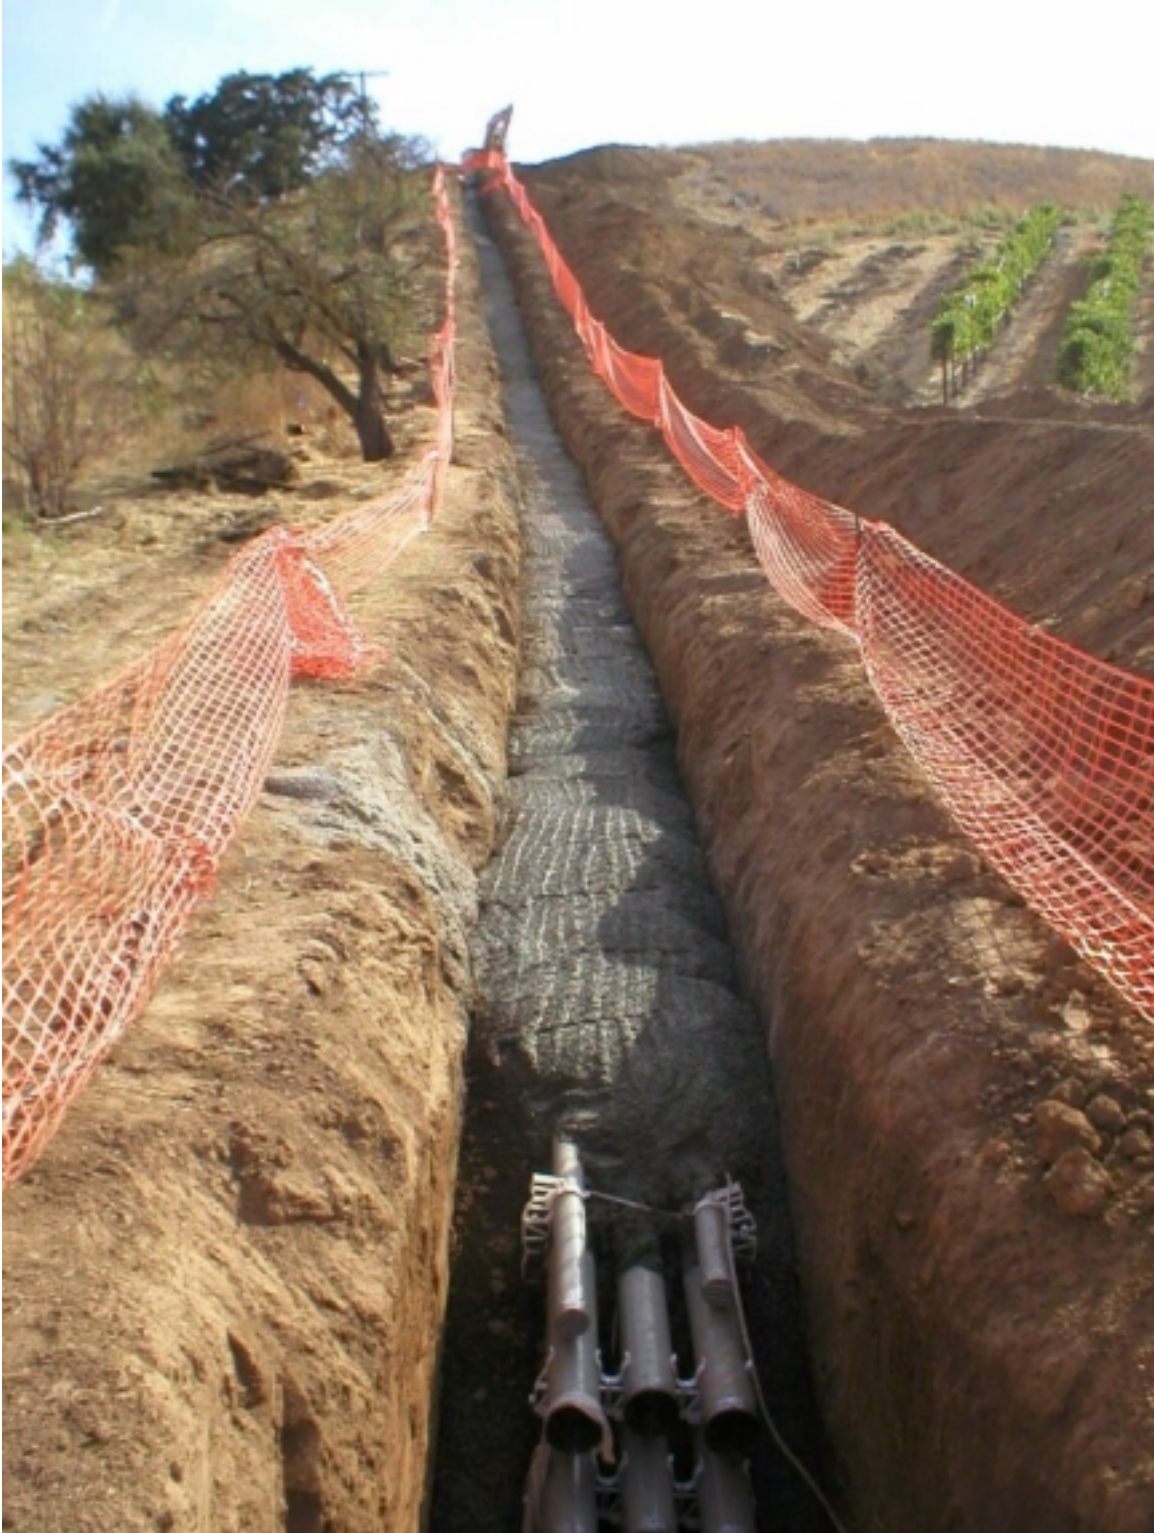
At the Transition Station on the Tesla-Newark corridor, grading is not yet complete. Topsoil from the trenching activities are being stored at the Transition Station site; other spoils are being taken to the Muller Yard. At the location where crews had to stop trenching at Station 10+60 due to surfacing water in the trench, water continues to be pumped back into the water district pool. Trenching and conduit installation have been completed and crews are back filling and compacting at Station 26+50 to 30+00 working down a steep slope (see Figure 2). Per land owner specifications, three water bars will be installed. An erosion control blanket cover and seeding will also be utilized to prevent erosion of the slope.

Figure 2: Trenching and conduit installation at Station 26+50 working down a steep slope.
