## **PROJECT MEMORANDUM PG&E – TRI-VALLEY 2002 CAPACITY INCREASE PROJECT**

**To:** Roosevelt Grant, CPUC  
**From:** Vida Strong, Aspen Project Manager  
**Date:** November 20, 2002  
**Subject:** Weekly Report #9: November 11, 2002 – November 17, 2002  
**CPUC Environmental Monitor (EM):** Anne Sweet

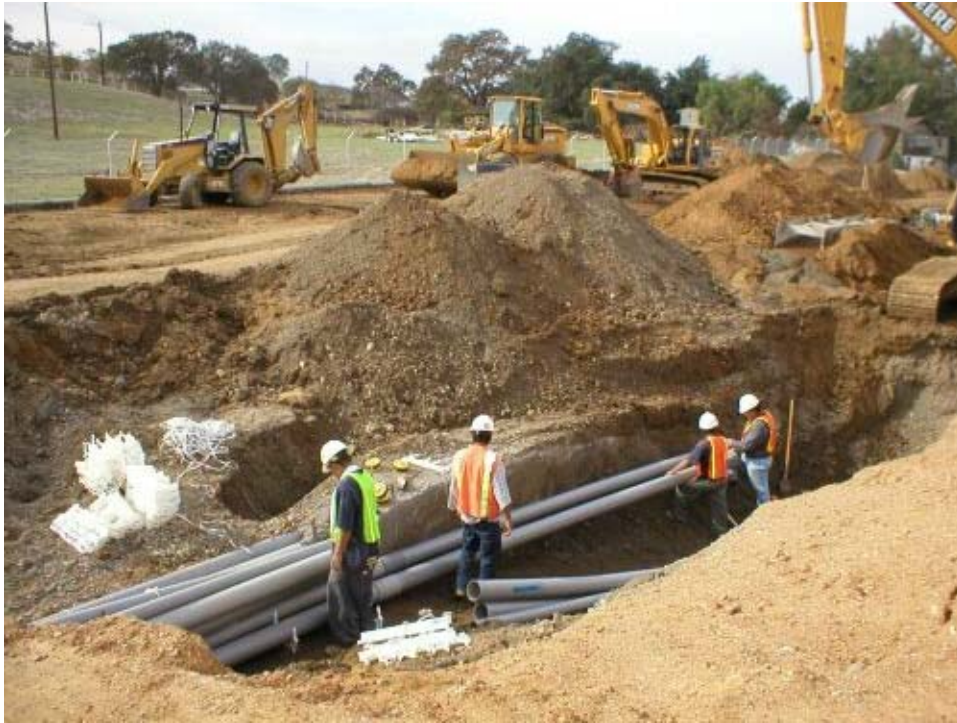
During the subject week, the CPUC EM toured the trench and conduit installation along New Vineyard Road. At Station 54+08, the duct bank is being split for engineering purposes where the trench line is being dug to a depth of 16 feet. The trench line is deep to allow installation underneath a storm drain (see Figure 1). The contractor finished excavating and concrete was poured over the installed conduit. Because of this large excavation, a large spoils pile was stored along the trench line. However, the location of the pile was in a depression on the opposite side of site resources, thus providing resource protection from run-off. Crews completed backfilling the trench by the end of the week.

Figure 1  
Deep trench and conduit installation around a storm drain within New Vineyard Road.

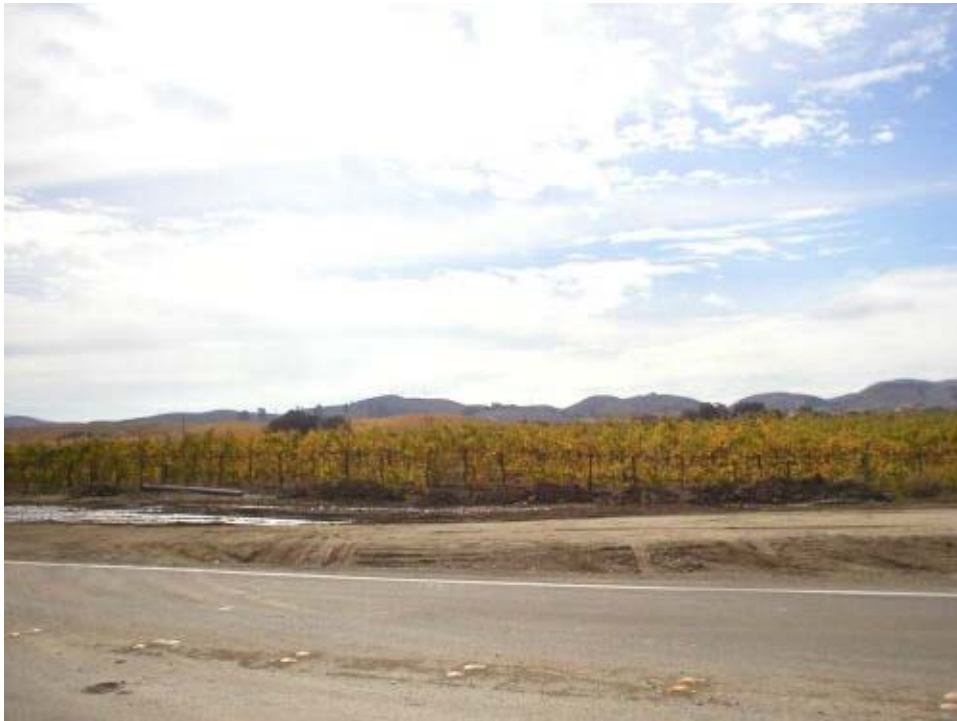
Dirt from construction activities were tracked into adjacent roadways. Essex EI continues working on the problem. On November 14<sup>th</sup> a truck driver dumped antifreeze along the right-of way at Station 308+25. Essex handled the issue as a minor problem because this was a first offense and no resource damage occurred. Truck drivers have been traveling outside of the right-of-way and using the Alameda County Flood Control District levee road to turn around, the Essex EI was notified of the problem. All other construction activities were in compliance with mitigation measures adopted in the EIR and other permitting requirements.

Figure 2  
Dirt tracked onto 'Old' Vineyard Avenue by construction vehicles.

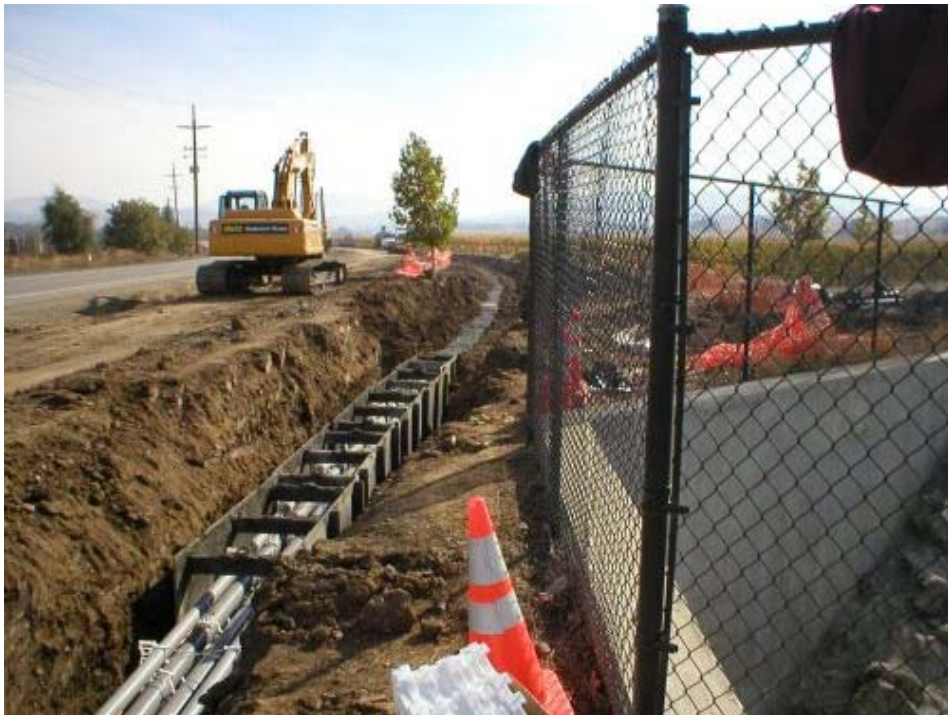
Figure 4

During the subject week, Buckland Vineyard Management continued the reinstallation of end-row posts for the grapevines removed along the project right-of-way between Isabel Avenue and the Mueller Yard. Trenching and conduit installation continued west of the dry drainage to Station 173+50, and along 'Old' Vineyard Avenue west of Highway 84 from Stations 88+00 to 109+00. Topsoil spoils are being placed along the trench line and subsoil spoils are being placed in a truck and hauled off site. On Wednesday, November 13<sup>th</sup> the CPUC observed dirt from construction activities being tracked by construction vehicles onto 'Old' Vineyard Ave. The Essex EI was notified of the problem (see Figure 2). The Essex EI has been working with the contractor to stop this problem and the tracking of dirt into the roadway has lessened. Trenching and conduit installation has progressed along 'Old' Vineyard Avenue to Station 109+00 over a flood control channel within an 18 inch culvert. PG&E had gotten permission from the City of Livermore and applicable jurisdictions to re-route two storm drains to release into the channel along the east side of the trench line along Vineyard Avenue. Drains were re-routed into the riprap on the east side of the creek (see Figures 3 and 4).

Trench over a flood control channel at Station 109+00 along 'Old' Vineyard Avenue.
