PROJECT MEMORANDUM PG&E – TRI-VALLEY 2002 CAPACITY INCREASE PROJECT

To: Jensen Uchida, CPUC
From: Vida Strong, Aspen Project Manager
Date: August 11, 2005
Subject: Weekly Report #70: August 1, 2005 – August 5, 2005
CPUC Environmental Monitors (EMs): Anne Sweet and Jenny Slaughter

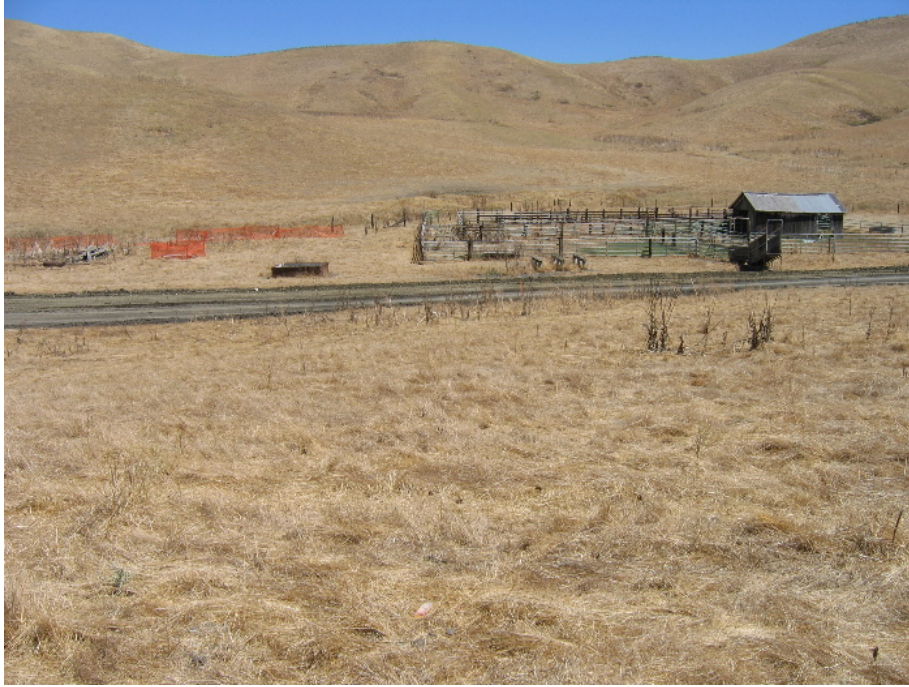
Figure 1 – New staging area along Moller Road, August 3, 2005.

Two additional lay down areas were approved in the CPUC NTP #7, one along Moller Road and another along North Livermore Avenue (see Figure 1). Both areas were inspected by the CPUC EM. One additional lay down area was reviewed by the CPUC EM and it was determined that a Variance would not be necessary because the area was within the limit of disturbance. However, in order for the area to be used, a biologist will have to identify any potential habitat for sensitive species and fence it off for avoidance. Also, the limits of the lay down area will have to be clearly marked.

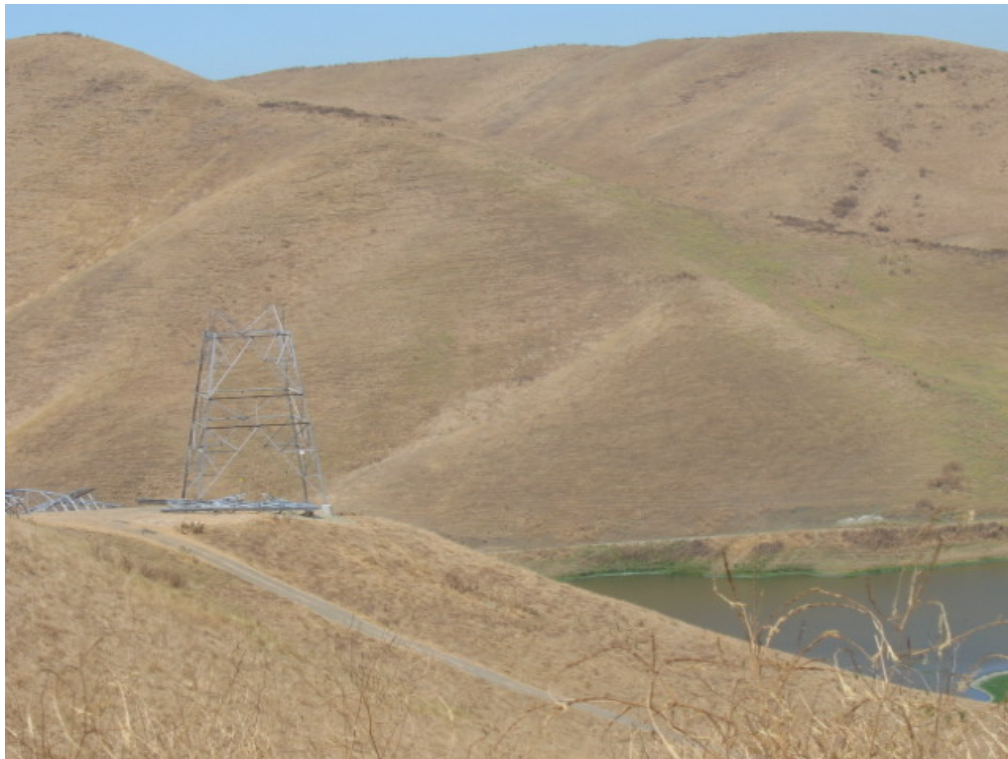
Figure 2 – Construction of Tower 7, August 3, 2005.

PG&E crews continued to work on Towers 6,7,10, and 11 during the subject week (see Figure 2). A biological monitor was monitoring the tower crews during the week.
