PROJECT MEMORANDUM PG&E – TRI-VALLEY 2002 CAPACITY INCREASE PROJECT

To: Jensen Uchida, CPUC
From: Vida Strong, Aspen Project Manager
Date: October 18, 2005
Subject: Weekly Report #80: October 9, 2005 – October 15, 2005
CPUC Environmental Monitor (EM): Anne Sweet

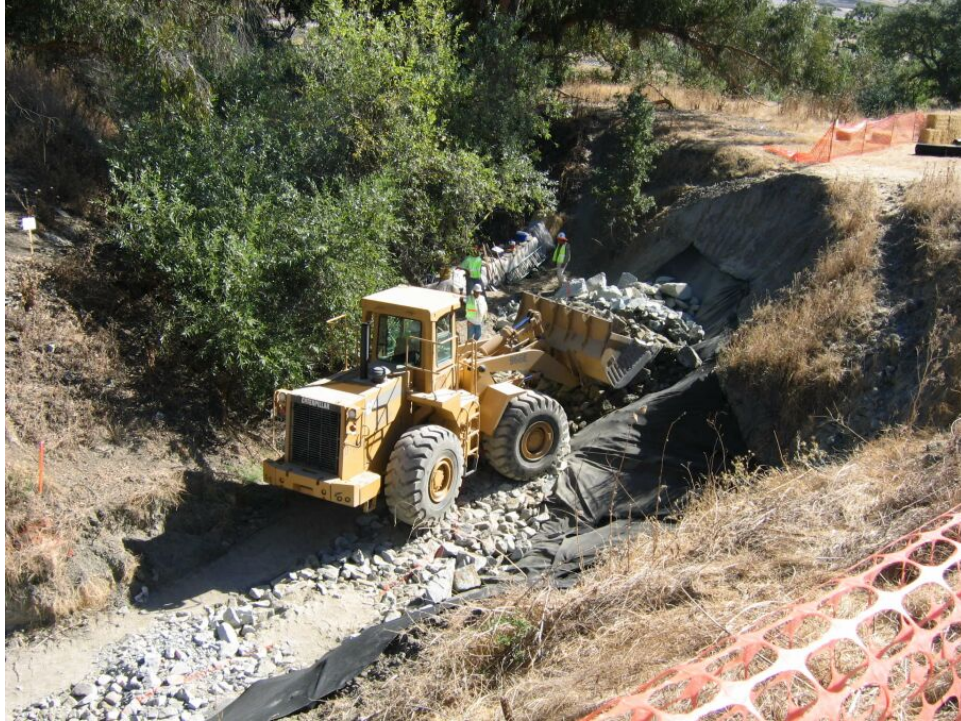
Figure 1 – Bank stabilization area within Tassajara Creek,
October 11, 2005.

The bank stabilization work flagging adjacent to Moller Road was approved on October 4. The CPUC EM conditioned the approval to have ready and on-site all of the necessary materials for an upstream coffer dam and water diversion pipe as outlined in the CDFG Streambed Alteration Agreement. The materials were brought to the site and the Tassajara Creek bank stabilization work including the installation of filter fabric and rock riprap continued through out the subject week (see Figure 1). Crews still need to remove dirt from within the installed riprap, restore the creek bed where heavy equipment traveled and tracked spoils, as well as dismantle the earthen ramp crews used to access the site. The CPUC EM notified PG&E that until the final bank work is complete, the coffer dams and diversion pipe must be on-site and installed prior to forecasted rain events. All work must be completed prior to the CDFG Streambed Alteration Agreement deadline of October 31.

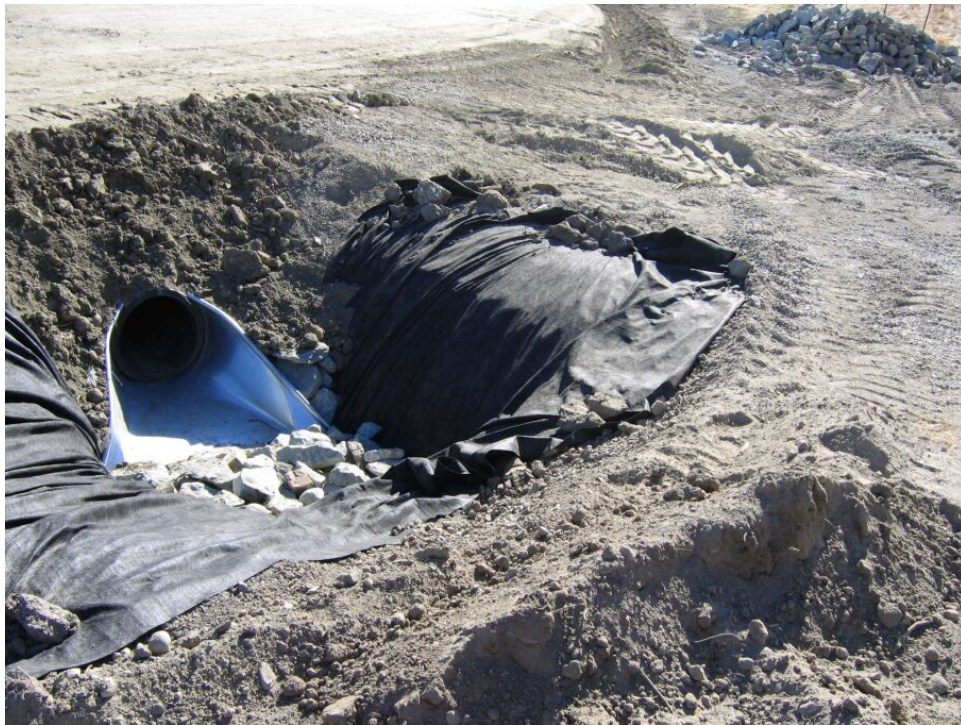
Rock was installed around the new culvert installations on Moller Road (see Figure 2). The CPUC EM expressed concerns that the culvert inlets seemed very deep and could pose a safety hazard and potential erosion concerns. During the subject week, crews also installed several french drains. The CPUC EM expressed concerns that existing wetland areas adjacent to the roads could be impacted by the new drain features. PG&E Planner Buck Jones responded that the Army Corps permit submittal outlined all of the installations and the potential impacts were included in the mitigation agreements. Given the existing site erosion topography, the CPUC EM had inquired if a hydrologist has field reviewed the new drainage installations.

Figure 2 – Culvert installation along Moller Ranch Road,
October 12, 2005.
