PROJECT MEMORANDUM PG&E – TRI-VALLEY 2002 CAPACITY INCREASE PROJECT

To: Jensen Uchida, CPUC
From: Vida Strong, Aspen Project Manager
Date: September 2, 2005
Subject: Weekly Report #73: August 21, 2005 – August 27, 2005
CPUC Environmental Monitors (EMs): Anne Sweet and Jenny Slaughter

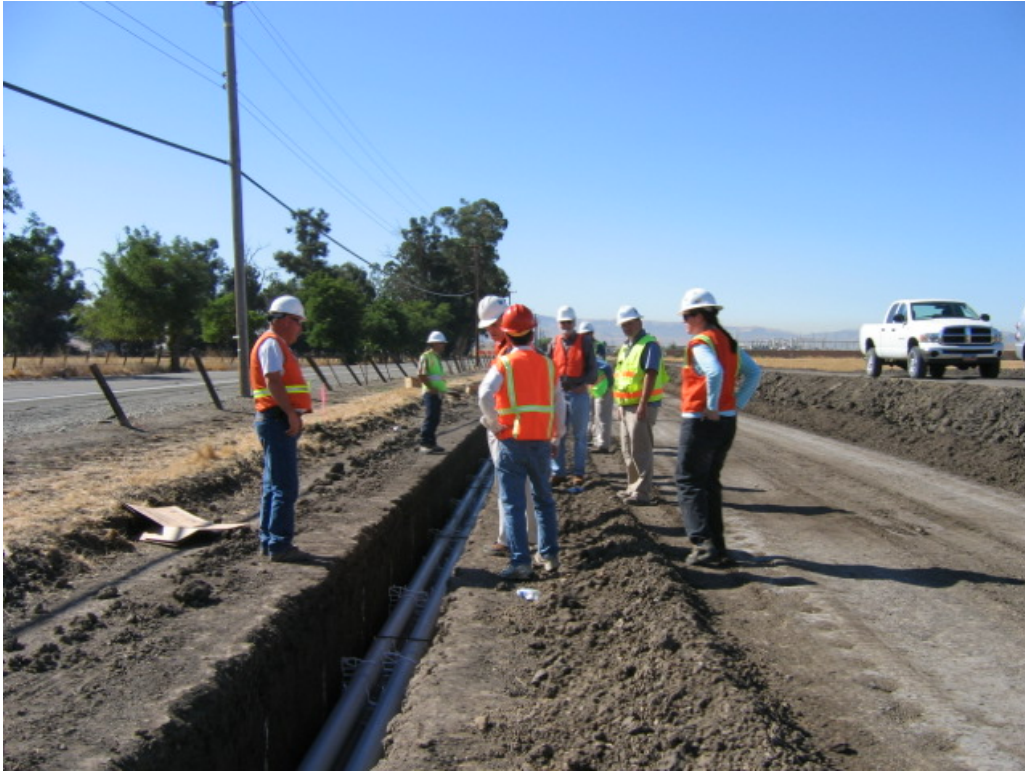
A field tour took place on August 23rd for the CPUC Project Managers (see Figure 1). After an environmental training tailgate meeting, the group toured the right-of-way and visited underground and overhead construction sites.

Figure 1 – CPUC staff inspecting trenching along North Livermore Ave., August 23, 2005.

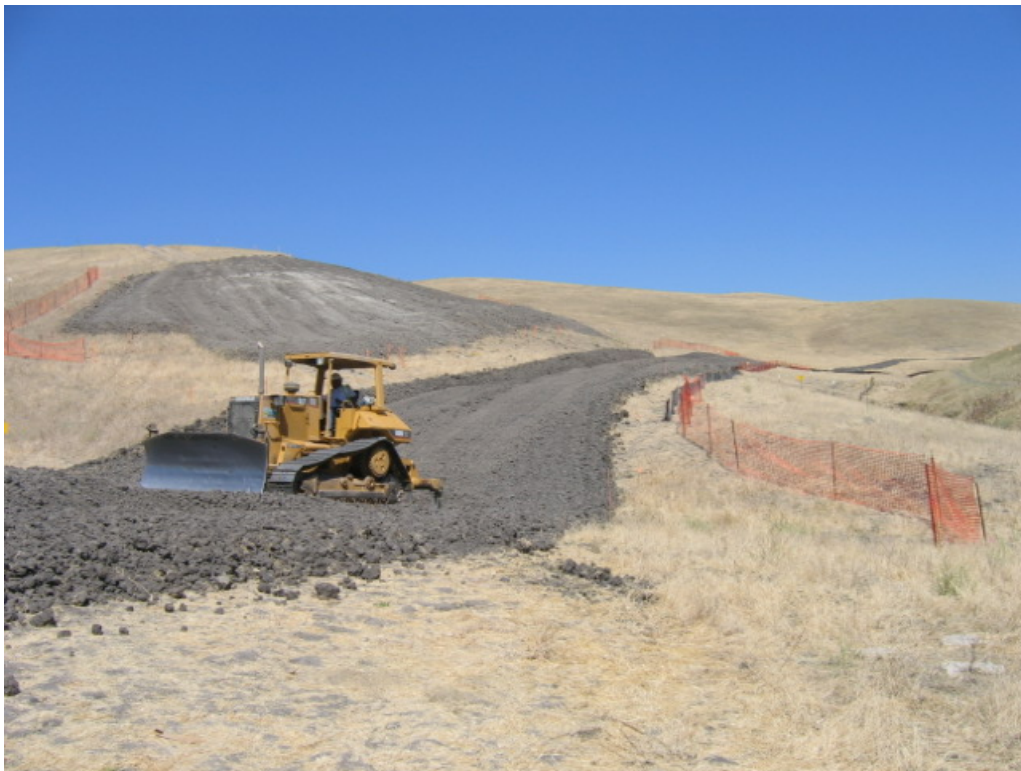
Granite Construction began work along Access Road 7 during the subject week (see Figure 2). Construction of this access road is necessary for equipment transport for the underground portion, which is being constructed by another contractor. The right-of-way was disked and graded and upon completion, will be an improved permanent road. One PG&E EI was present for the road construction.

Figure 2 – Construction of Access Road 7, August 24, 2005.

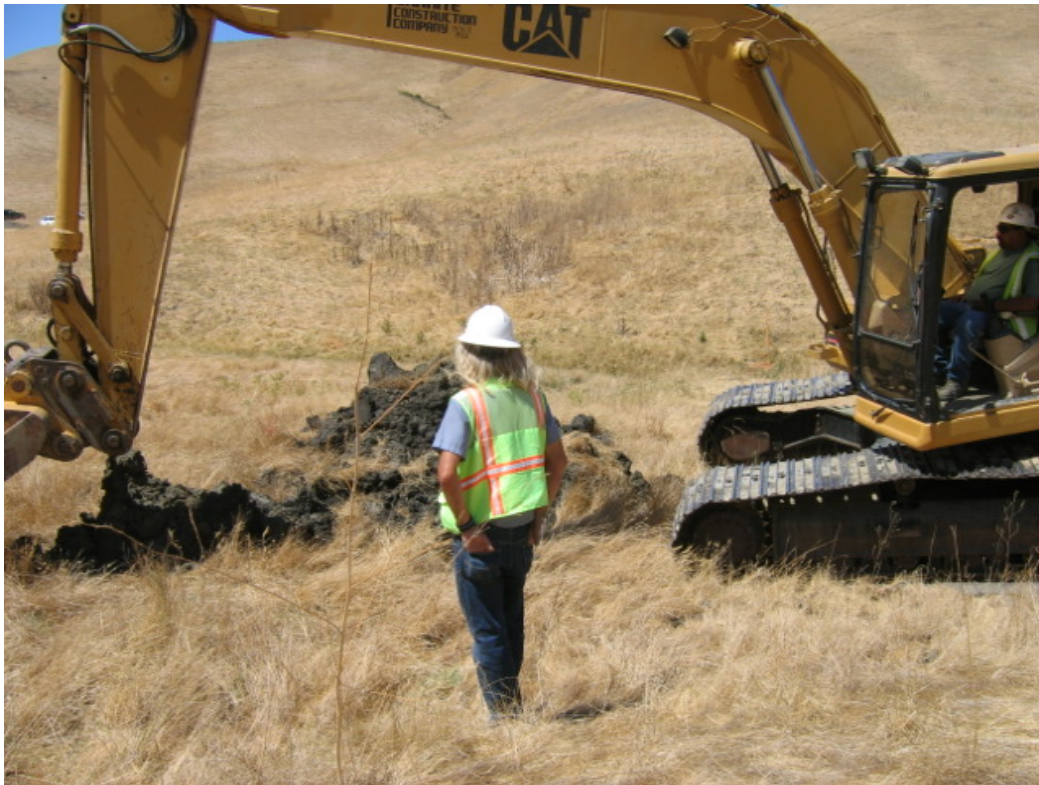
Granite crews began work in the mitigation pond site on August 24th (see Figure 3). Seven test pits were excavated in order to determine soil conditions in the area. A PG&E EI was present during the work in the area and led the excavator to the test pit sites to avoid any impact to the Congdon's tarplant. At least two populations of the rare plant were identified adjacent to the mitigation pond site and these areas were fenced off with orange fence for avoidance. One population, which was within the access road alignment, will not be impacted because crews have reconfigured the construction of the road in order to avoid all rare plants.

Figure 3 – A PG&E EU monitors excavation within the mitigation pond area, August 24, 2005.
