PROJECT MEMORANDUM SCE – VIEJO SYSTEM PROJECT

To: Michael Rosauer, CPUC
From: Vida Strong, Aspen Project Manager
Date: September 29, 2004
Subject: Weekly Report #8: September 19, 2004 – September 25, 2004
CPUC Environmental Monitor (EM): Christopher Meyer

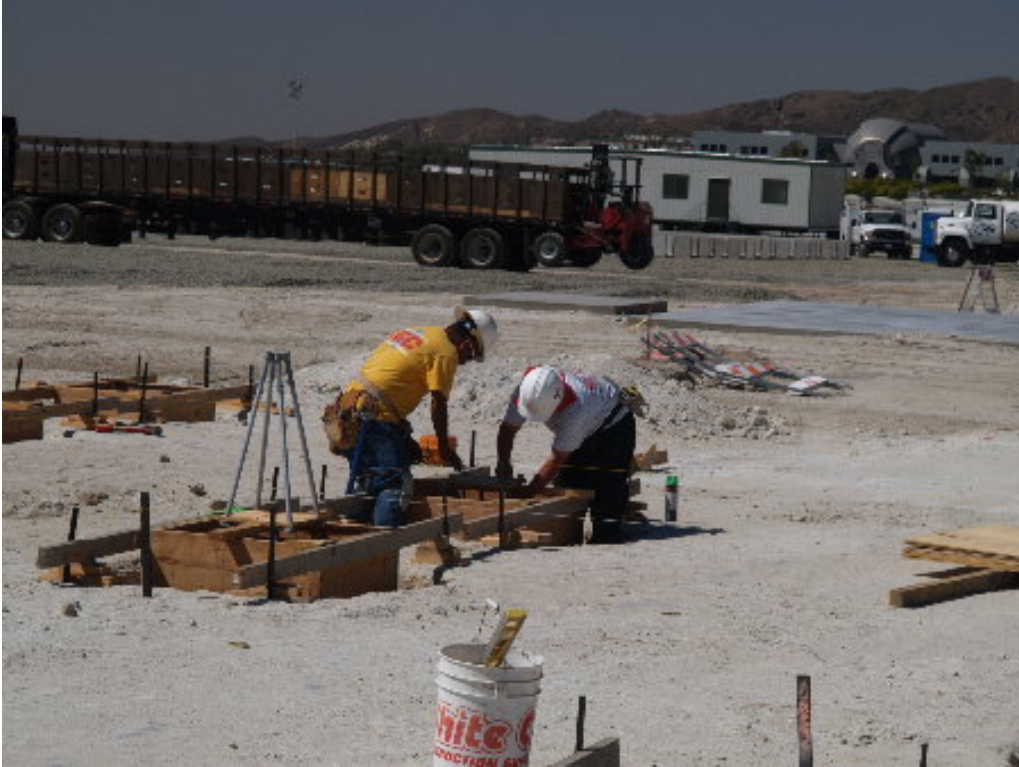
Figure 1 – Crews working on the form work and anchor bolts for the foundation pilings at the substation site.

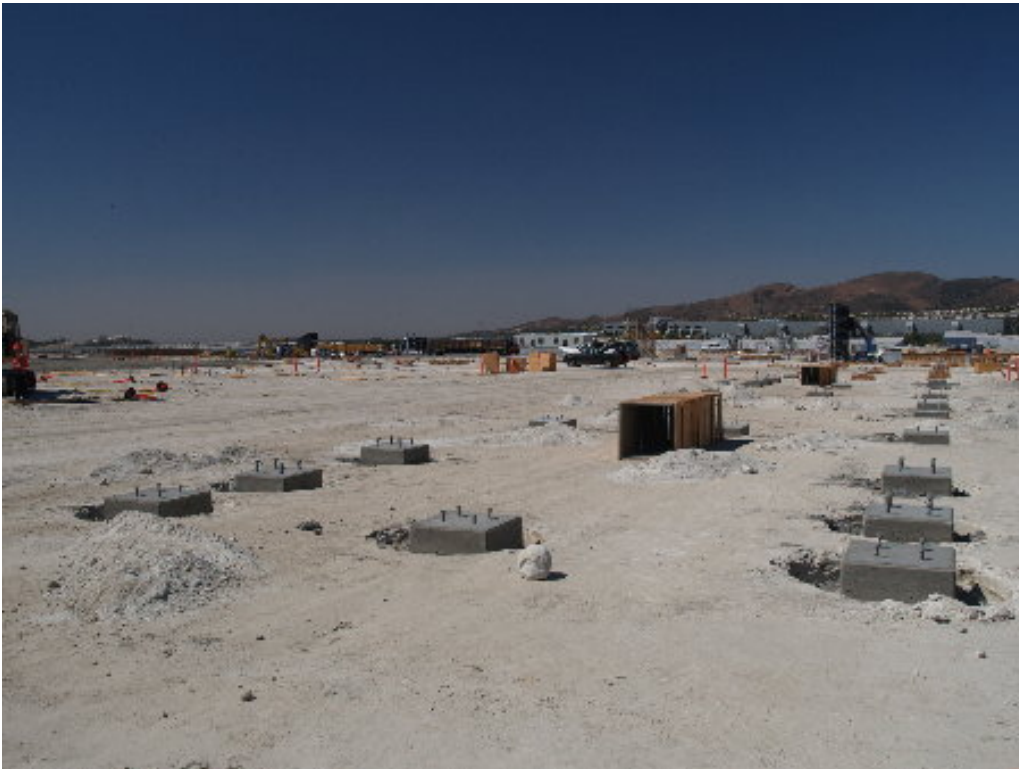
A drilling machine continued working during the subject week. The drilling crew worked with a coring bit and an auger bit for boring the holes to depth and a side-cut bit to make the shelf at the top of the foundation hole. Numerous bore holes throughout the substation site have been completed and are covered by plywood and marked with orange warning flagging. A small crew has been working on framing the foundations and setting the anchor bolts in the bore holes (see Figure 1). Several of the foundation pedestals have been completed on the southeastern portion of the substation site (see Figure 2).

Figure 2 – Completed foundation pilings with anchor bolts. Most structures at the substation site will rest on raised foundations.

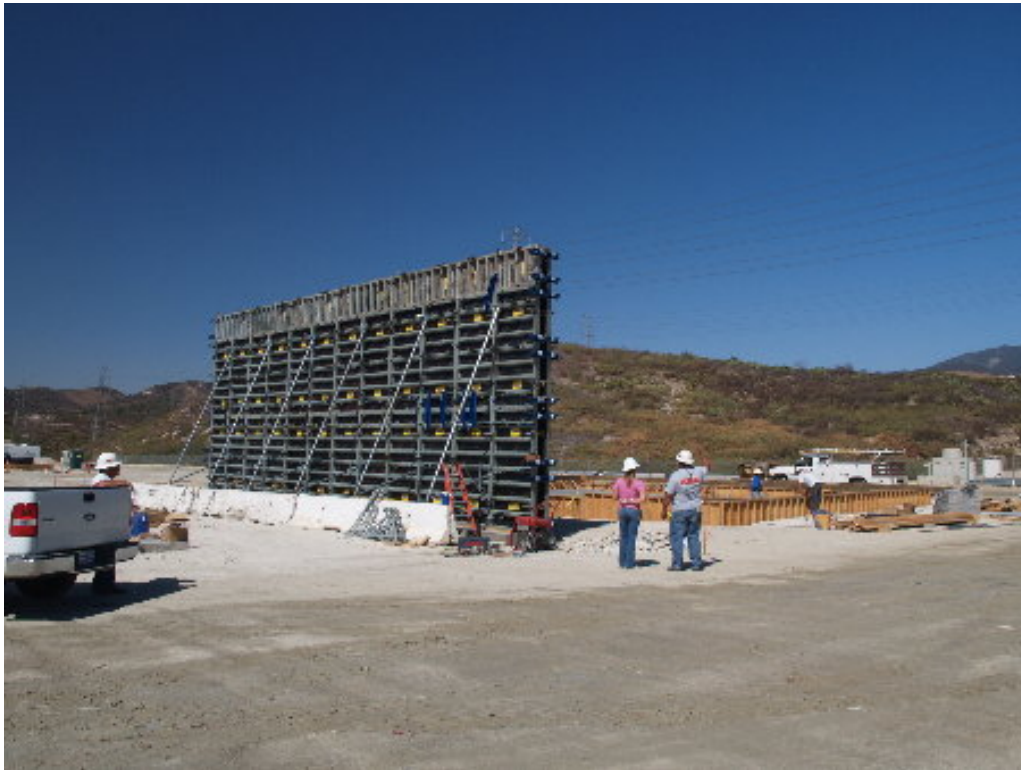
The ironwork for both firewalls has been completed and the eastern firewall is ready for the concrete pour (see Figure 3). The reusable formwork will be moved to the western firewall and installed for the concrete pour on September 29. The wall height of the wall will be extended with cinderblocks once the concrete has cured. The purpose of the wall is to protect the adjacent electrical building from a transformer fire and isolate the two A transformers in case of a problem.

Figure 3 – The reusable form for the vertical firewall that will separate one of the two A transformers (230 kV) and the electrical building has been set up and is ready for the concrete pour.
