<b>California Public Utilities Commission</b> <b><i>Mitigation Monitoring, Compliance, and Reporting</i></b> <b><i>Program</i></b>
	<b>Cleveland National Forest Power Line Replacement</b> <b>Projects</b>  <b>Compliance Status Report: 101</b>  <b>August 9, 2020</b>

This compliance status report covers construction activities from July 27 through August 9, 2020.

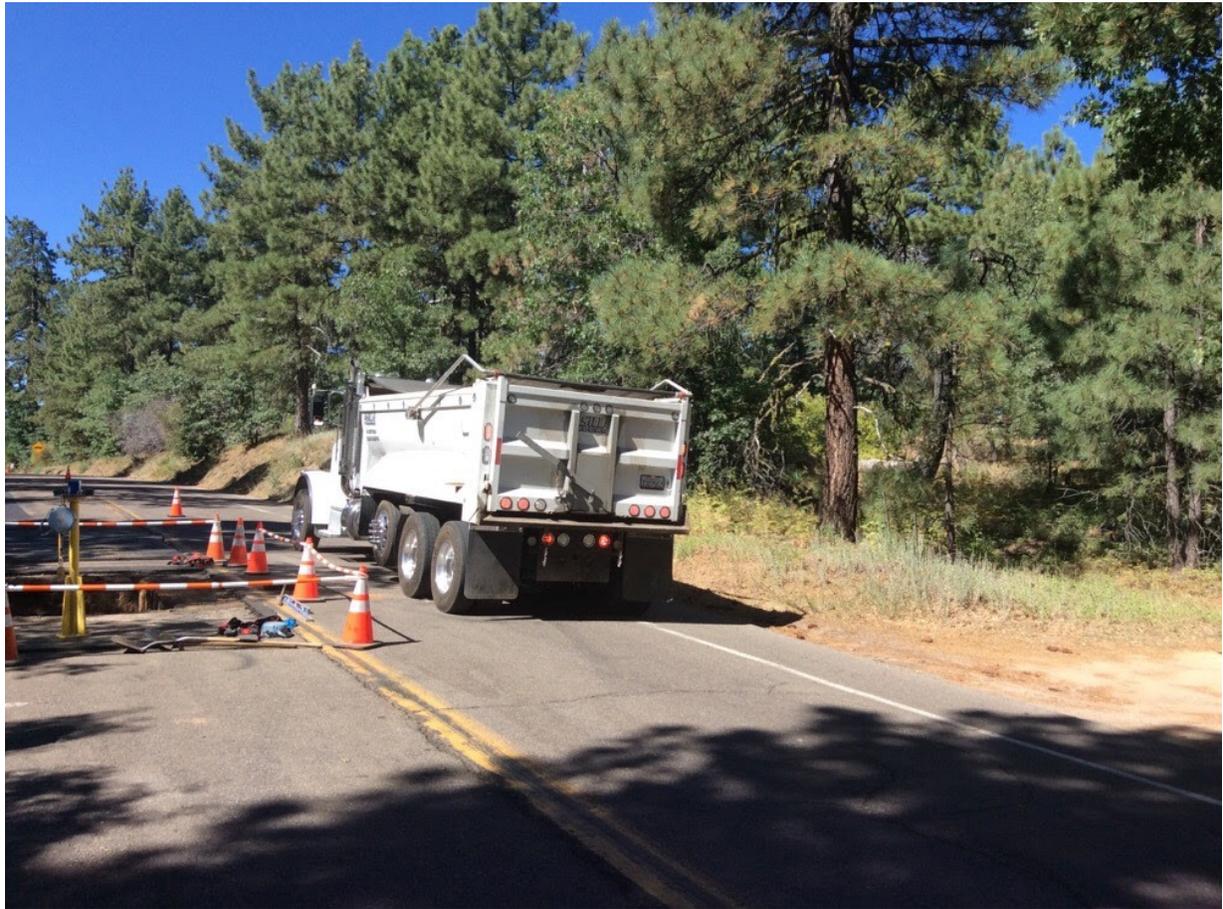
**Photo 1:** Haul truckloads of spoils from trenching activities on C 440 were observed to be covered while traveling on public roadways in accordance with APM AIR-02.

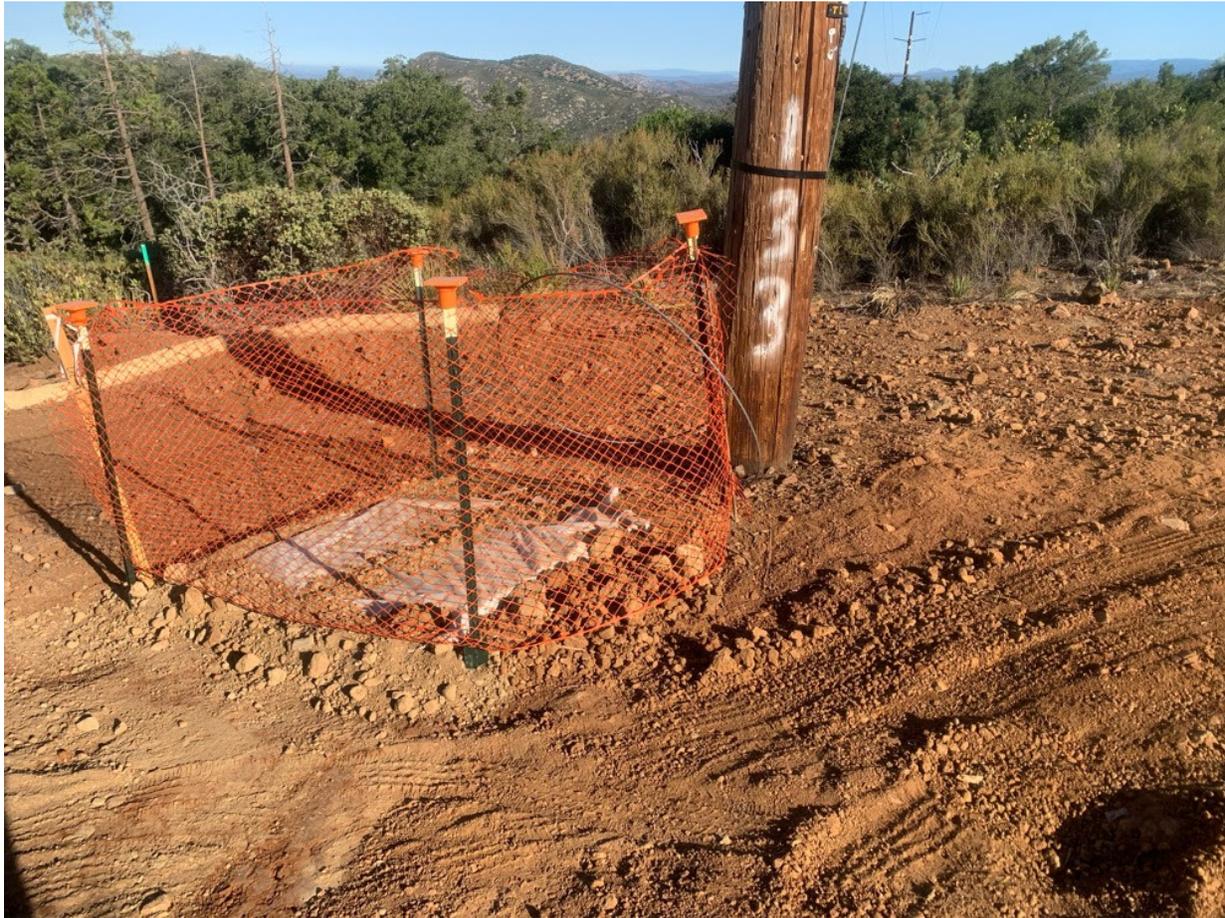
**Photo 2:** A direct-bury pole hole at Pole P258558 (TL 626 Conversion South (C 79B)) was observed to be covered to prevent wildlife entrapment in accordance with MM BIO-23.

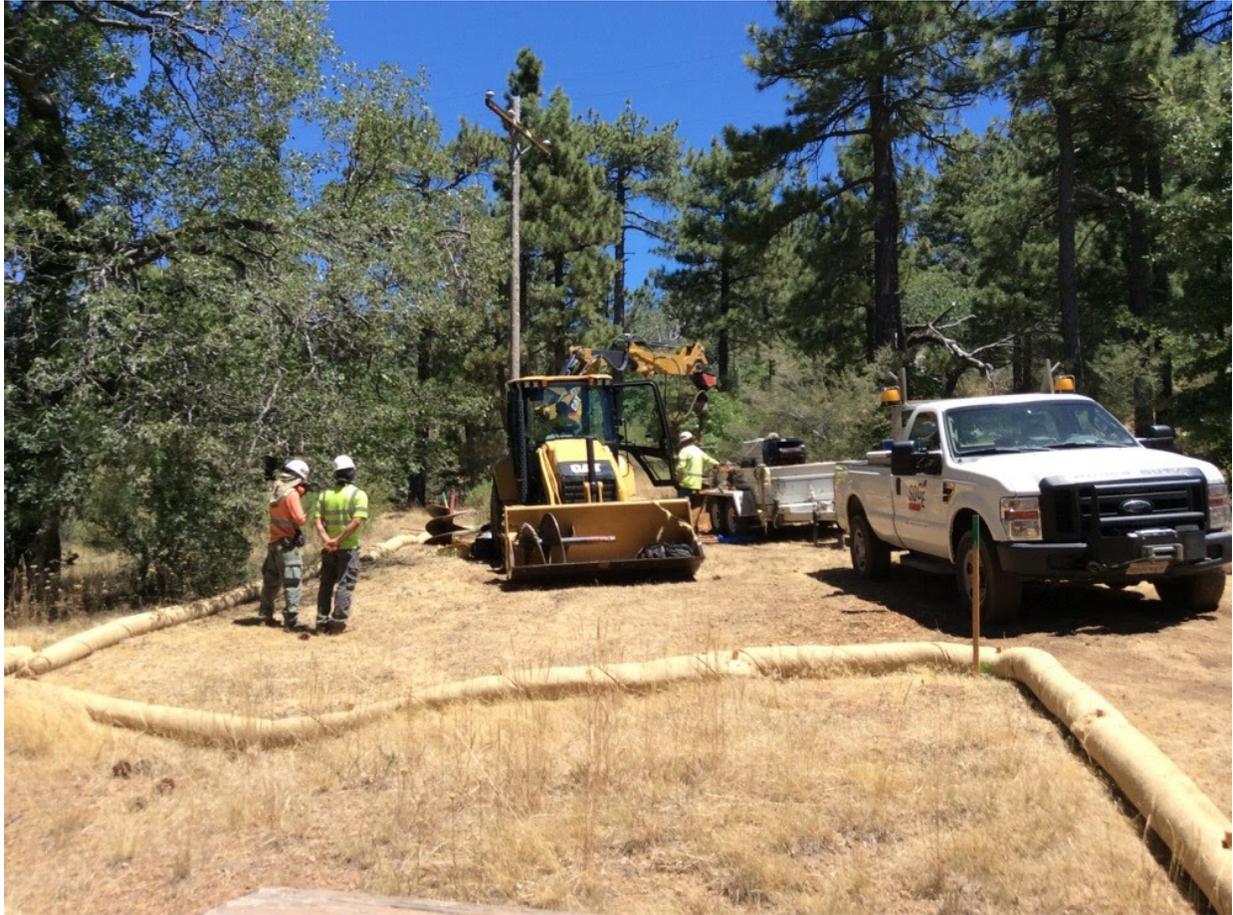
**Photo 3:** Archaeological and Cultural Monitors were observed monitoring pole hole digging along C 440 in accordance with the HPMP (MM CUL-1) and APM CUL-04.

CPUC ECMs observed cultural resource monitors, including archaeological and Native American monitors, monitoring construction activities that occurred within or adjacent to identified archaeological or cultural resource site boundaries in accordance with the Historic Properties Management Plan (HPMP), MM CUL-1, MM CUL-3, and APM CUL-04 (see Photo 3 – Attachment A). Cultural ESAs were marked

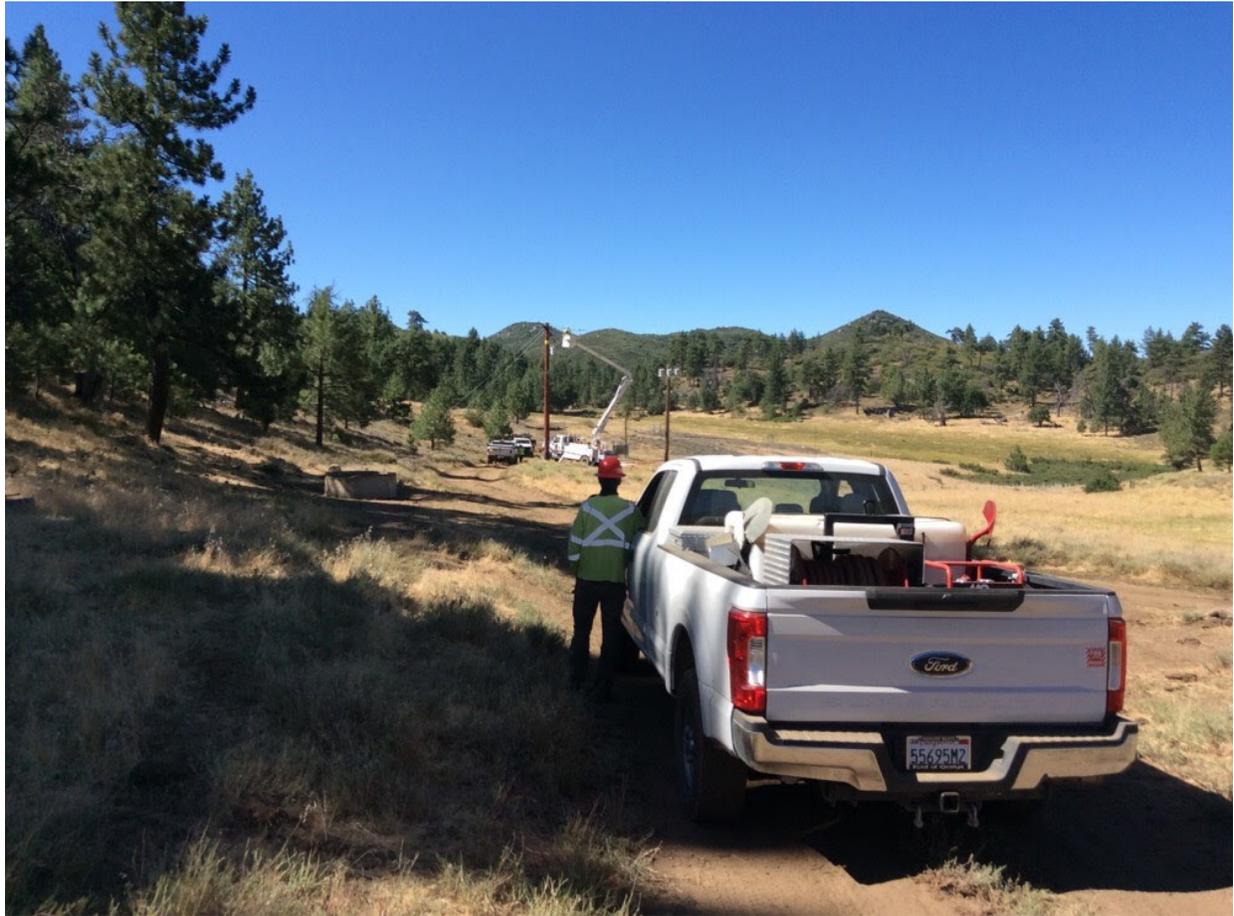
**Photo 4:** A Dedicated Fire Patrol was present and equipped with at least 150 gallons of water with pump and hose during conductor dead-end activities at Pole P45308 (C 440) in accordance with the CFPPP Fire Prevention Matrix for conductor replacement of de-energized lines off USFS land with an Elevated FPI (MM FF-1).

In accordance with the Construction Fire Prevention/Protection Plan (CFPPP) (MM FF-1), San Diego Gas & Electric (SDG&E) and their construction contractors were observed communicating Fire Potential Index (FPI) and Project Activity Levels (PALs) to work crews at daily tailboard meetings, during which daily fire requirements and restrictions for work on private land and on National Forest System (NFS) land were discussed. All project-related vehicles and equipment were observed carrying the required set of fire tools (each set containing a 5-gallon backpack pump, round point shovel, Pulaski, and 2A10BC fire extinguisher). Construction crews were observed staging a set of fire tools within 50 feet of work activities as required by APM HAZ-04 and other tools as required by the CFPPP, and appropriate Fire Patrols were observed on site during activities that required their presence (see Photo 4 – Attachment A). Fire boxes were observed at staging yards and stocked with the required firefighting tools.

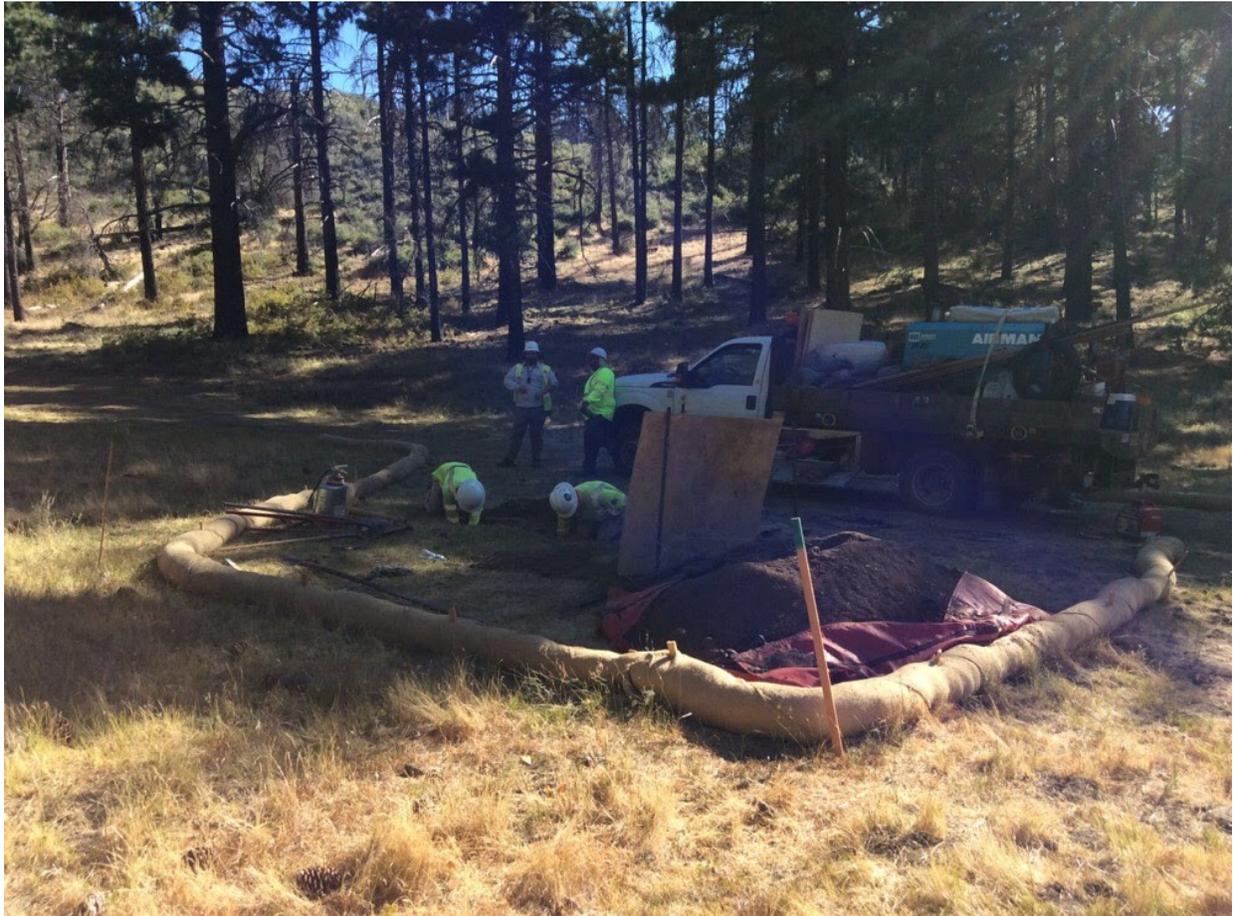
**Photo 5:** A crew was observed installing grounding rods and wire at Pole P259909 (C 440). Erosion control BMPs at the site were observed in good condition in accordance with the ECP, the SWPPP, and APM HYD-09.

To prevent impacts to hydrology and water quality, site-specific sediment and erosion control BMPs were observed being implemented and maintained along project alignments in accordance with the project Erosion Control Plan (ECP), Stormwater Pollution Prevention Plan (SWPPP; MM HYD- 1 and MM BIO-7), and APM HYD-09 (see Photo 5 – Attachment A). Other BMPs in the SWPPP, such as hydromulch application, concrete waste containment, and street sweeping, were also observed along the alignments. Hydrological resources were flagged for avoidance, and work activities occurred outside of hydrological resources in accordance with APM HYD-06. During this reporting period, a CPUC ECM worked with Biological Monitors to ensure that uncovered spoils stockpiles were covered in a timely manner.

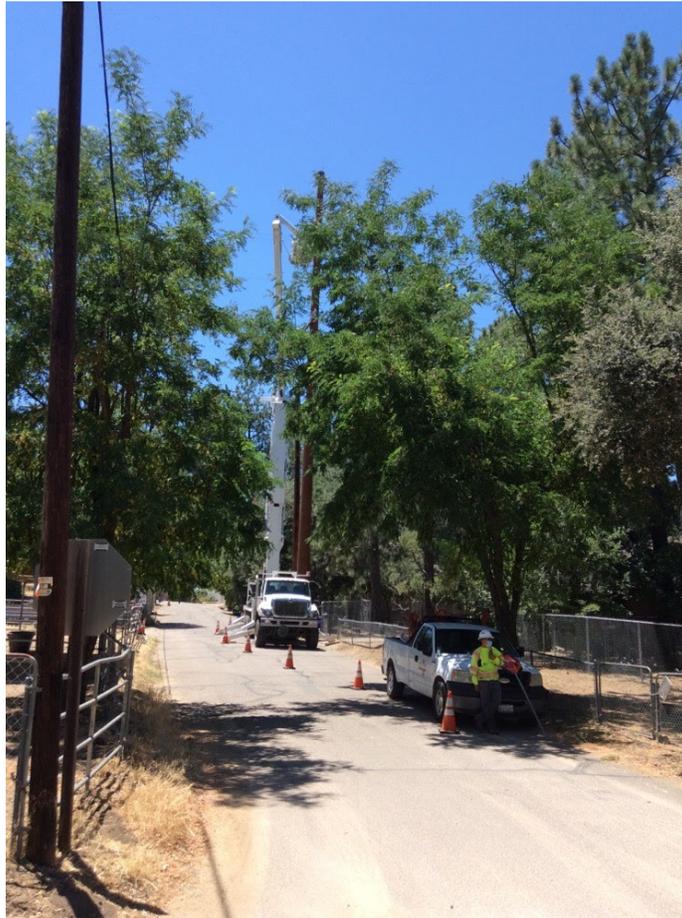
**Photo 6:** A crew was observed conducting overhead work at Pole Z173157 (TL 629A). Cones, signage, and flagpersons were used to direct one-way traffic around the work area in accordance with the TCP (APM TRANS-05) and APM TRANS-02.

Traffic control measures were observed being implemented in accordance with APM TRANS-01 through APM TRANS-05 during this reporting period (see Photo 6 – Attachment A).
