California Public Utilities Commission <i>Mitigation Monitoring, Compliance, and Reporting</i> <i>Program</i>
	Cleveland National Forest Power Line Replacement Projects
	Compliance Status Report: 107 November 1, 2020

This compliance status report covers construction activities from October 19 through November 1, 2020.

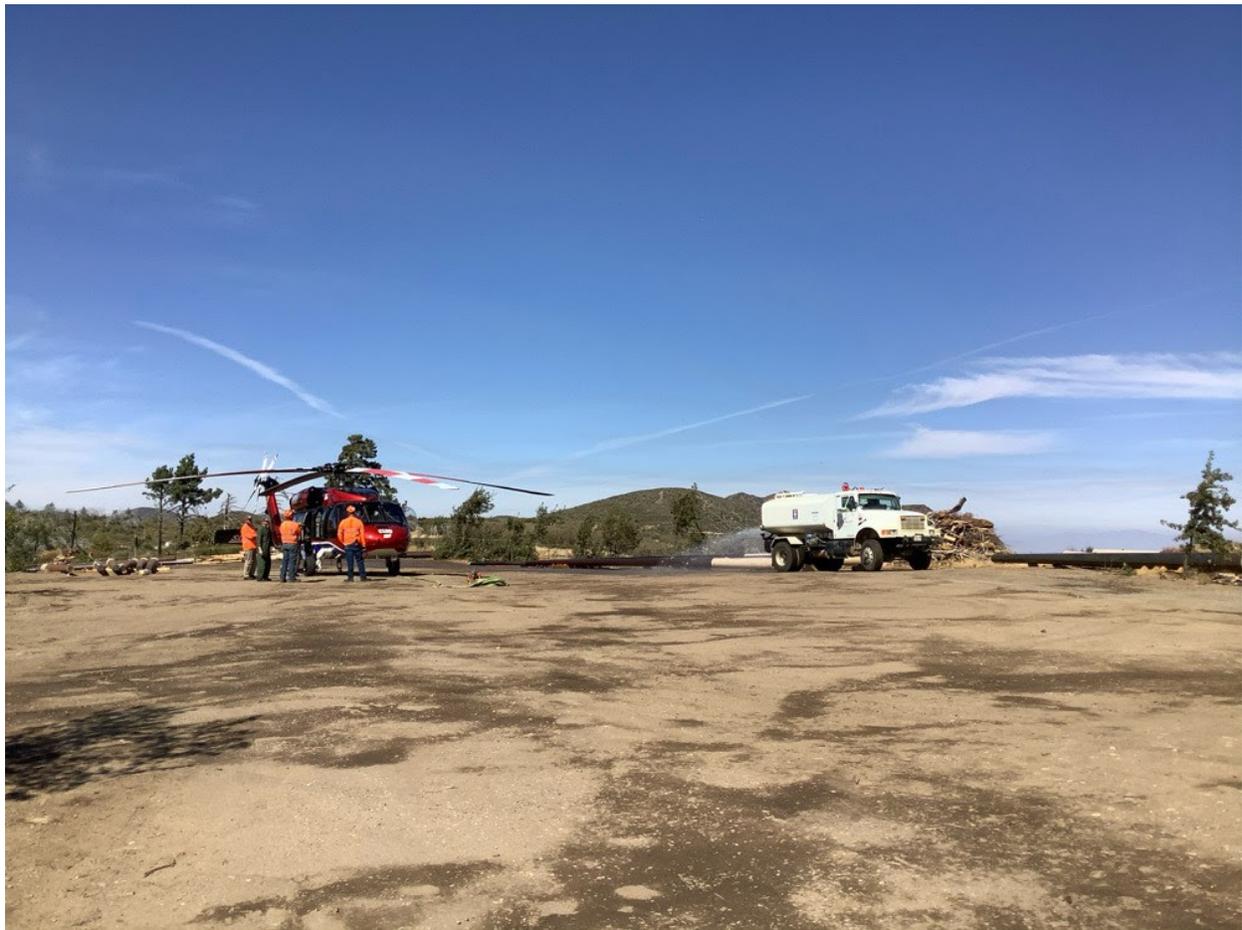
Photo 1: A water tender was observed applying water at Shrine Camp Staging Yard (C 440) prior to helicopter operations to minimize dust emissions from rotor wash in accordance with APM AIR-02 and the Aviation Safety Plan (MM PHS-5).

To prevent fugitive dust emissions during project activities, crews were observed applying water along unpaved access roads and in work areas in accordance with APM AIR-02 and during helicopter operations in accordance with the Aviation Safety Plan (MM PHS-5) (see Photo 1 – Attachment A). Haul trucks used for dirt export were observed utilizing load covers to prevent dust emissions in accordance with APM AIR-02, and construction personnel were observed maintaining posted speeds of 15 miles per hour on unpaved access roads in accordance with APM AIR-03 and MM BIO-24.

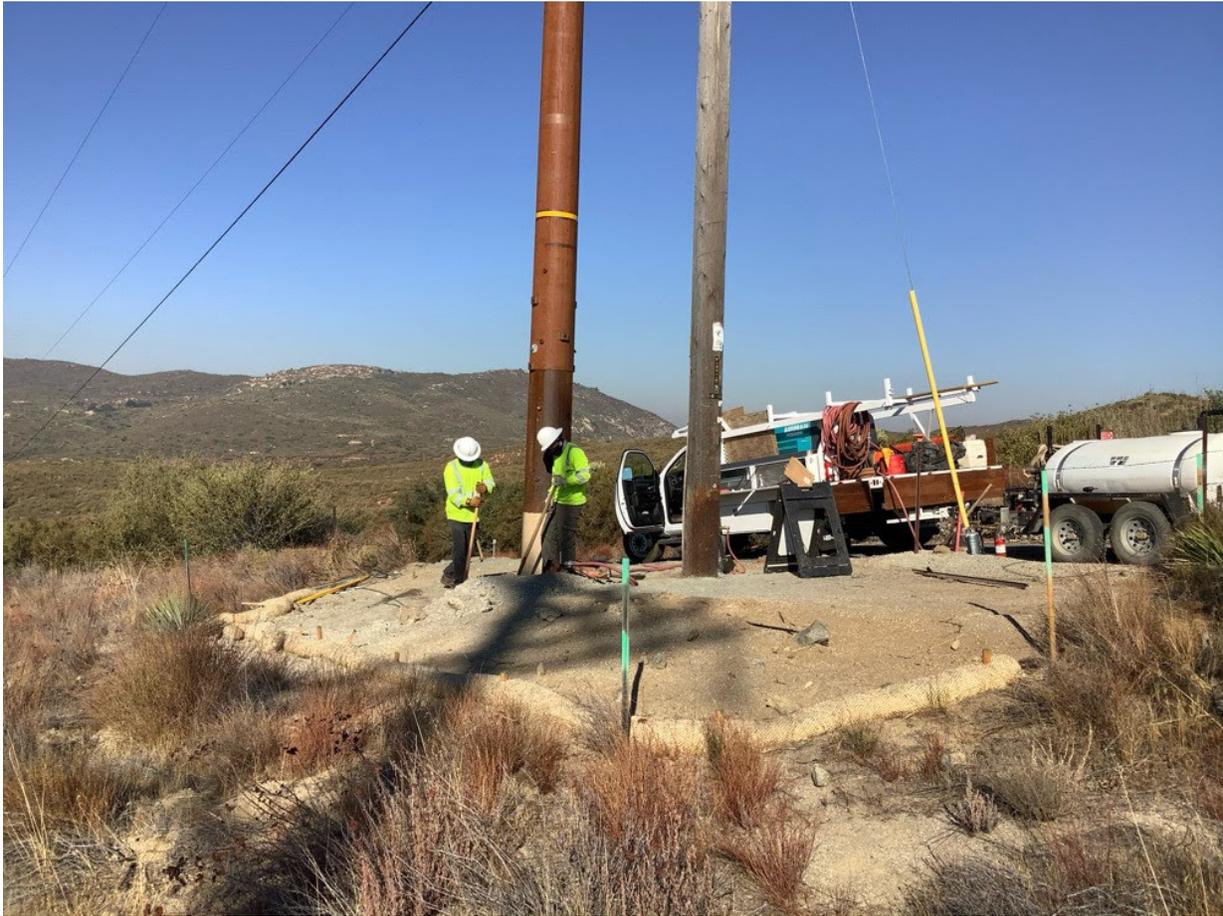
Photo 2: A crew was observed trenching for ground rod installation at Pole P198439 (C 79B) within clearly delineated work limits in accordance with MM BIO-1.

Approved workspaces were observed delineated with staking and flagging, and work crews were observed adhering to work space limits and staying on approved access roads in accordance with MM BIO-1 (see Photo 2 – Attachment A). Workers were observed having completed the Worker Environmental Awareness Program (WEAP), as shown by project hard hat stickers in accordance with MM BIO-2. Biological monitors were observed conducting full-time monitoring of initial ground-disturbing activities, such as vegetation removal, in accordance with MM BIO-3, and monitoring all other construction activities to ensure compliance with mitigation measures, applicant proposed measures, and permit conditions in accordance with MM BIO-22. In accordance with MM BIO-14 and MM BIO-16, Environmentally Sensitive Area (ESA) signs and flagging were observed installed around areas with special-status species, and ESAs were observed being avoided by crews. Excavations were observed covered to prevent wildlife entrapment in accordance with MM BIO-23, and crews were observed containing trash at work areas in accordance with MM BIO-26. During this reporting period, a CPUC ECM worked with an on-site Biological Monitor to ensure that a partially uncovered pole hole was addressed in a timely manner.

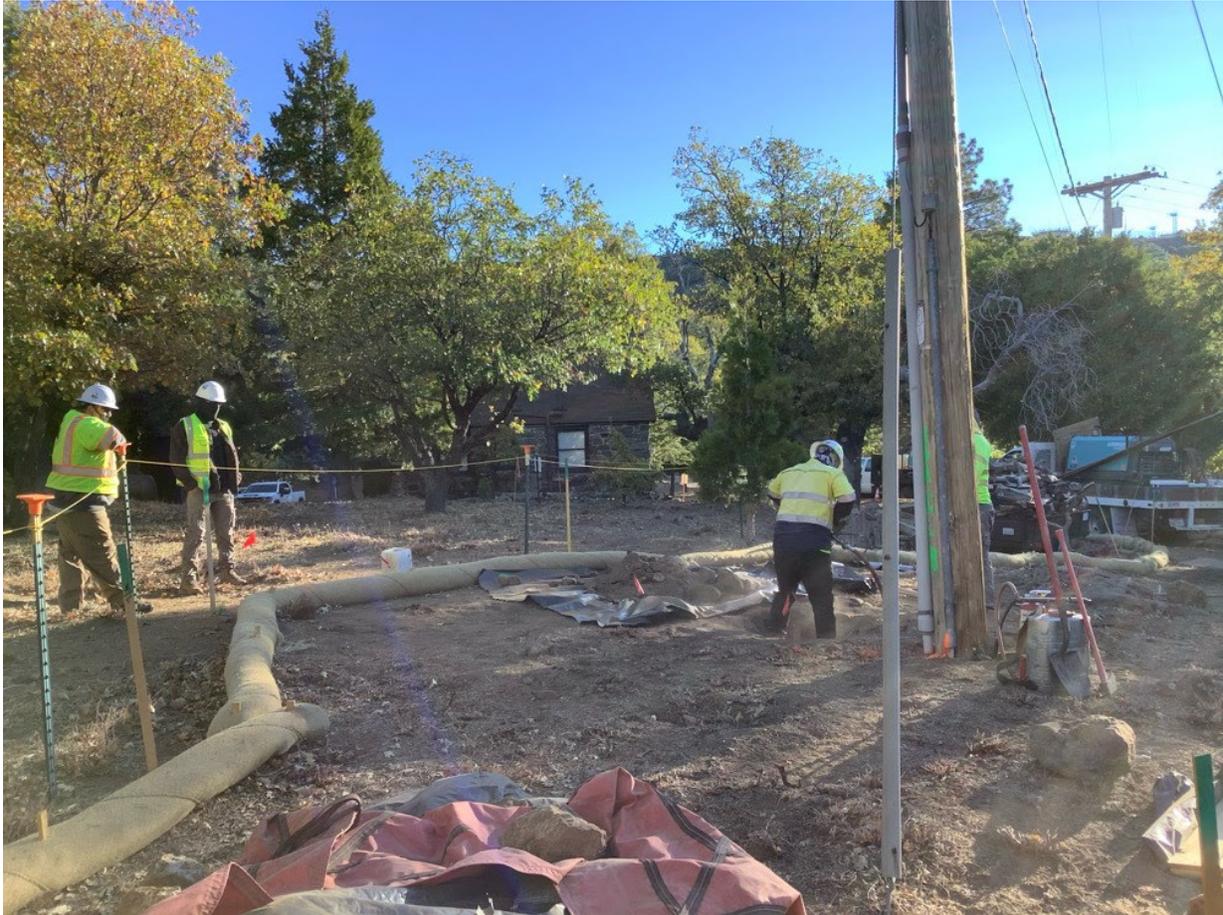
Photo 3: Archaeological and Cultural Monitors were observed monitoring pole hole digging at a site on C 440 in accordance with the HPMP, APM CUL-04, MM CUL-1, and MM CUL-3. In addition, crew members were observed respecting a clearly marked ESA adjacent to the work site in accordance with the HPMP and APM CUL-03.

CPUC ECMs observed cultural resource monitors, including archaeological and Native American monitors, monitoring construction activities that occurred within or adjacent to identified archaeological or cultural resource site boundaries in accordance with the Historic Properties Management Plan (HPMP), MM CUL-1, MM CUL-3, and APM CUL-04. Cultural ESAs were marked to prevent construction access to areas with cultural and/or historical resources in accordance with the HPMP, and work crews were observed respecting cultural ESA boundaries (see Photo 3 – Attachment A).

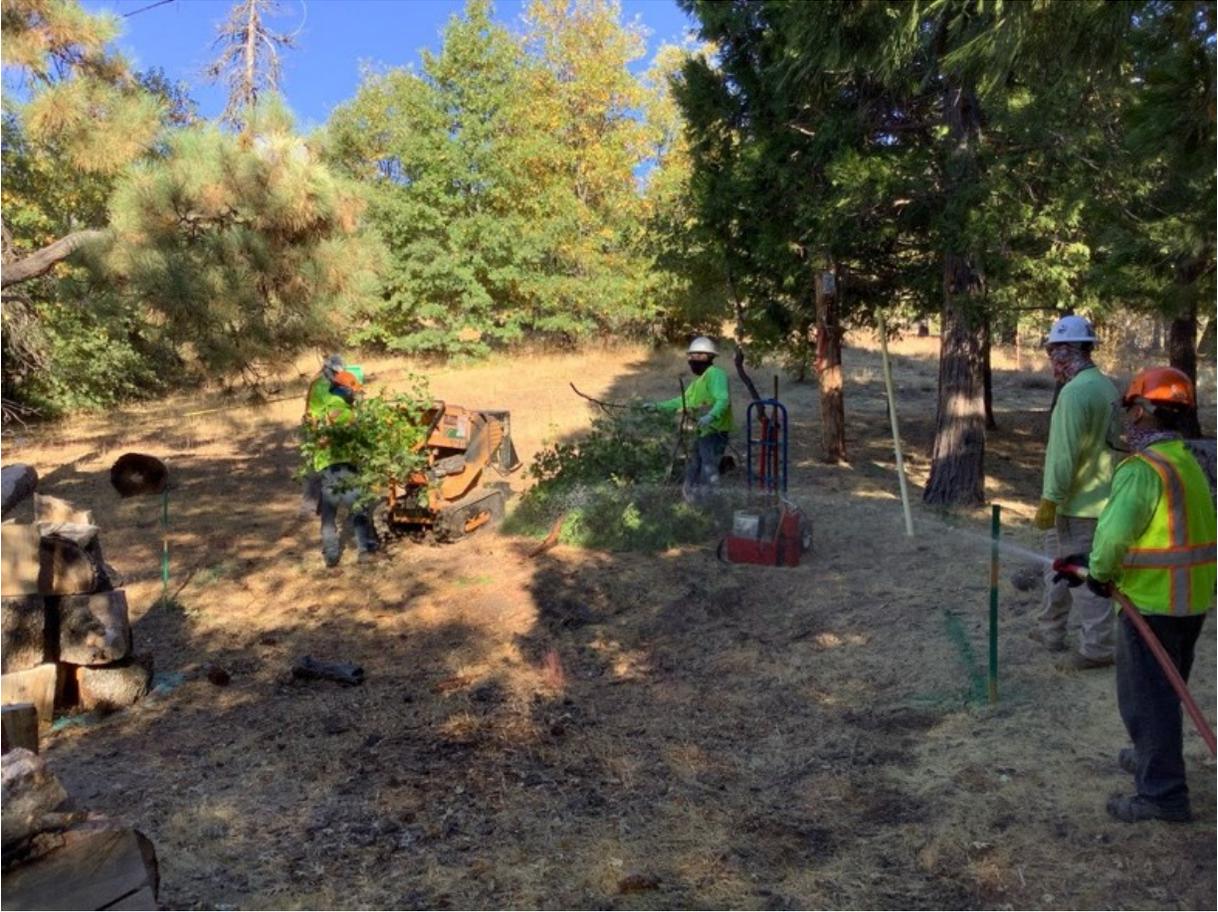
Photo 4: During chipping at Pole P40213 (C 440), a full set of fire tools was observed within 50 feet of the activity, at least 100 gallons of water with pump and hose were observed on site, and the area was wet down to prevent ignitions in accordance with the CFPPP for chipping on NFS land with a PAL D.

In accordance with the Construction Fire Prevention/Protection Plan (CFPPP) (MM FF-1), San Diego Gas & Electric (SDG&E) and their construction contractors were observed communicating Fire Potential Index (FPI) and Project Activity Levels (PALs) to work crews at daily tailboard meetings, during which daily fire requirements and restrictions for work on private land and on National Forest System (NFS) land were discussed. All project-related vehicles and equipment were equipped with a full set of fire tools (each set containing a 5-gallon backpack pump, round point shovel, Pulaski, and 2A10BC fire extinguisher). Construction crews were observed staging a set of fire tools within 50 feet of work activities as required by APM HAZ-04 and implementing other fire prevention measures as required by the CFPPP (see Photo 4 – Attachment A), and appropriate Fire Patrols were observed on site during activities that required their presence. Fire boxes were observed at staging yards and stocked with the required firefighting tools.

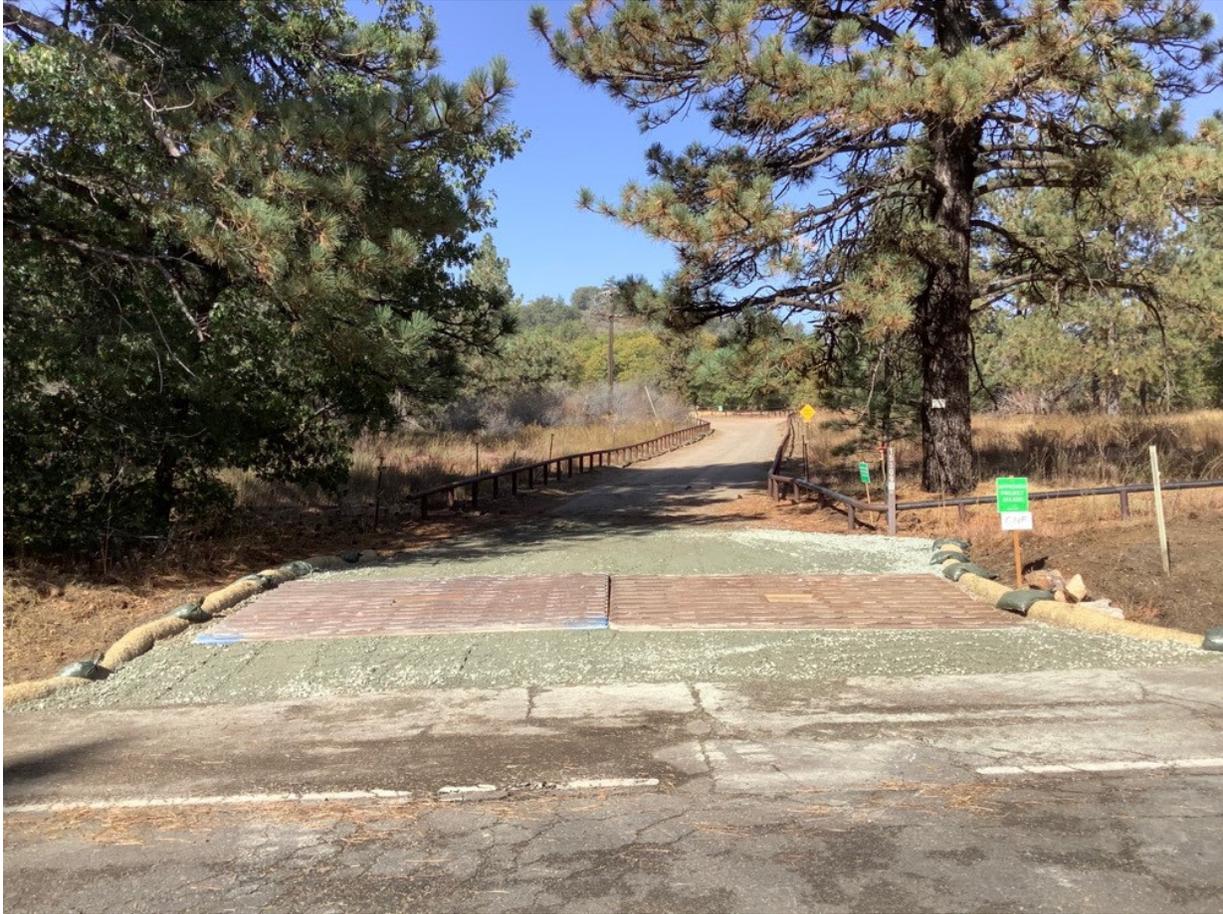
Photo 5: The entrance to Escondido Ravine Road (C 440) was stabilized with gravel and rattle plates to prevent trackout in accordance with the SWPPP.

To prevent impacts to hydrology and water quality, site-specific sediment and erosion control BMPs were observed being implemented and maintained along project alignments in accordance with the project Erosion Control Plan (ECP), Stormwater Pollution Prevention Plan (SWPPP; MM HYD-1 and MM BIO-7), and APM HYD-09. Other BMPs in the SWPPP, such as hydromulch application, concrete waste containment, street sweeping, and access road entrance stabilization (see Photo 5 – Attachment A) were also observed along the alignments. Hydrological resources were flagged for avoidance, and work activities occurred outside of hydrological resources in accordance with APM HYD-06.

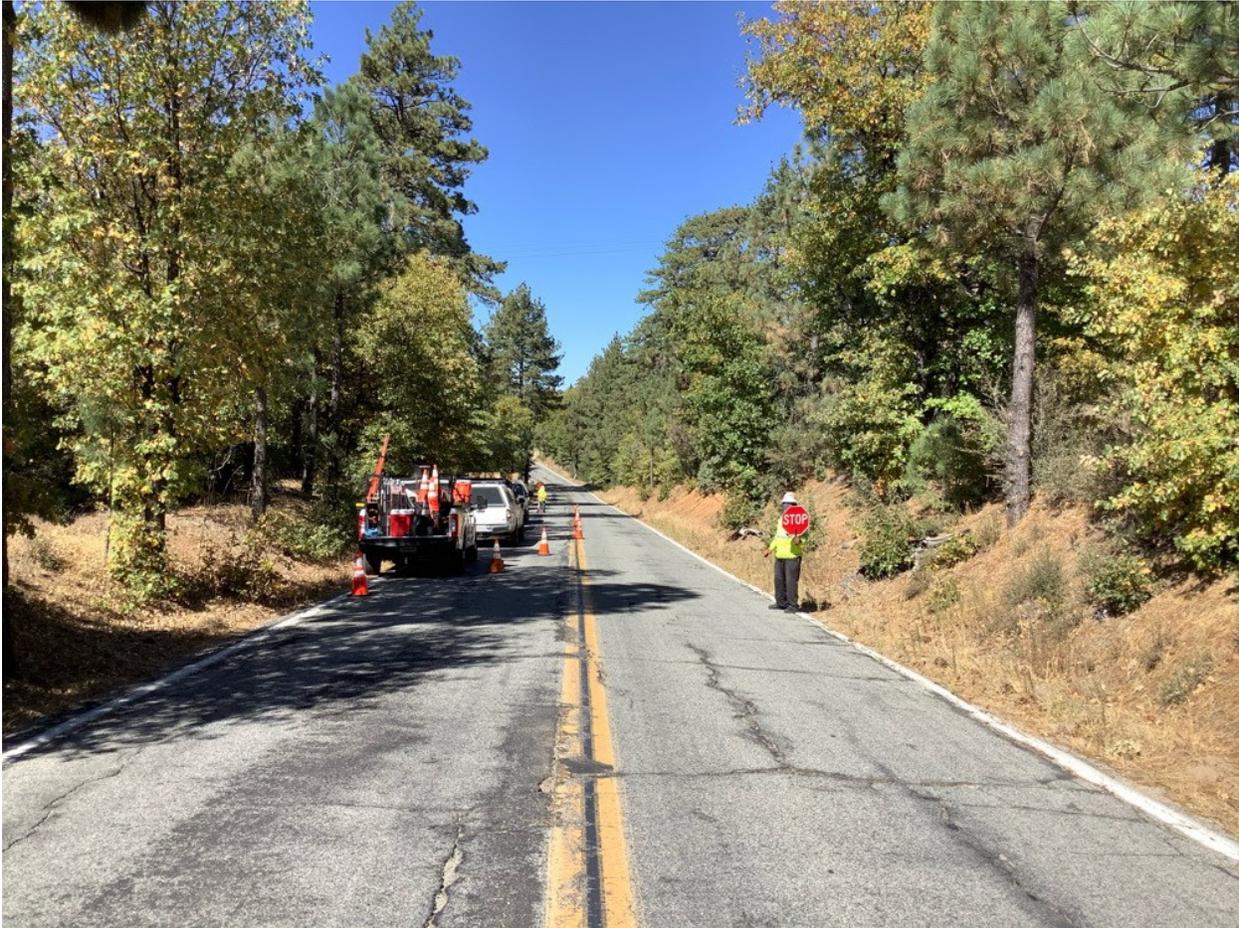
Photo 6: Cones, signage, and flagpersons were used to direct one-way traffic on Sunrise Highway during construction activities at Pole P40476 (C 440) in accordance with APM TRANS-02.

Traffic control measures were observed being implemented in accordance with APM TRANS-01 through APM TRANS-05 during this reporting period (see Photo 6 – Attachment A).
