California Public Utilities Commission <i>Mitigation Monitoring, Compliance, and Reporting Program</i>
	Cleveland National Forest Power Line Replacement Projects Compliance Status Report: 111 December 27, 2020

This compliance status report covers construction activities from December 14 through December 27, 2020.

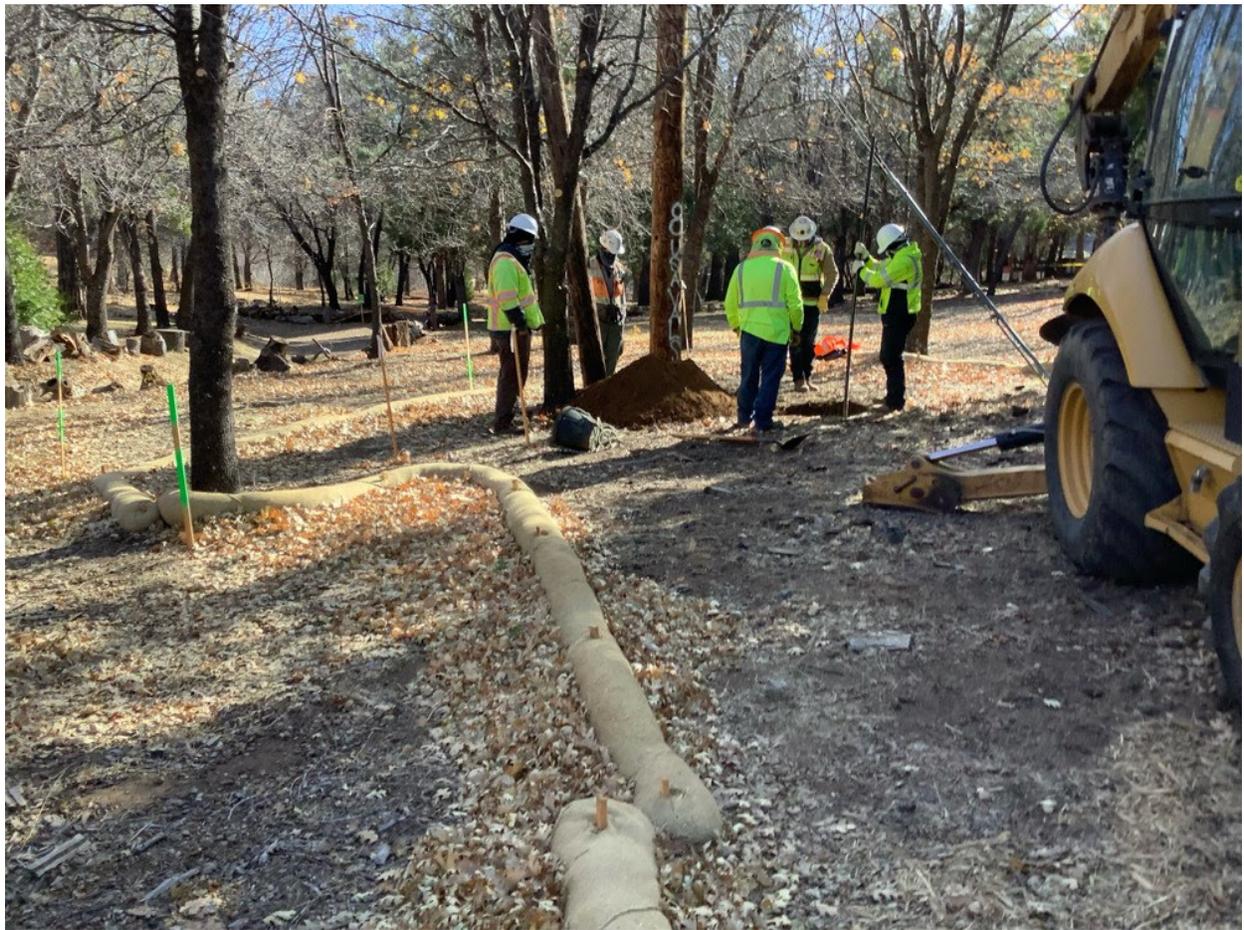
Photo 1: A crew was observed digging a direct bury pole hole at Pole P40211 (C 440) within clearly delineated work limits in accordance with MM BIO-1.

Approved workspaces were observed delineated with staking and flagging, and work crews were observed adhering to work space limits and staying on approved access roads in accordance with MM BIO-1 (see Photo 1 – Attachment A). Workers were observed having completed the Worker Environmental Awareness Program (WEAP), as shown by project hard hat stickers in accordance with MM BIO-2. Biological monitors were observed conducting full-time monitoring of initial ground-disturbing activities, such as vegetation removal, in accordance with MM BIO-3, and monitoring all other construction activities to ensure compliance with mitigation measures, applicant proposed measures, and permit conditions in accordance with MM BIO-22. In accordance with MM BIO-14 and MM BIO-16, Environmentally Sensitive Area signs and flagging were observed installed around areas with special-status species, and ESAs were observed being avoided by crews. Excavations were observed covered to prevent wildlife entrapment in accordance with MM BIO-23, and crews were observed containing trash at work areas in accordance with MM BIO-26. During this reporting period, a CPUC ECM worked with on-site monitors to ensure an improperly covered excavation was addressed in a timely manner.

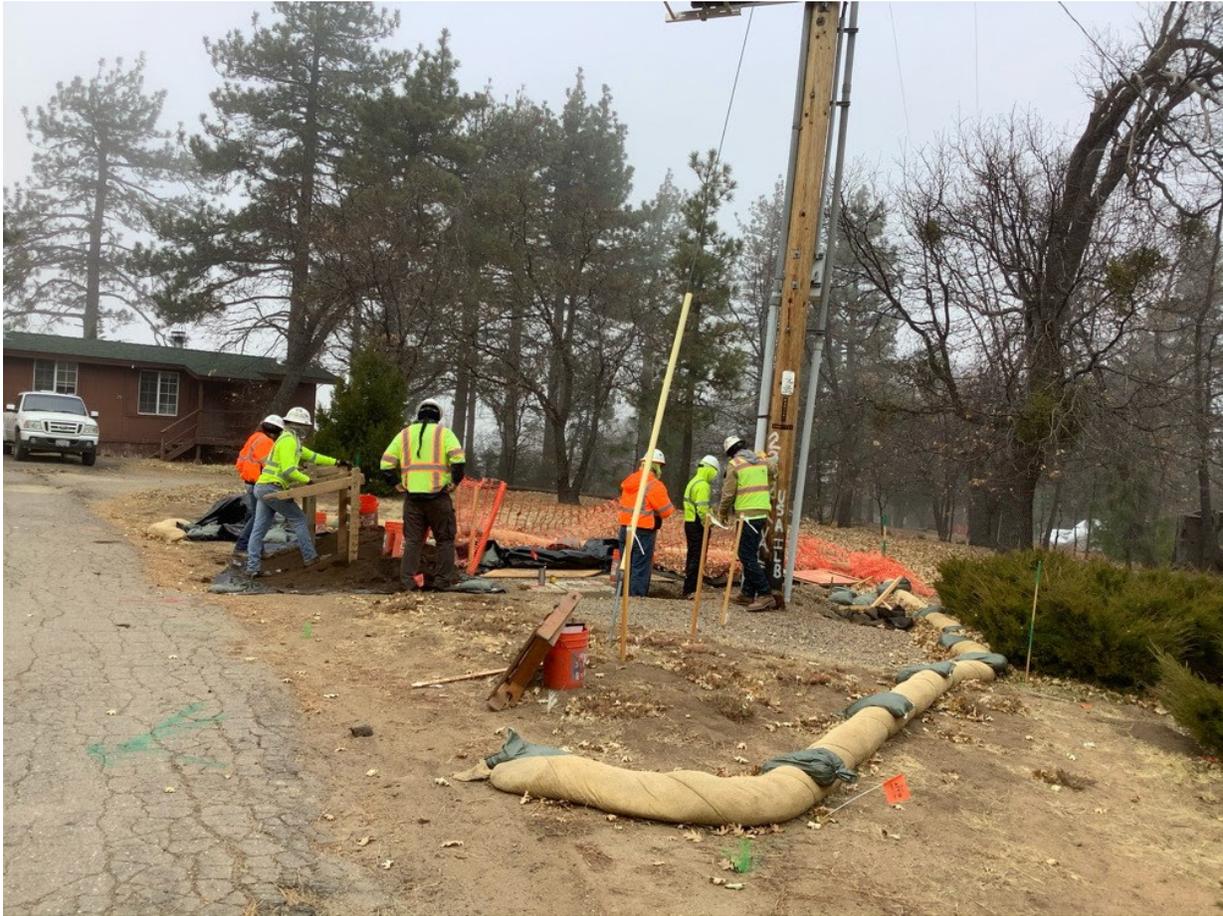
Photo 2: Cultural and Archaeological Monitors were observed monitoring trench excavation and screening spoils for resources along C 440 in accordance with the HPMP, APM CUL-04, MM CUL-1, and MM CUL-3.

CPUC ECMs observed cultural resource monitors, including archaeological and Native American monitors, monitoring construction activities that occurred within or adjacent to identified archaeological or cultural resource site boundaries in accordance with the Historic Properties Management Plan (HPMP), MM CUL-1, MM CUL-3, and APM CUL-04 (see Photo 2 – Attachment A). Cultural ESAs were marked to prevent construction access to areas with cultural and/or historical resources in accordance with the HPMP, and work crews were observed respecting cultural ESA boundaries (see Photo 3 – Attachment A).

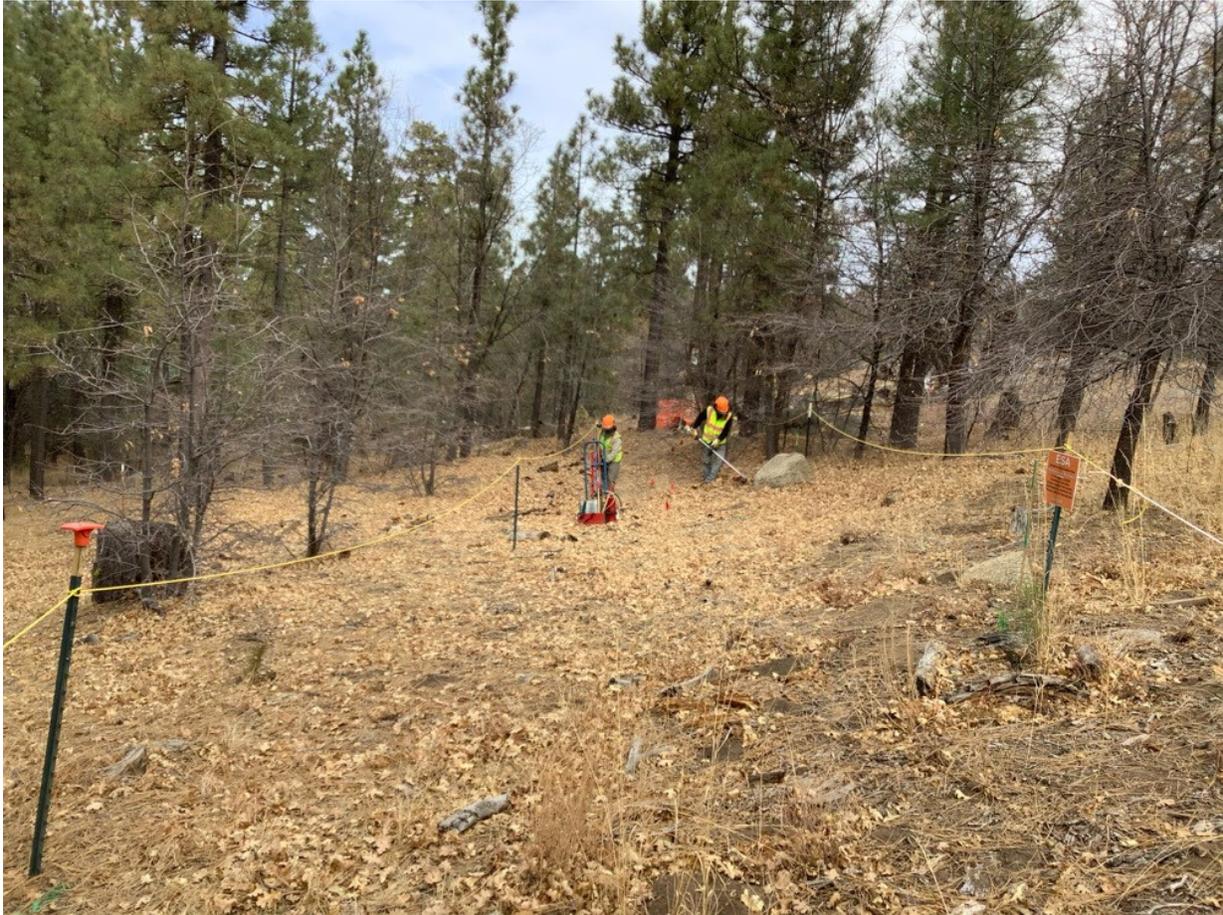
Photo 3: Crews were observed adhering to clearly delineated ESAs along C 440 in accordance with the HPMP and APM CUL-03.

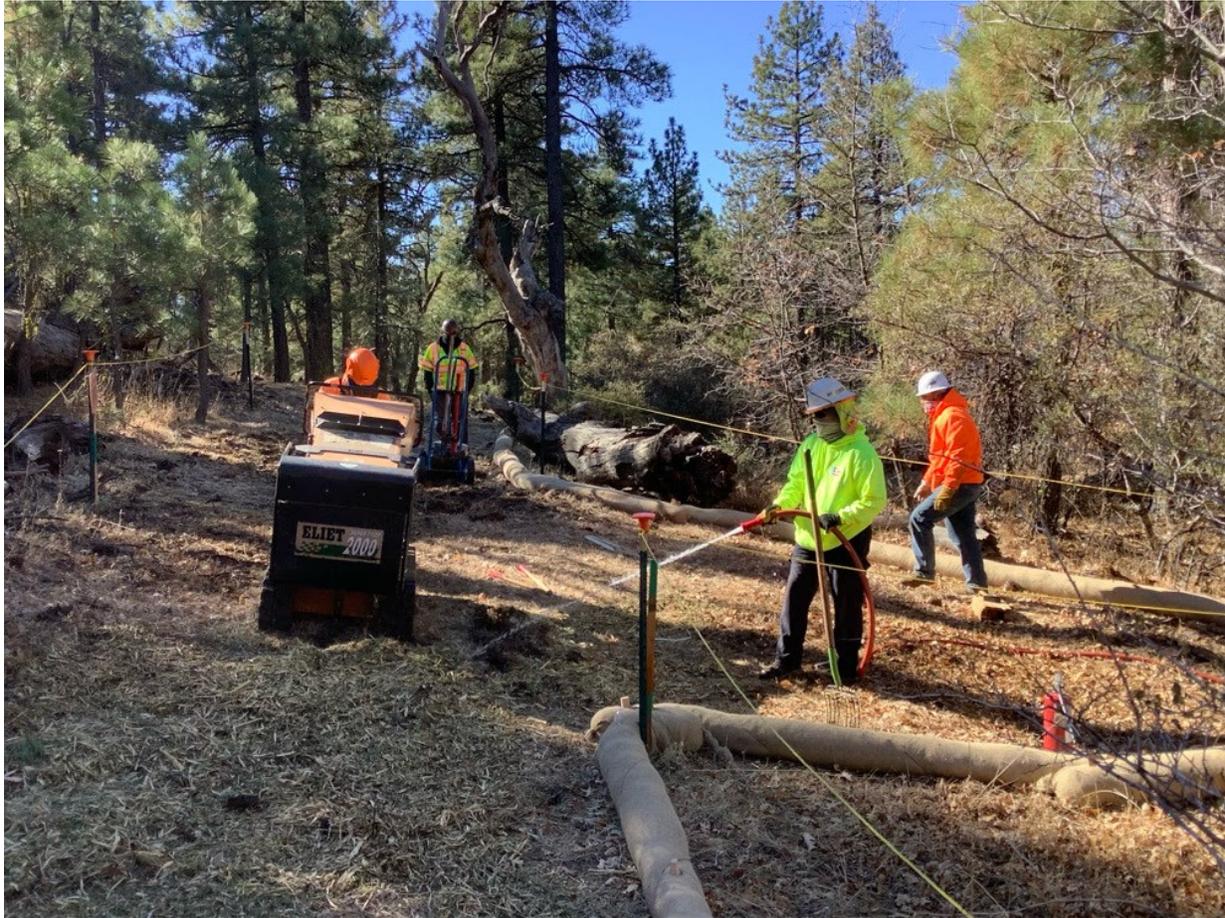
Photo 4: A crew was observed chipping along the underground alignment near Pole P40289 (C 440). A full set of fire tools was observed within 50 feet of the activity, at least 100 gallons of water with pump and hose were observed on site, and the area was wet down to prevent ignitions in accordance with the CFPPP for chipping on NFS land with a PAL C.

extinguisher). Construction crews were observed staging a set of fire tools within 50 feet of work activities as required by APM HAZ-04 and implementing other fire prevention measures as required by the CFPPP (see Photo 4 – Attachment A), and appropriate Fire Patrols were observed on site during activities that required their presence. Fire boxes were observed at staging yards and stocked with the required firefighting tools.

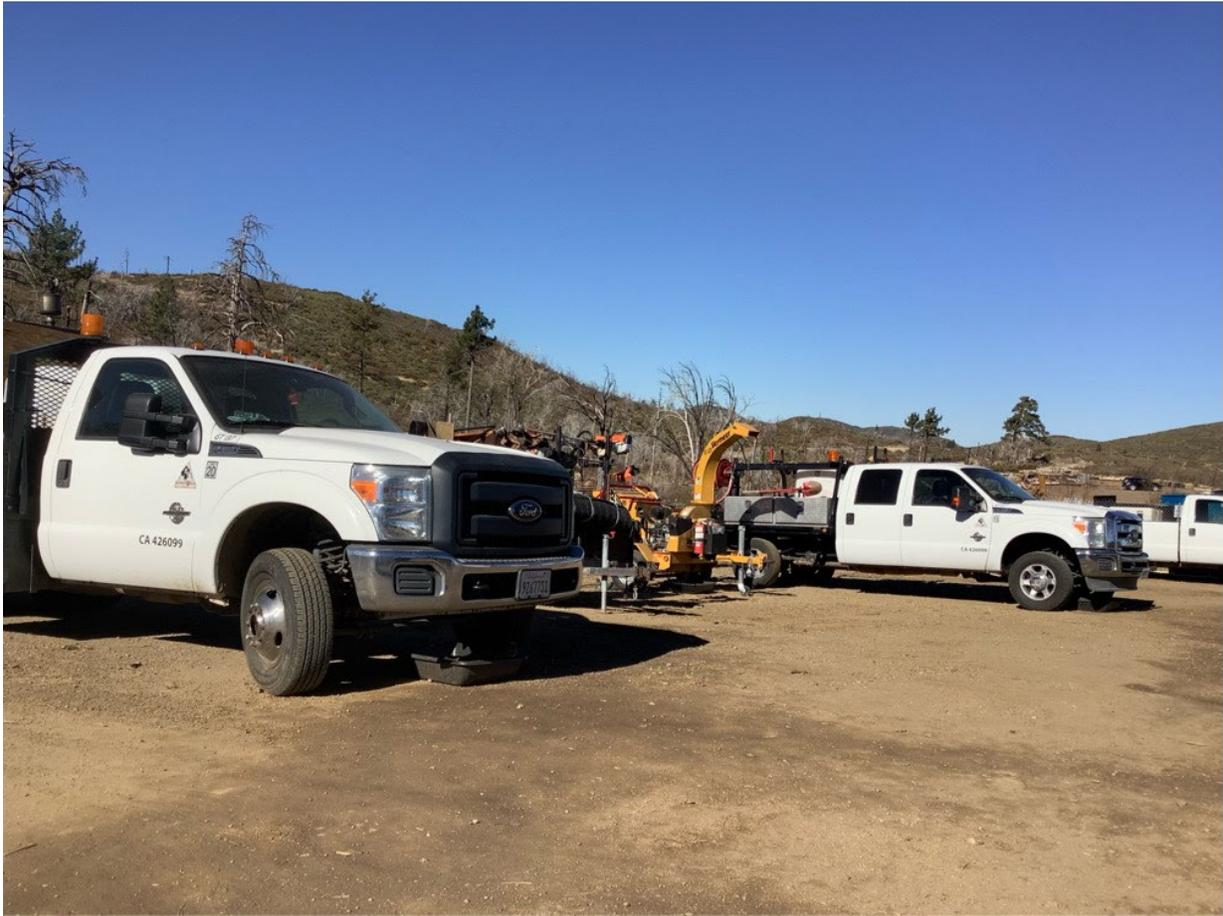
Photo 5: Drip pans were observed under staged vehicles and equipment at Shrine Camp Staging Yard (C 440) to prevent leaks or spills from being discharged onto the ground in accordance with the SRNP and MM PHS-2.

To prevent leaks and spills from being discharged into the soil in accordance with the Spill Response and Notification Plan (SRNP) and MM PHS-2, construction crews were observed implementing spill prevention BMPs, such as using drip pans under staged equipment (see Photo 5 – Attachment A) and beneath equipment during mechanical work and refueling, staging spill kits at work sites, using double-walled fuel tanks or implementing secondary containment beneath staged fuel tanks, and cleaning up spills and disposing of contaminated soils in the designated and properly labeled hazardous waste barrels.

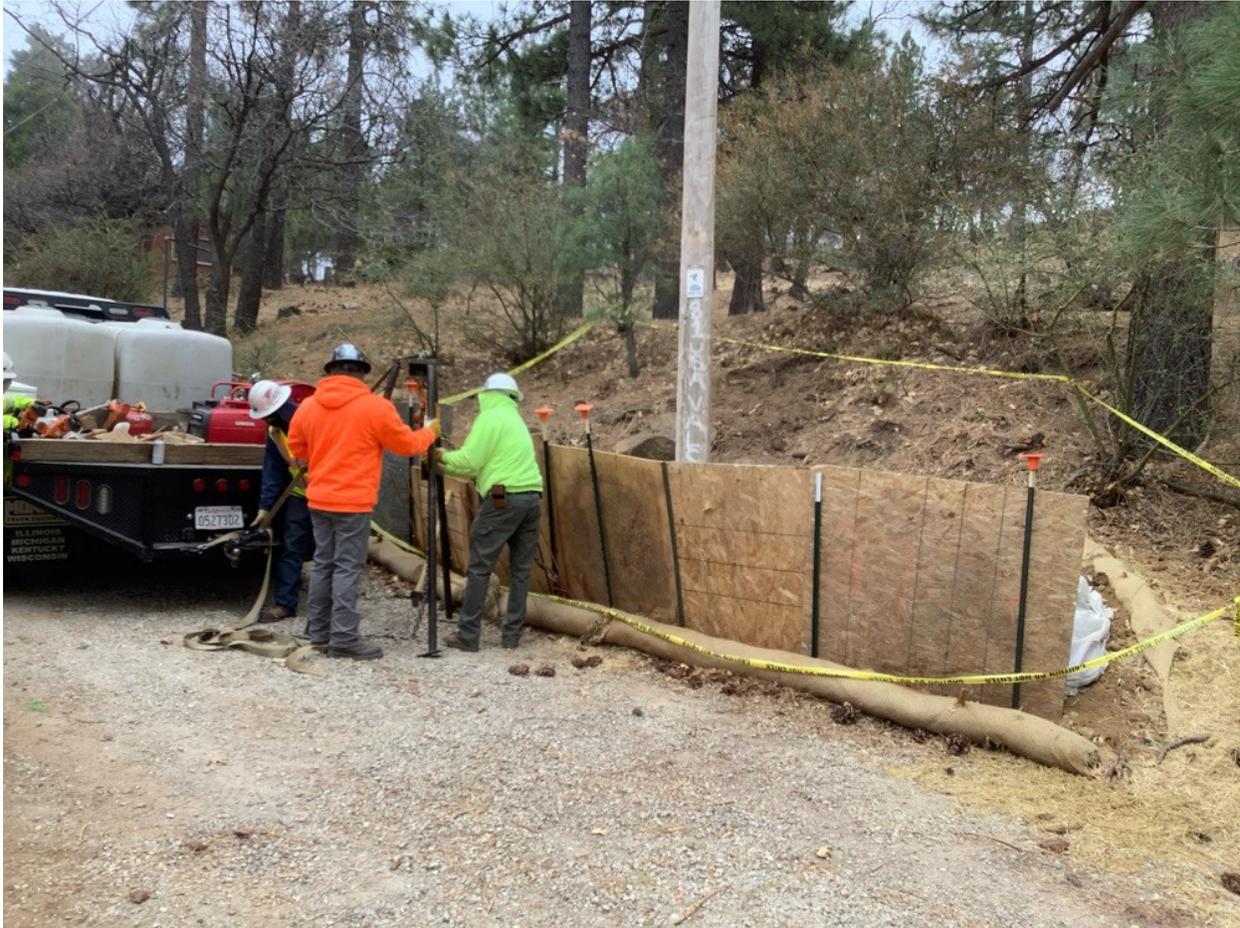
Photo 6: A crew was observed maintaining plywood erosion control BMPs at Pole P40430 (C 440) to contain spoils within the work area in accordance with APM HYD-09, the ECP, and the SWPPP (MM HYD-1, MM BIO-7).

To prevent impacts to hydrology and water quality, site-specific sediment and erosion control BMPs were observed being implemented and maintained along project alignments in accordance with the project Erosion Control Plan (ECP), Stormwater Pollution Prevention Plan (SWPPP; MM HYD-1 and MM BIO-7), and APM HYD-09 (see Photo 6 – Attachment A). Other BMPs in the SWPPP, such as hydromulch application, concrete waste containment, street sweeping, and access road entrance stabilization were also observed along the alignments. Hydrological resources were flagged for avoidance, and work activities occurred outside of hydrological resources in accordance with APM HYD-06.
