<p>California Public Utilities Commission <i>Mitigation Monitoring, Compliance, and Reporting Program</i></p>
	<p>South Bay Substation Relocation Project</p> <p>Compliance Status Report: 019</p> <p>January 31, 2016</p>

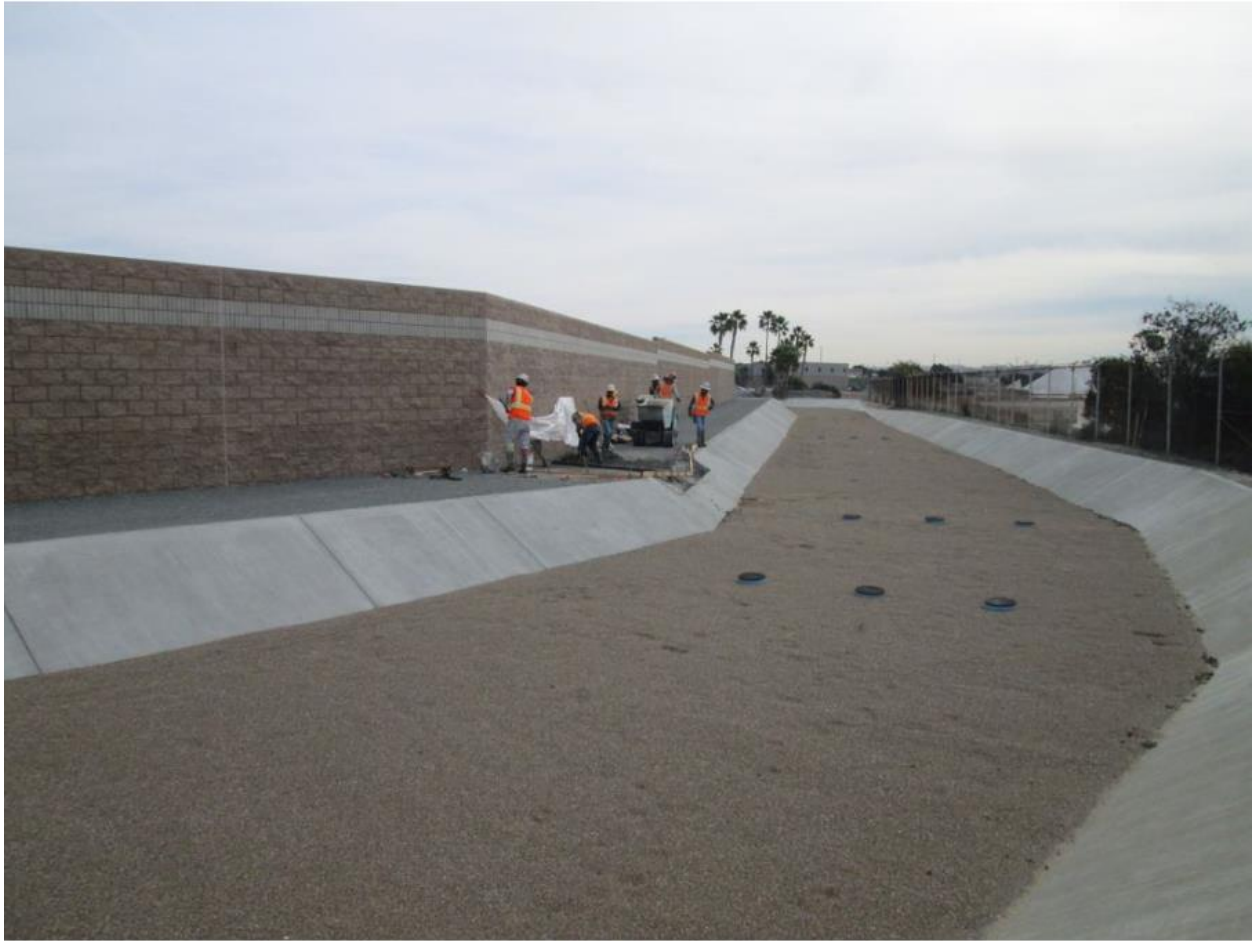
Photo 1: Crews were observed placing concrete forms in the Bay Boulevard Substation screening wall outlets.

- Setting of forms for concrete aprons between the perimeter wall and bioretention basin (See Photo 1—Attachment A)
- Forming, setting steel, and pouring concrete for drainage pipes
- Extending the rip-rap in the southwestern drainage point

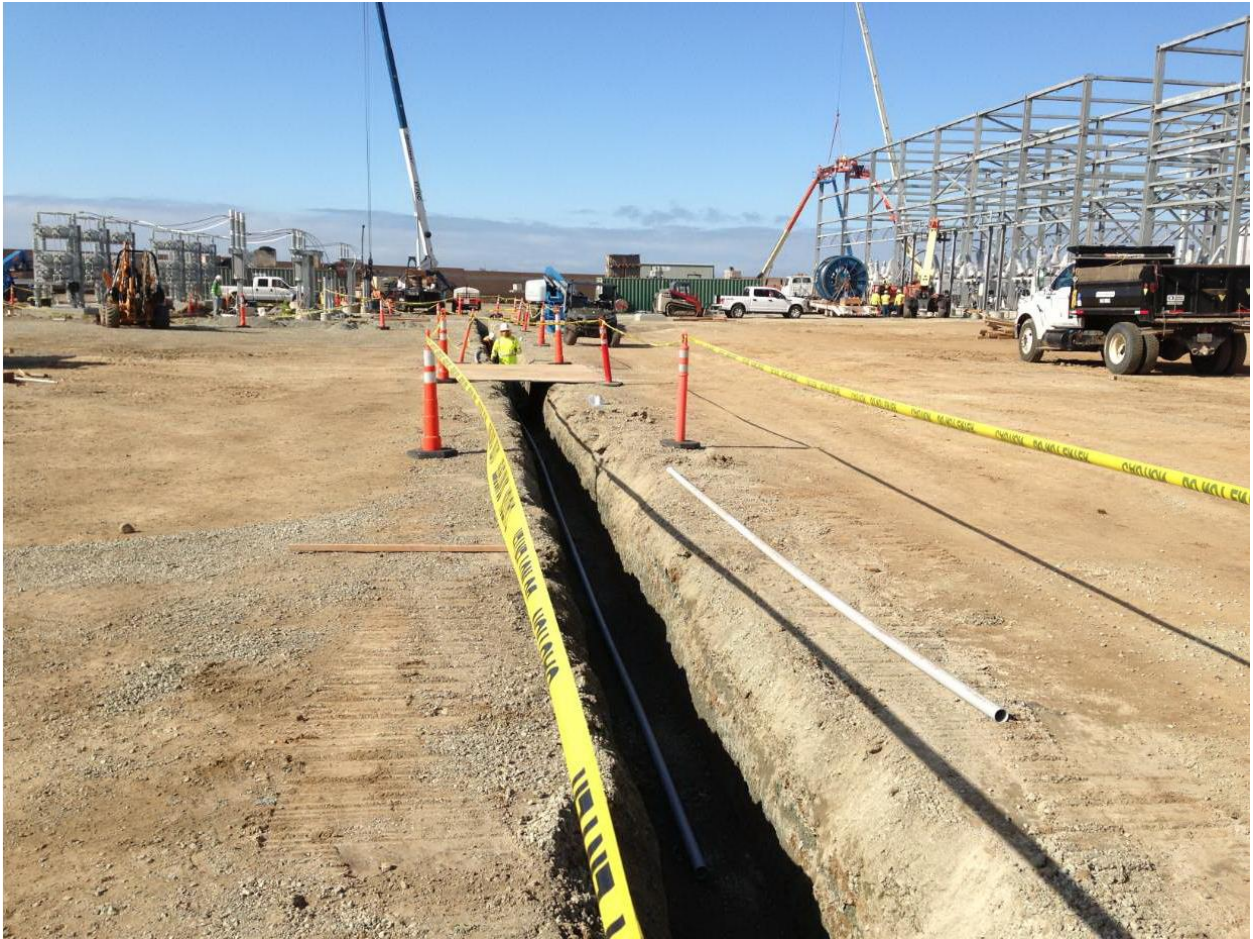
Photo 2: Crews were observed erecting steel at the Bay Boulevard Substation and continuing to install conduit.

- Setting transformers
- Trenching and installing duct banks
- Installing substation ground grid
- Installing 69 kilovolt (kV) steel structures, wire terminations and conduit (See Photo 2—Attachment A)
- Began erecting the 230 kV transformer firewalls and installing conduit in the 230 kV yard

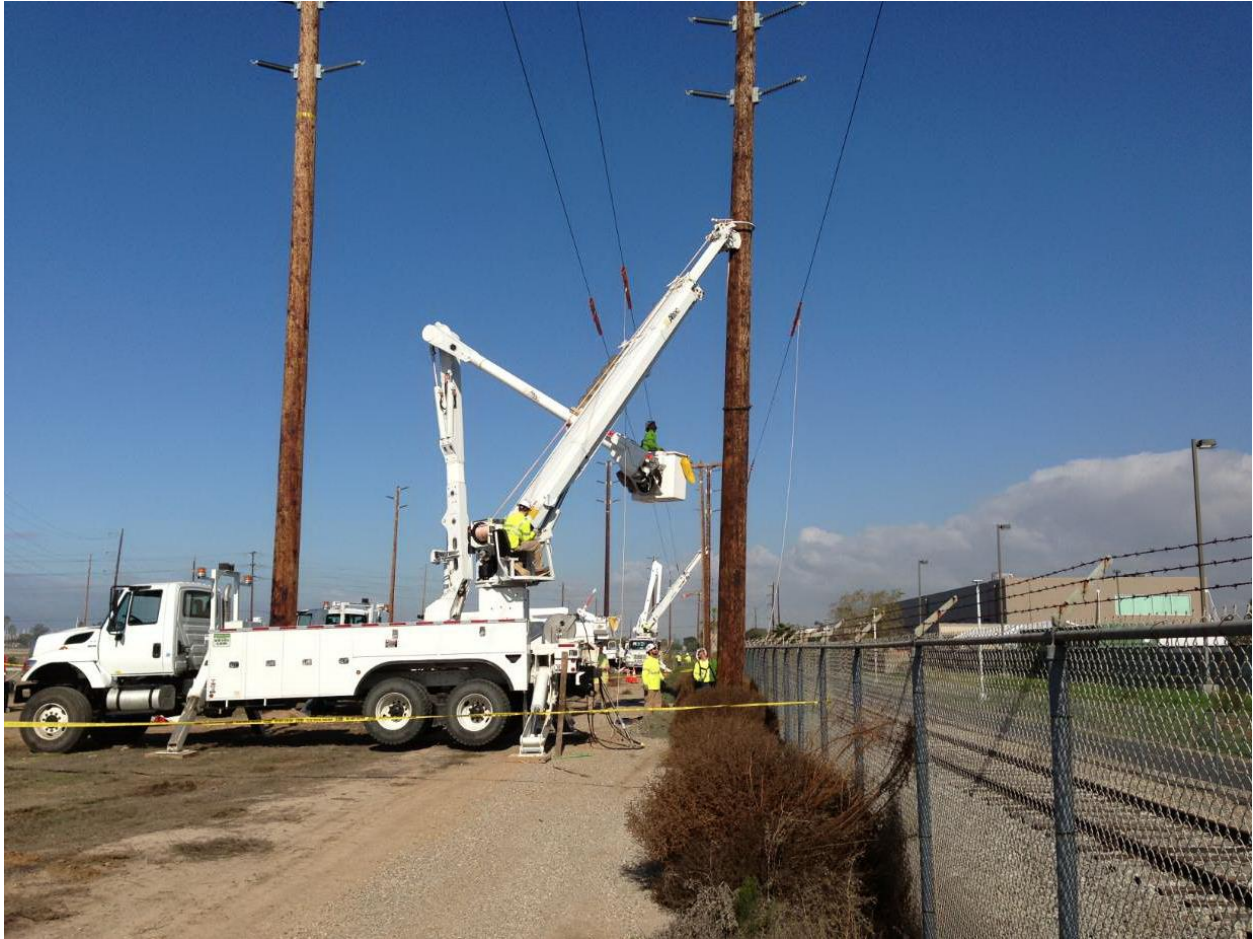
Photo 3: Crews were observed removing 69kV poles along the transmission line alignment.

- Framing, excavating and setting poles (See Photo 3—Attachment A)
- Transferring the 12 kV conductor underbuild onto the new 69 kV wood poles
- Pushing conduit through underground HOBAS pipe
- Conducting trenching operations, dewatering, and installing underground duct banks for a 69kV line.
- Installing and backfilling a riser pole for a 69kV line
- Conducting vault repair and proofing for a 69kV line

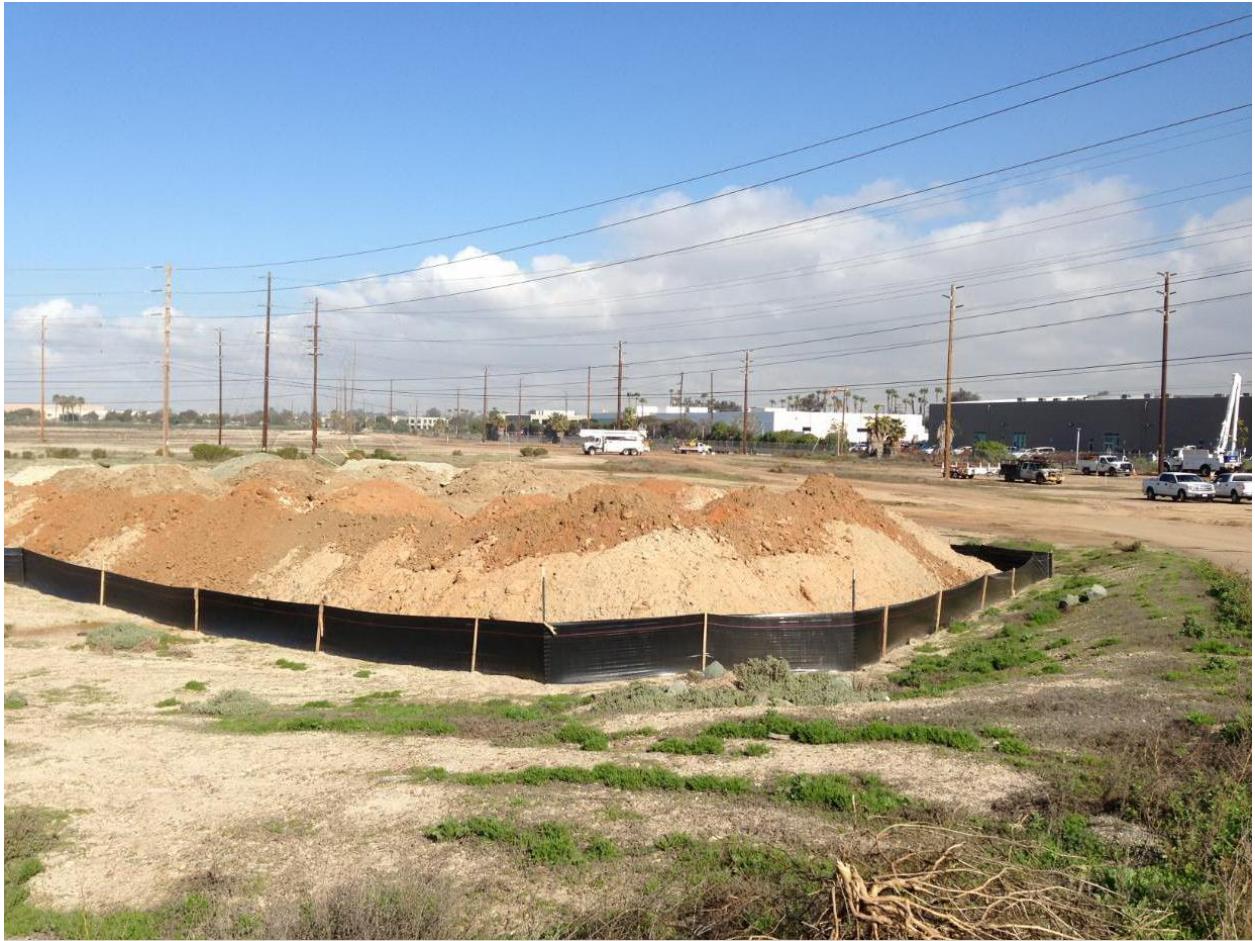
Photo 4: Stockpiles along the transmission line alignment were secured with silt fencing in accordance with the SWPPP.

SWPPP BMPs installed at the Bay Boulevard Substation site and along the transmission alignment, including silt fencing and straw wattles installed along the temporary perimeter fence and around stockpiles, were in good working condition (See Photo 4—Attachment A). Spill prevention, trash containment measures, and concrete washout areas were observed in place during conduit installation and backfilling activities associated with the 138kV underground transmission line. Portable sanitation facilities (i.e. toilets and wash stations) were observed on catchment units in accordance with SWPPP (See Photo 5—Attachment A).

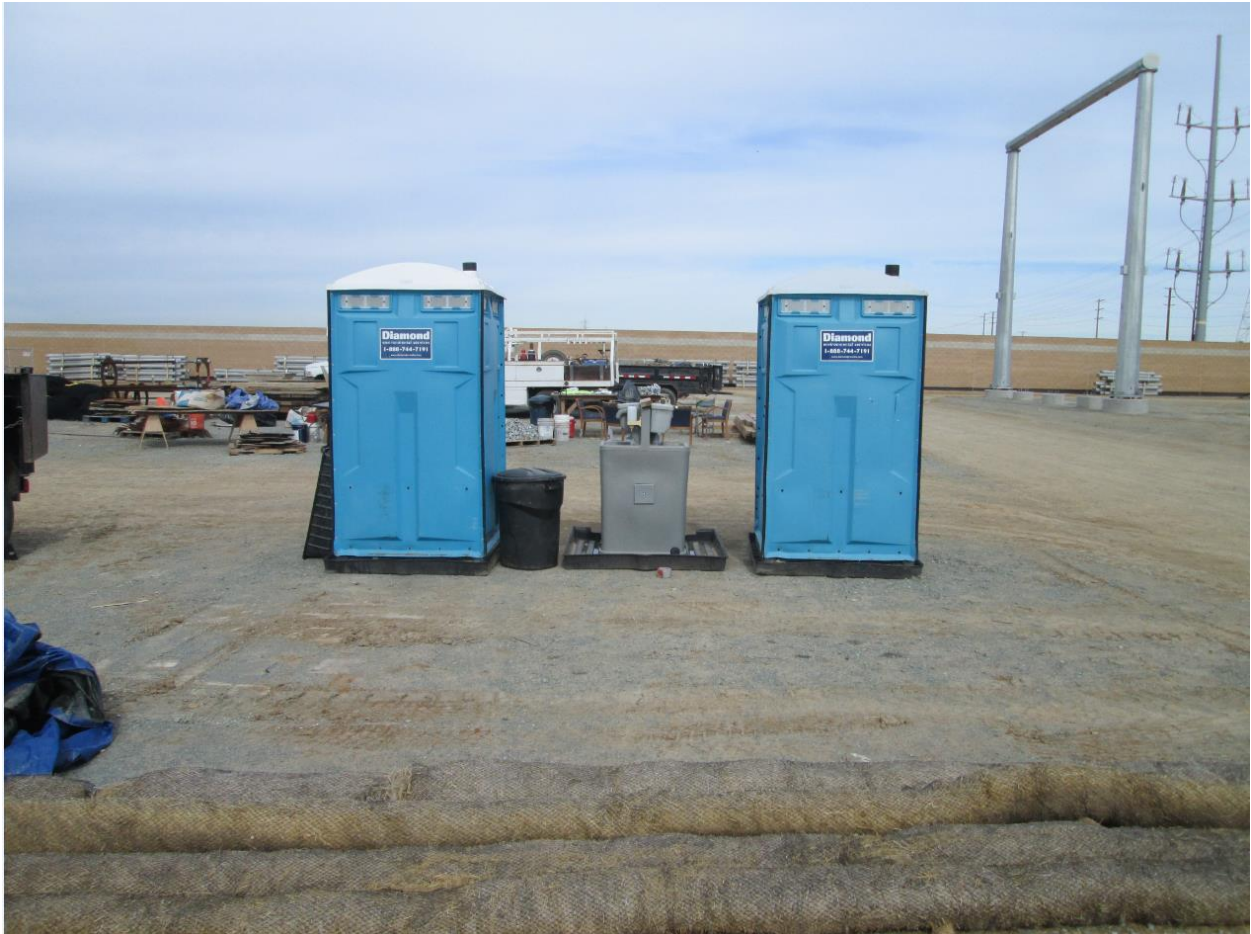
Photo 5: Portable sanitation facilities (i.e. toilets and wash stations) were observed on catchment units in accordance with SWPPP.

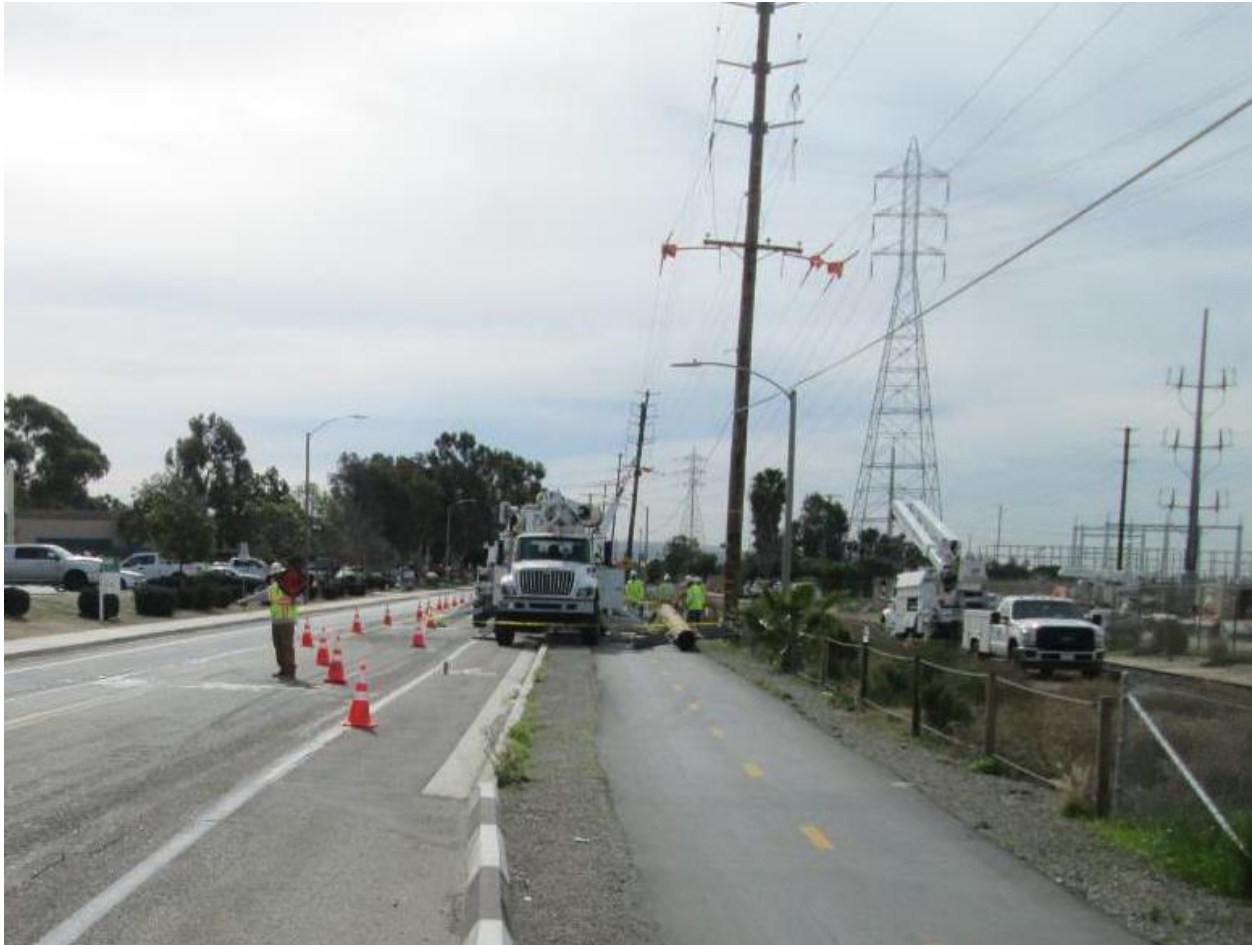
Photo 6: Crews were observed preparing a new 69kV pole for installation along Bay Boulevard. Traffic control flaggers were used to divert traffic around staged equipment in accordance with MM TRA-1.

Traffic control measures were observed being utilized in accordance with the Traffic Management Plan (MM TRA-01). Traffic control flaggers were observed directing traffic during construction activities associated with the transmission line along Bay Boulevard (See Photo 6—Attachment A). Signage was observed placed along Bay Boulevard in accordance with the Traffic Management Plan/Traffic Control Permit to notify bicyclists of the bike path closures and to notify drivers to share the road. Heavy-duty construction vehicles were observed using Palomar Avenue in accordance with APM-TRA-01 and flag persons were observed during the hauling of oversized loads to the site.
