Protection On Power Lines:

PIER FINAL PROJECT REPORT CEC-500-2006-022

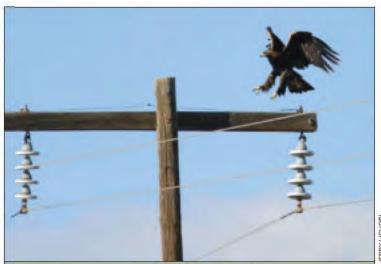
FIGURE 2.2: Golden eagle landing on avian-safe pole. Early research on avian electrocutions and pole modifications focused largely on golden eagles.

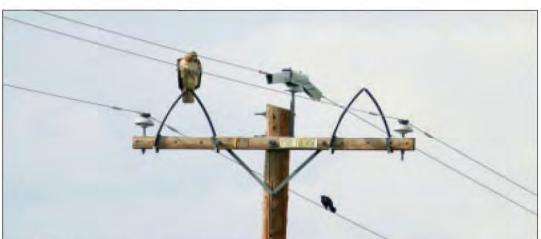
FIGURE 2.5: Perch discouragers have been installed on utility poles to prevent raptors or corvids from preying upon sensitive species. However, this is not recommended, as perch discouragers are intended to manage where birds perch, not to entirely prevent perching.

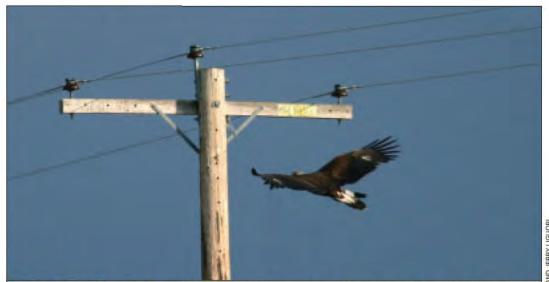
FIGURE 4.14: Juvenile golden eagle about to land on a distribution pole that is not avian-safe.

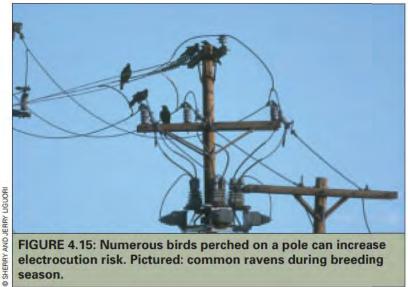
FIGURE 4.15: Numerous birds perched on a pole can increase electrocution risk. Pictured: common ravens during breeding season.

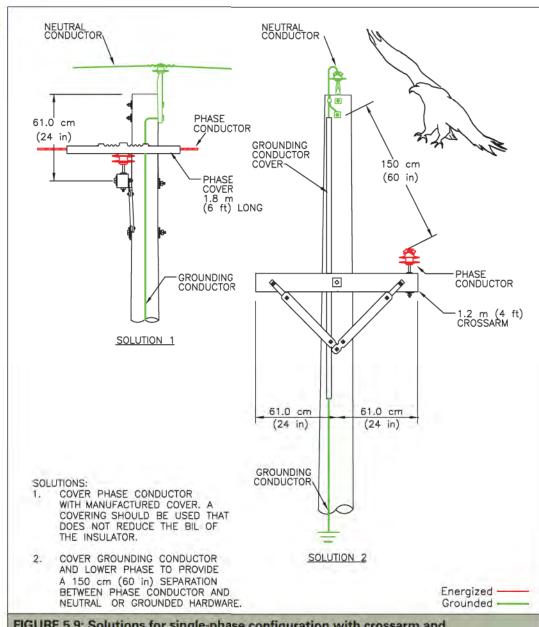
FIGURE 5.9: Solutions for single-phase configuration with crossarm and overhead neutral.

for avian-safe phase-to-ground separation (Figure 5.9, Solution 2).

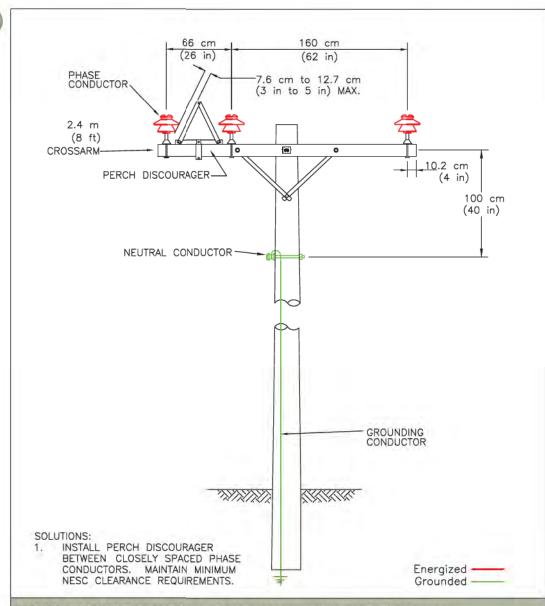
FIGURE 5.14: Solution for three-phase crossarm using perch discourager.

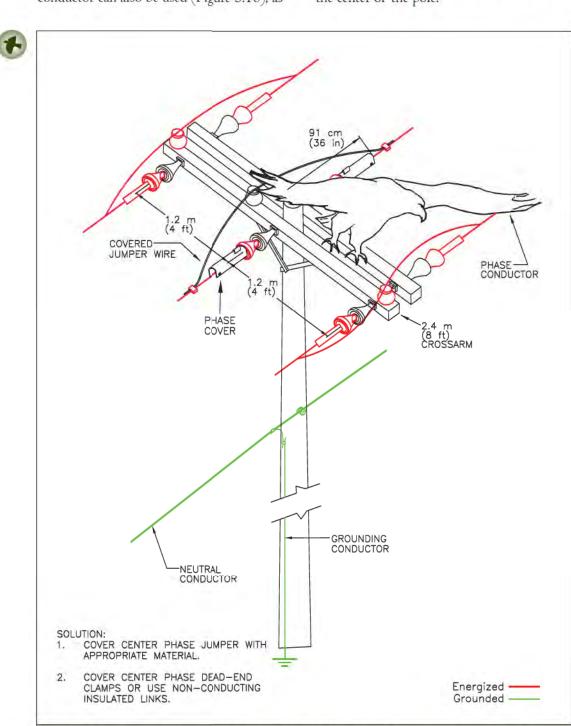
FIGURE 5.16: Solution for three-phase double dead-end with exposed jumper wires.

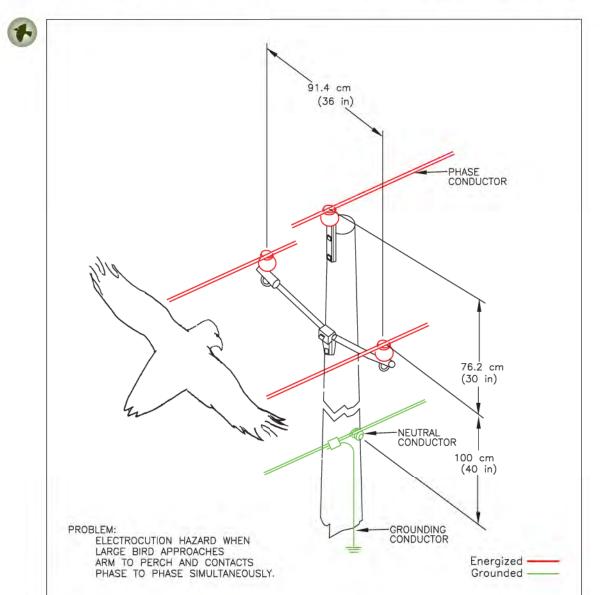
FIGURE 5.17: Problem compact three-phase design.

ingly, this configuration presented a significant eagle electrocution problem on a line in southern Utah, while a nearby line of the same construction did not electrocute any eagles (PacifiCorp, unpubl. data). Overall, streamline poles comprised 10% of poles surveyed in Utah and Wyoming from 2001 to 2002 (n=74,020) and accounted for I3%

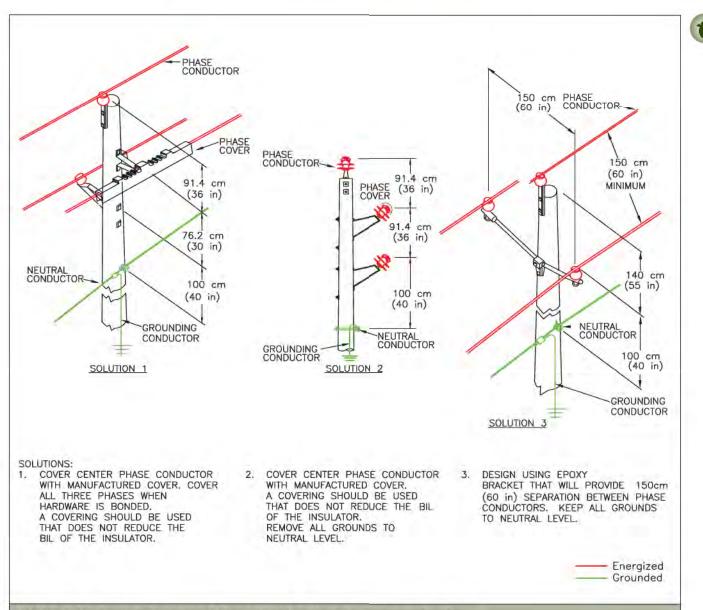
FIGURE 5.19: Avian-safe compact three-phase designs for new construction.

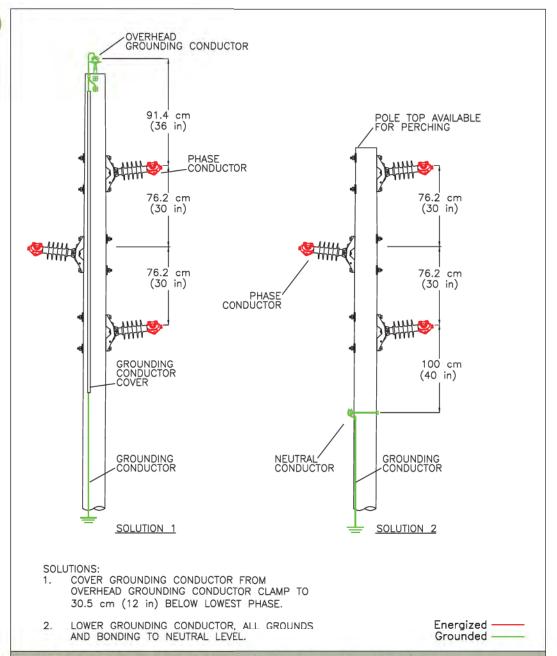
#### FIGURE 5.21: Solutions for distribution horizontal post insulator designs.

Covering the vertical grounding conductor from the overhead grounding conductor clamp to 30 cm (I2 in) below the lowest phase and disconnecting insulator bracket bonds (Figure 5.21, Solution I);

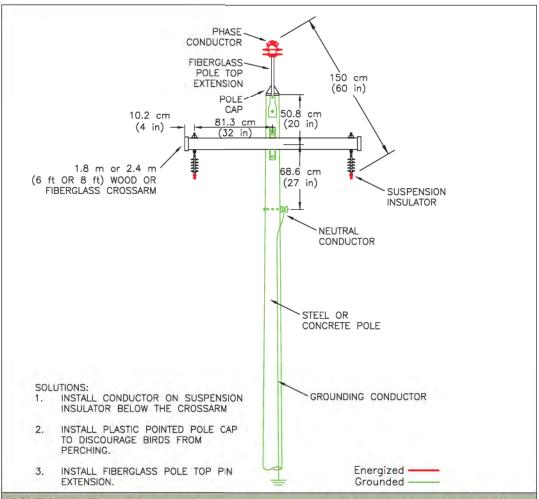
FIGURE 5.33: Three-phase configuration on a steel or reinforced concrete pole with suspended insulators.

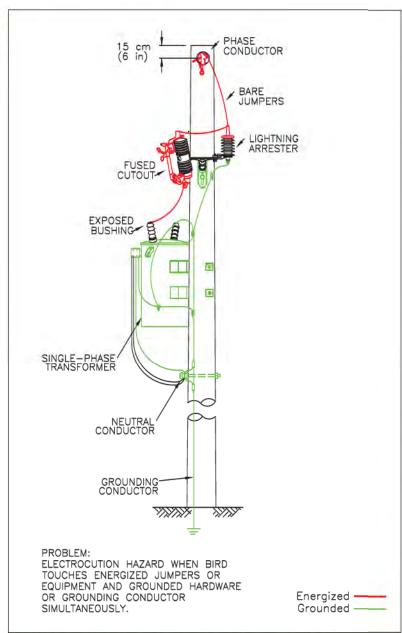
FIGURE 5.45: Problem single-phase transformer bank.

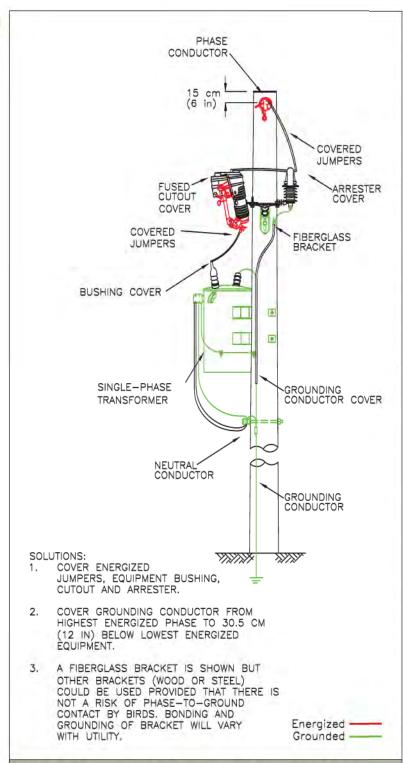
FIGURE 5.47: Solution for single-phase transformer bank.

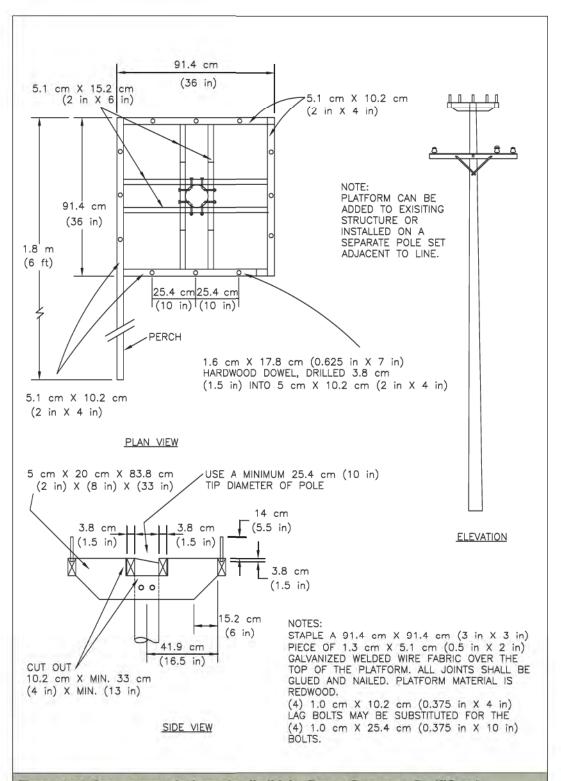
Figure 6.12: Osprey nest platform details (Idaho Power Company, PacifiCorp).

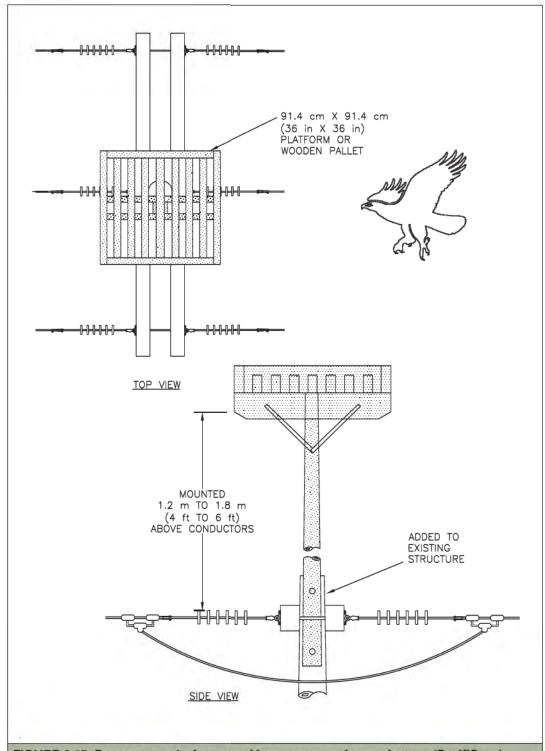
FIGURE 6.15: Raptor nest platform used by ospreys and some buteos (PacifiCorp). This design is recommended when a new nest pole cannot be erected.

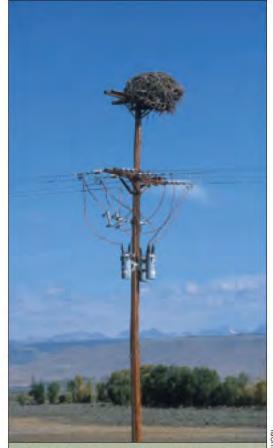
FIGURE 6.16: Osprey nest in Wyoming atop double dead-end pole. Nesting material that may drop onto the conductors or equipment poses fire, outage, and equipment damage risks.
