## **Geotechnical Study**

Sycamore to Penasquitos  
230kV Transmission Line  
San Diego County, California

**Project No.: T-0126-G**

**April 15, 2015**

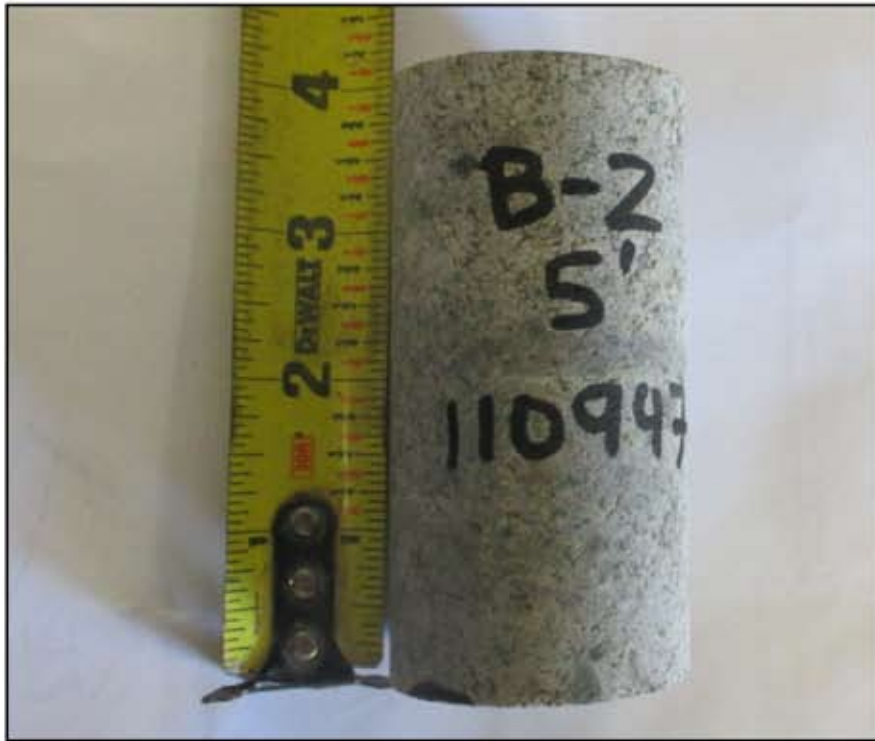
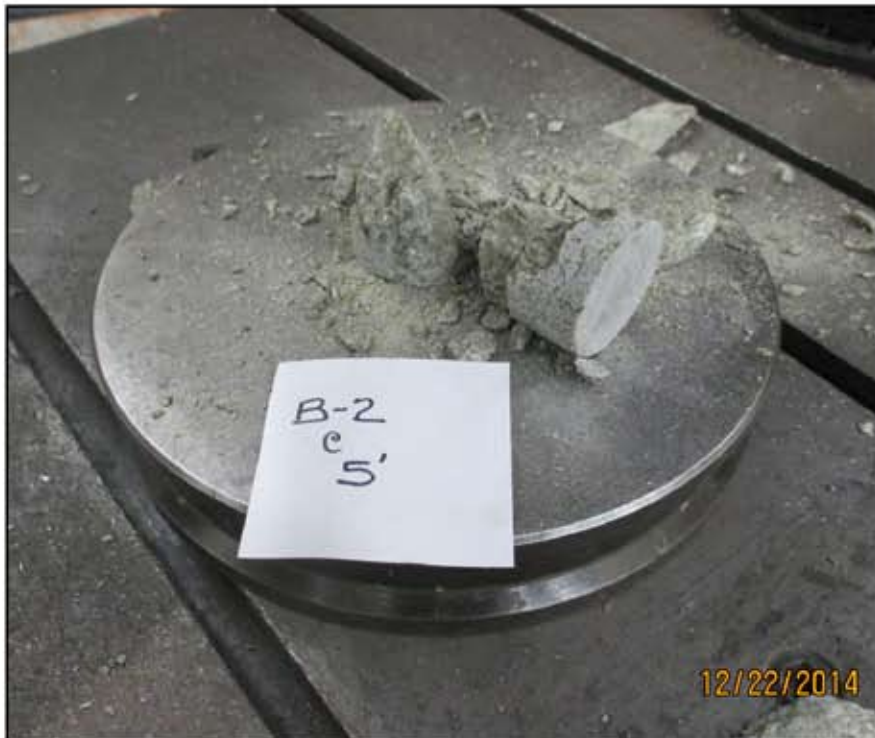
**Figure No.: E-1**

**B-2 (P-24) - 5 Feet**

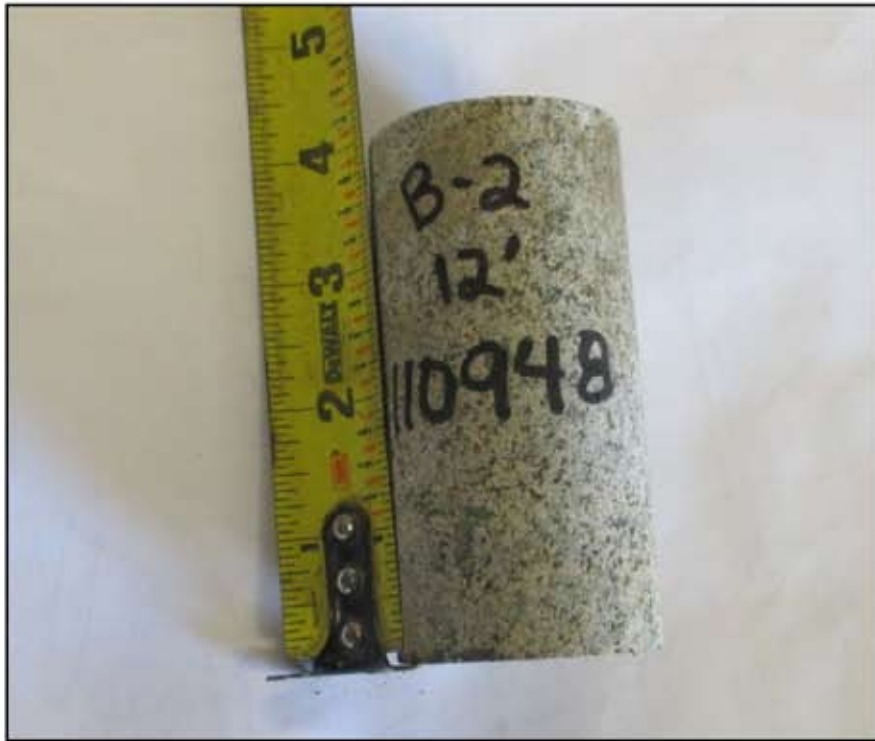
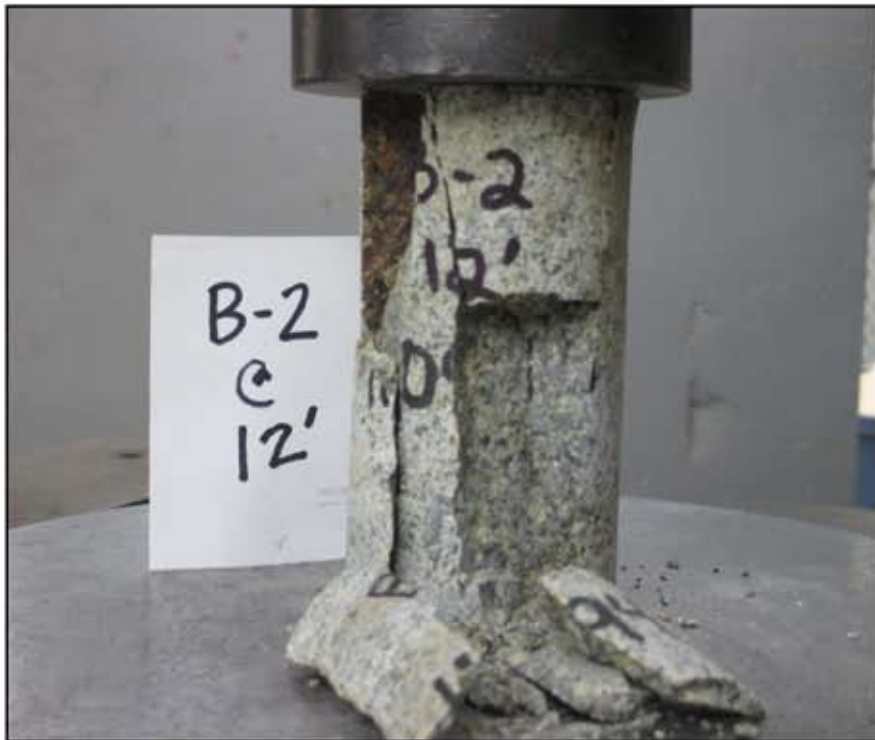
**Figure No.: E-2**

**B-2 (P-24) - 12 Feet**

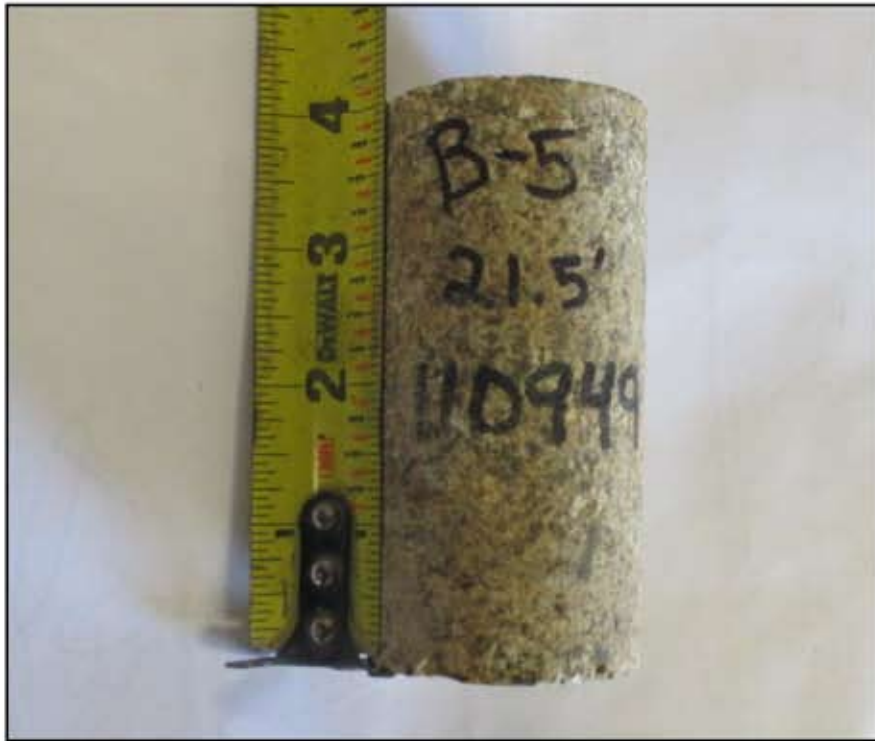
Figure No.: E-3

**B-5 (P-36) - 21.5 Feet**

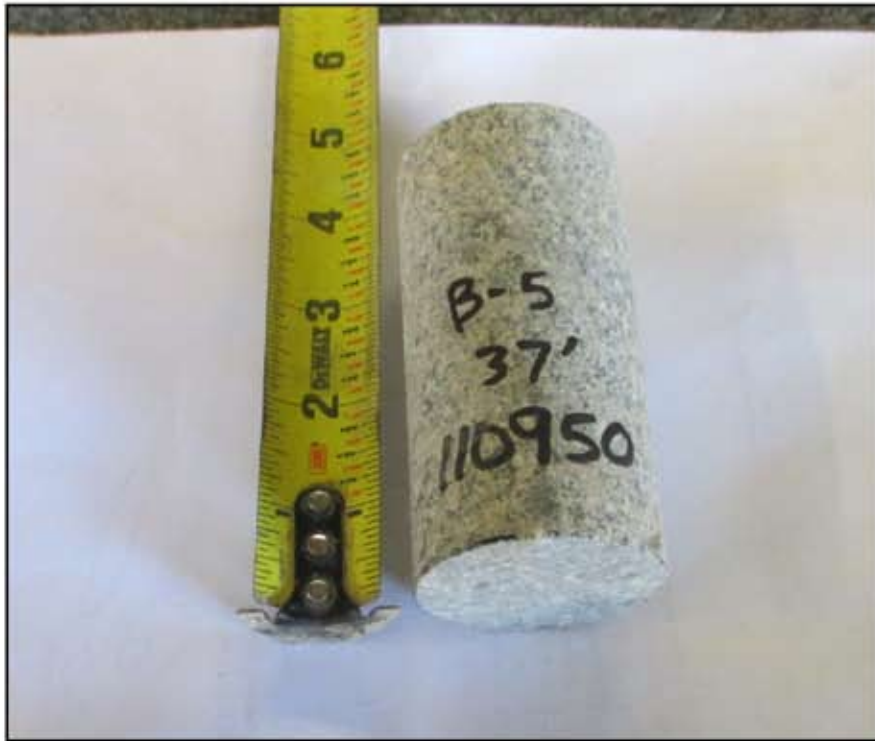
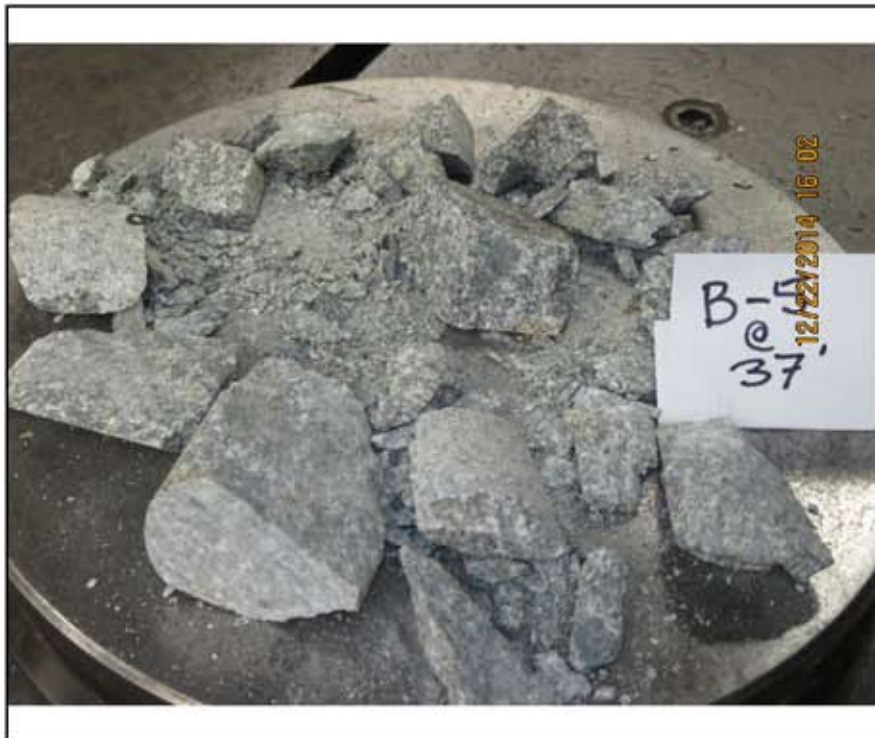
Figure No.: E-4

## B-5 (P-36) - 37 Feet

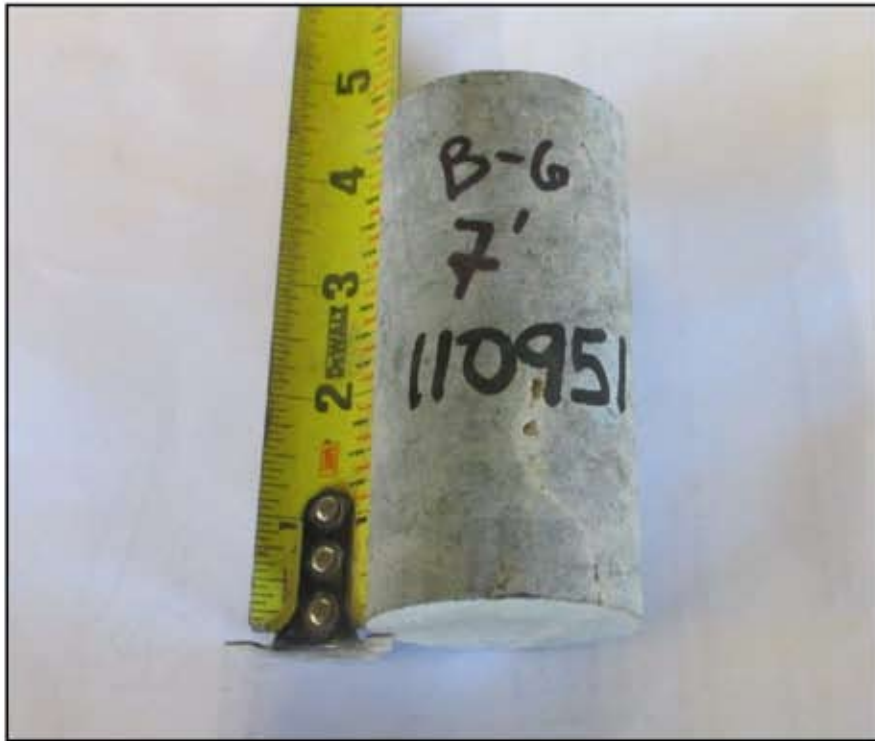
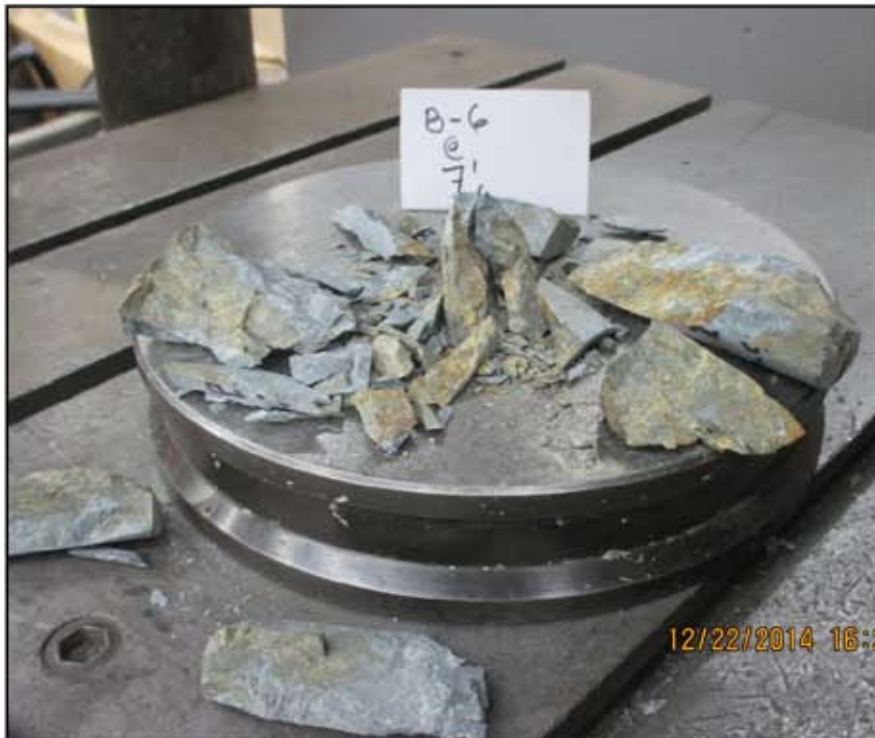
**Figure No.: E-5**

**B-6 (P-39) - 7 Feet**
