**SAN DIEGO GAS & ELECTRIC COMPANY  
CLEVELAND NATIONAL FOREST  
POWER LINE REPLACEMENT PROJECTS  
ACCESS ROAD CONDITION EVALUATION AND  
REPAIR DESIGN REPORT**

**DECEMBER 2016**

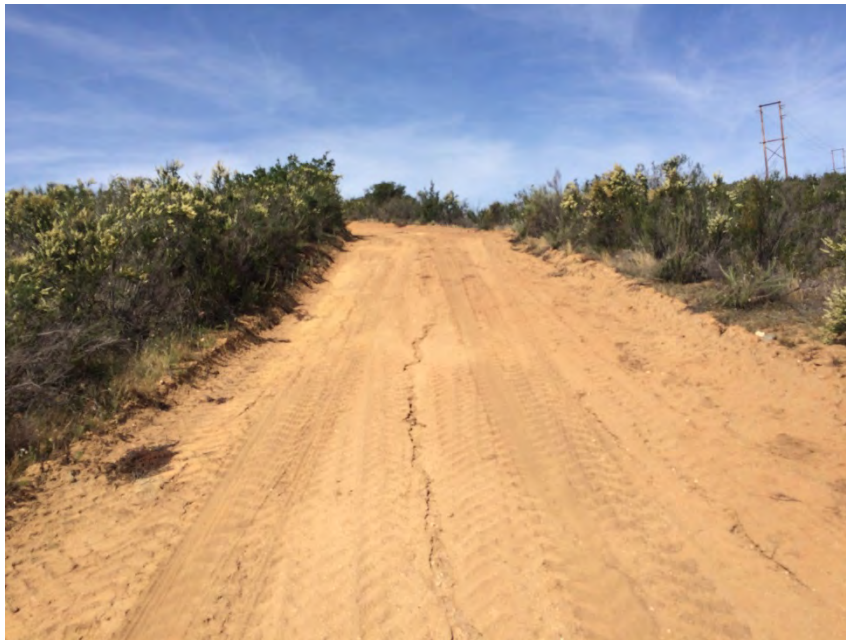
TL625B-12 - 160 east of fork to Pole Z272860, looking west

32°47'41.69"N, 116°45'10.68"W	20 feet east of fork in spur road to Pole Z272860	32°47'42.14"N, 116°45'09.18"W	160 feet east of fork in spur road to Pole Z272860	No	No	Yes	No	TL625B-12	18	Minor rilling, approximately 4” wide by 2” deep noted. Water bars have been installed and are functioning as designed.
32°47'42.14"N, 116°45'09.18"W	80 feet southwest of Pole Z272860	32°47'40.59"N, 116°44'43.08"W	Pole Z272860	No	Yes	N/A	No	TL625B-13	18	No erosion noted. Riprap at outlet from pad is located properly and in good condition.

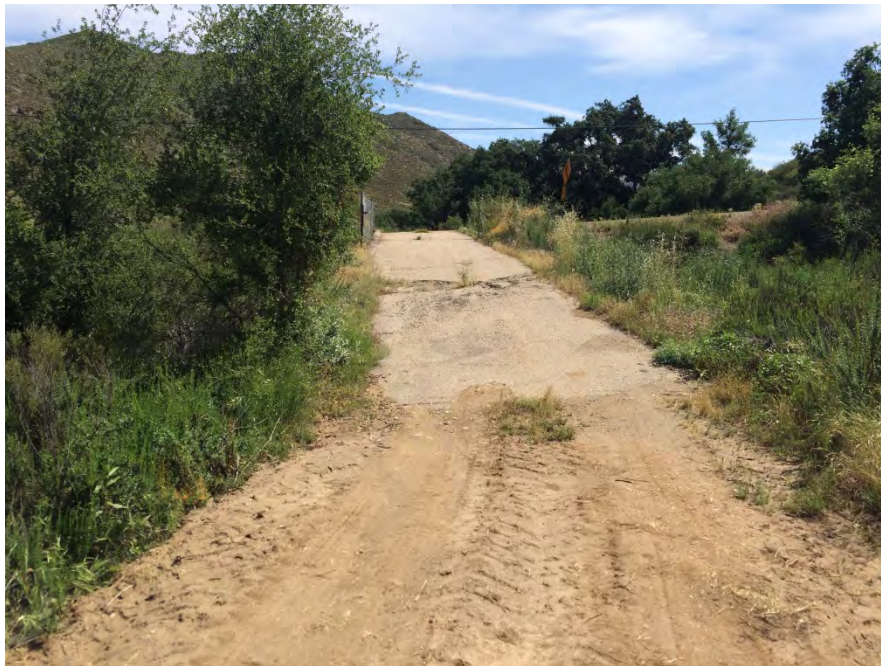
TL625B-15a - 100 feet southwest of entrance to road leading to Poles Z272866 through Z272869, looking northeast

TL625B-15e – Midway between Poles Z272866 and Z272867, rilling noted near existing pole slated for removal. Pad area to be restored through Habitat Restoration Plan

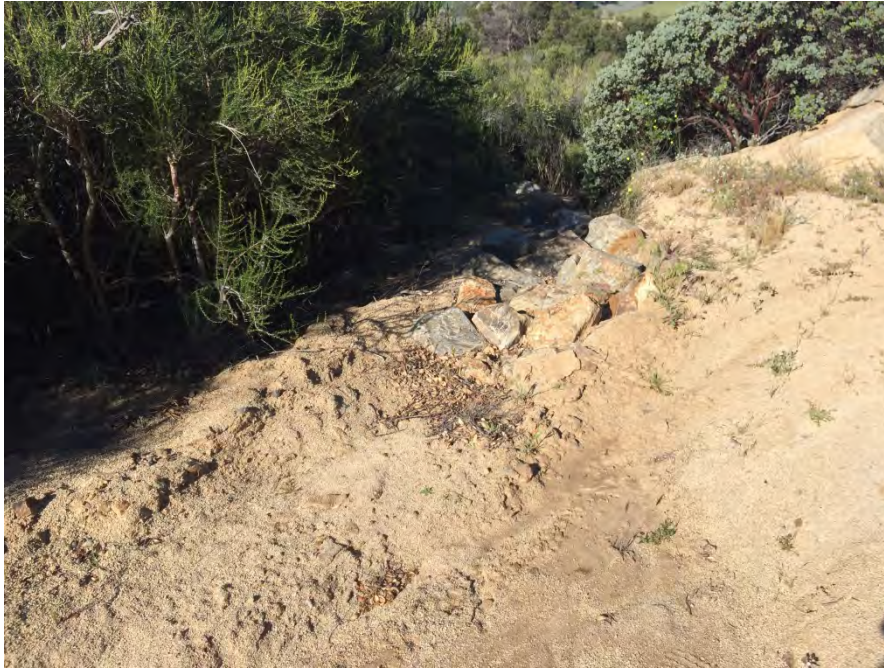
TL629E-02b – Sediment accumulation south of Z44164, to be cleaned up during construction

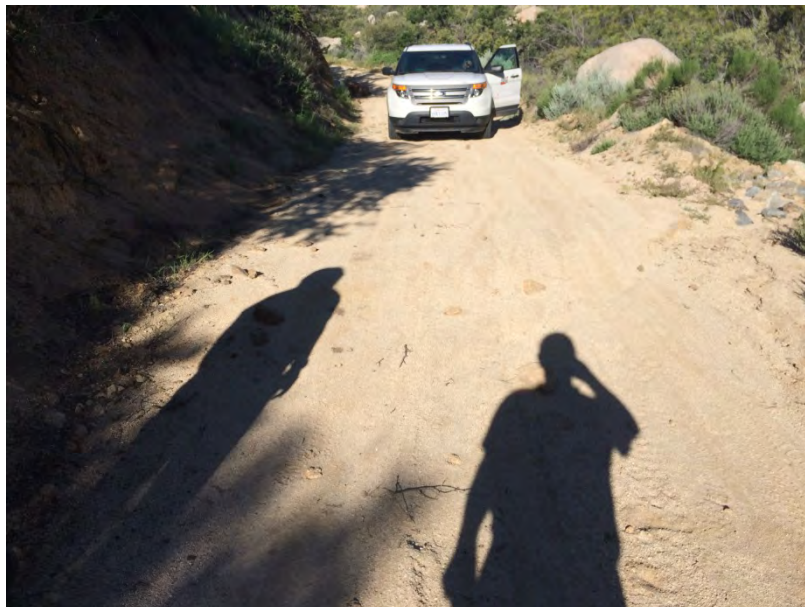
TL629E-03a - 300 feet east of Pole Z44165 looking west

32° 43' 06.00"N, 116° 26' 30.33"W	270 feet east of Pole Z44165	32° 43' 06.39"N, 116° 26' 28.28"W	490 feet east of Pole Z44165	No	No	Yes	No	TL629E-03a- TL629E-03c	2	Rilling noted on/across road approximately 18” wide by 4” deep. Water bars have been installed, but have failed. The waterbar on the east end/upstream end of the road segment should be reconstructed and the rip rap at the end of the waterbar should be lowered to allow runoff to exit the roadway. An additional waterbar should be installed near the center of the reach to minimize rilling potential in the future. The waterbars should be repaired during construction and maintained under SDG&E’s O&M program.
32° 43' 02.95"N, 116° 26' 03.23"W	40’ west of Pole Z44170	32° 43' 02.45"N, 116° 26' 01.62"W	160 feet southeast of Pole Z44170	No	No	Yes	No	TL629E-04a, TL629E-04b	4	Erosion was not noted along road reach. Waterbars have been installed and in general are functioning properly. However, during construction, additional rip rap shall be added at the outlet of waterbars to minimize future erosion and sediment transport.

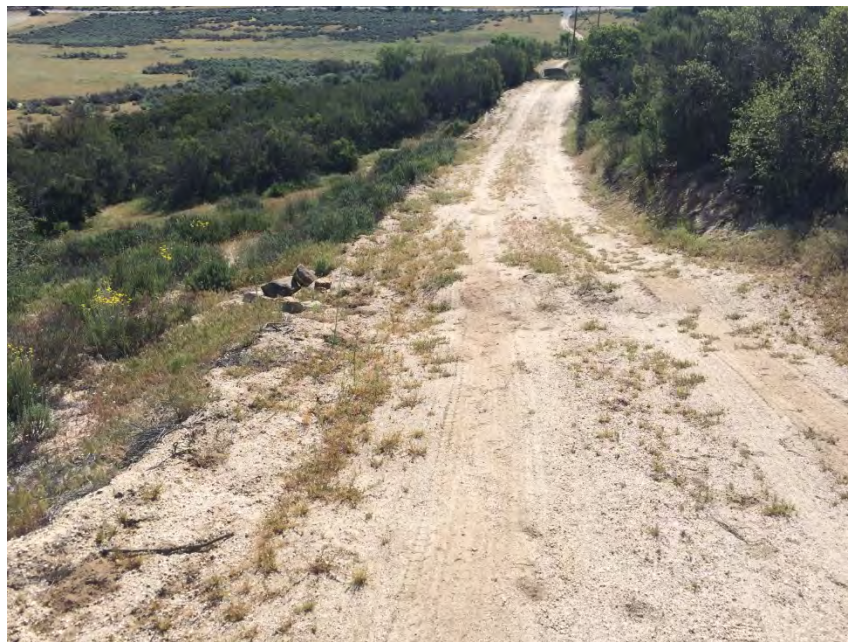
TL629E-04b – Along spur road to Pole Z44170 looking east, additional rock to be added to riprap

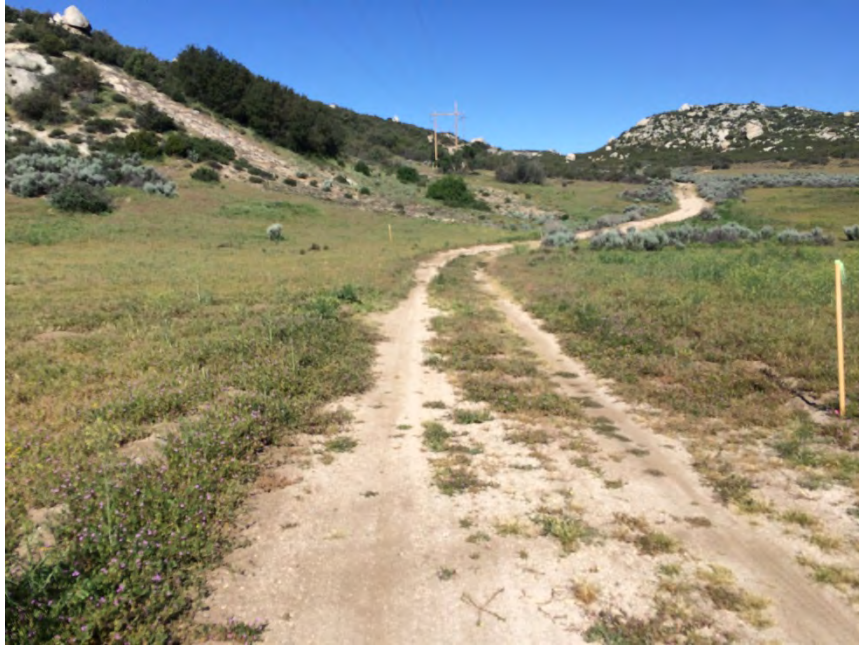
TL629E-05a - 470 feet east of spur road to Z44170 through Z44172 looking west

32°43'2.04"N, 116°25'54.03"W	150 feet east of spur road to Z44170 through Z44172	32°42'59.77"N, 116°25'46.95"W	La Posta Road crossing	No	Yes	N/A	No	TL629E-05a, TL629E-05b	N/A	Access road is generally flat and no erosion was noted.
32° 42' 54.44"N, 116° 25' 25.36"W	180 feet west of Pole Z44177	32° 42' 54.04"N, 116° 25' 24.00"W	60 feet west of Pole Z44177	No	No	Yes	No	TL629E-06	6	Minor rilling, approximately 6” wide and 2” deep, was noted along north side of the road. Waterbars have been installed and are functioning as designed.
32° 42' 53.10"N, 116° 25' 19.82"W	250 feet west of Pole Z44178-79	32° 42' 52.90"N, 116° 25' 18.76"W	100 feet west of Pole Z44178-79	No	No	Yes	No	TL629E-07a- TL629E-07c	7 (west portion)	Erosion was not noted along road reach. Waterbars have been installed and in general are functioning properly. Sediment accumulation was noted in riprap at the downstream end of waterbars and shall be cleaned up during construction and maintained under SDG&E’s O&M program.

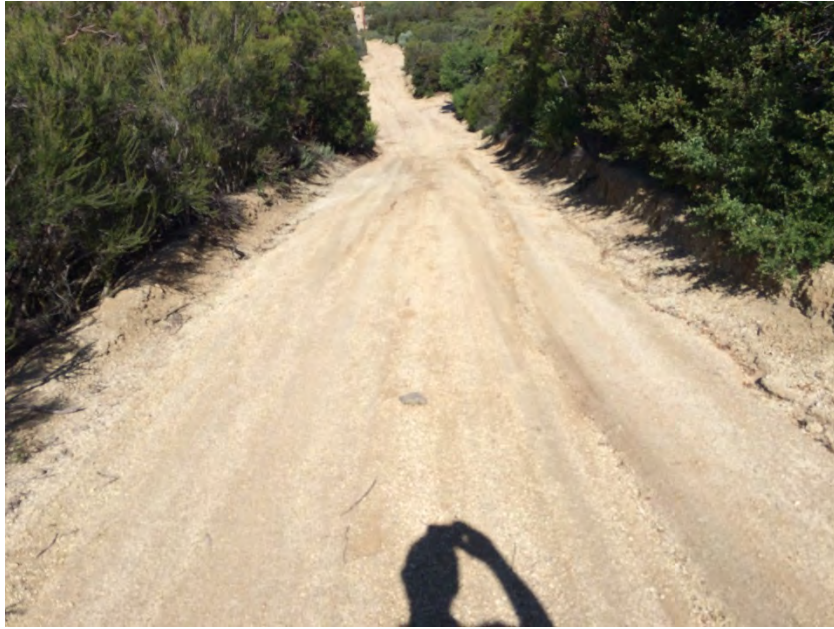
TL629E-06 - 60 feet west of Pole Z44177 looking west, minor rilling along north side of road

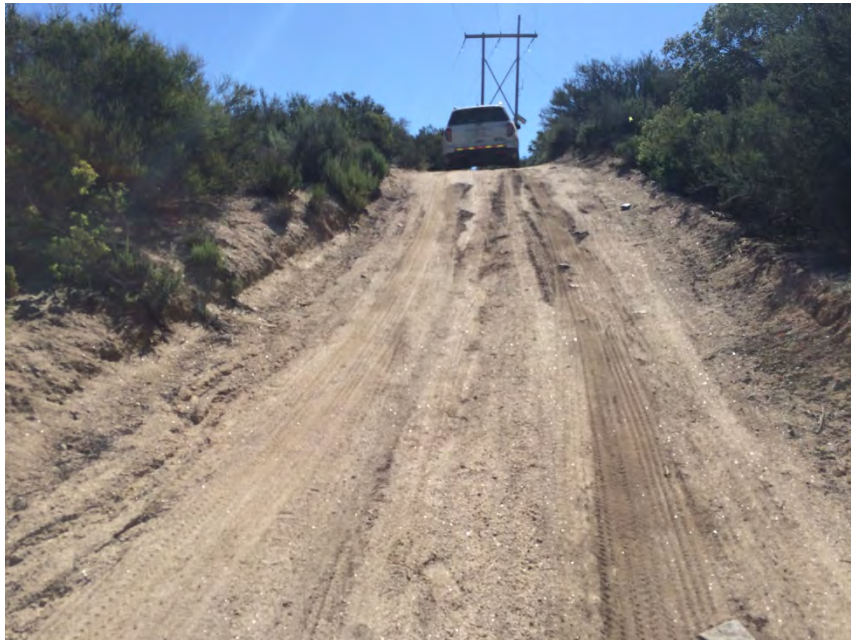
TL629E-07a - 250 feet west of Pole Z44178-79 looking east

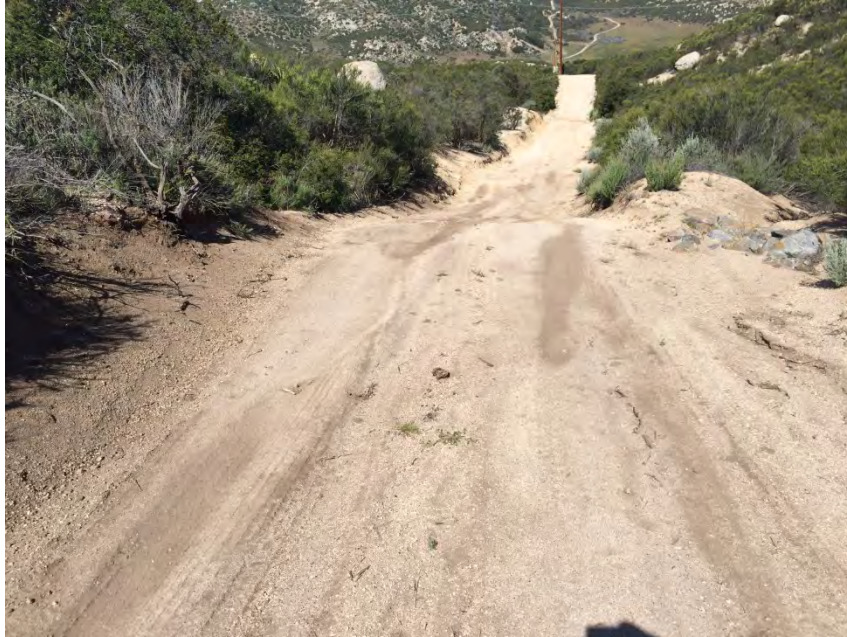
TL629E-07b - 135 feet west of Pole Z44178-79 looking west

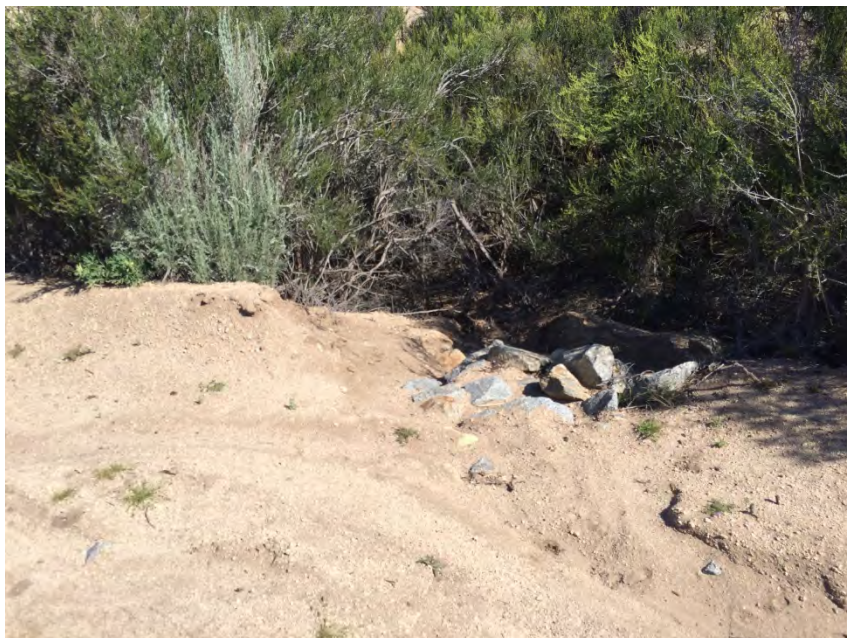
TL629E-07c - 100 feet west of Pole Z44178-79, sediment accumulation in riprap to be cleaned out

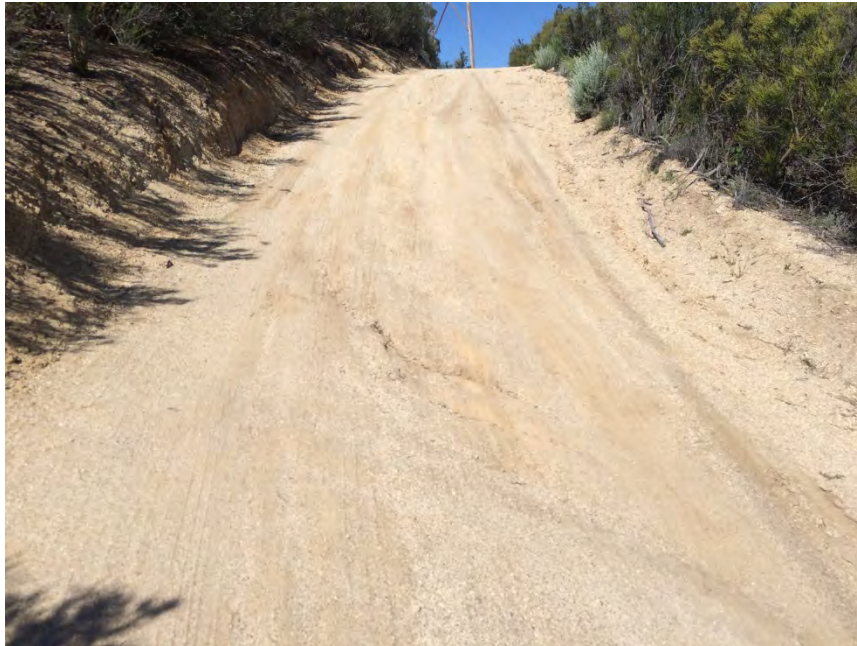
TL629E-08a - 55 feet west of Pole Z44180-81 looking east, minor rilling across the road

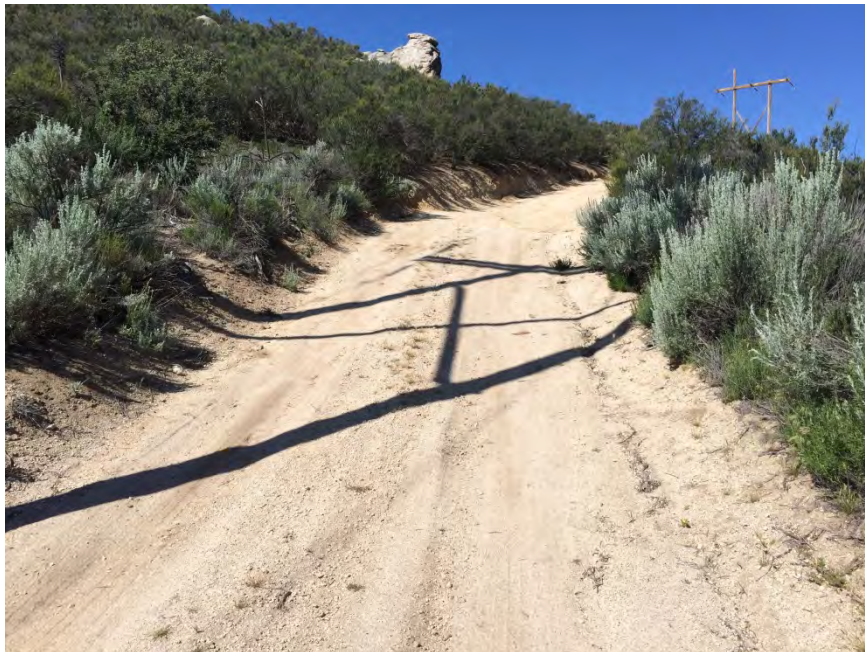
TL629E-08b - Near Pole Z44180-81 looking east

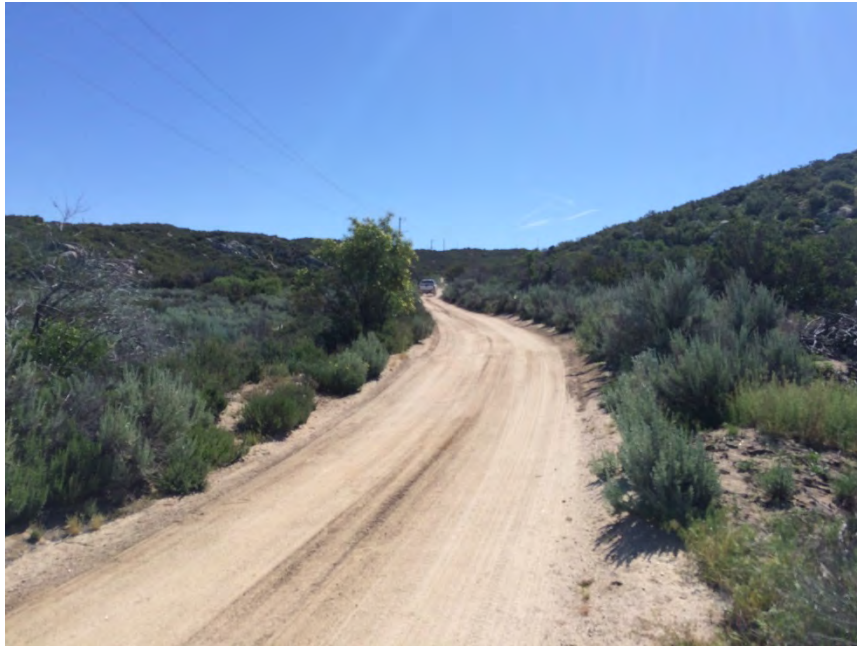
TL629E-09a - Near Pole Z44182-83 looking east

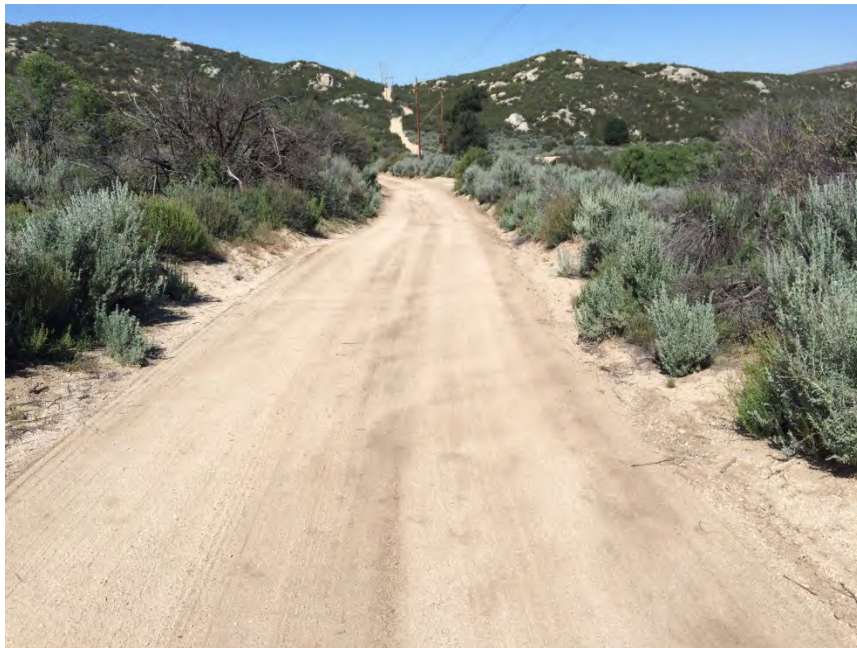
TL629E-09b – 60 feet west of Pole Z44184 looking west

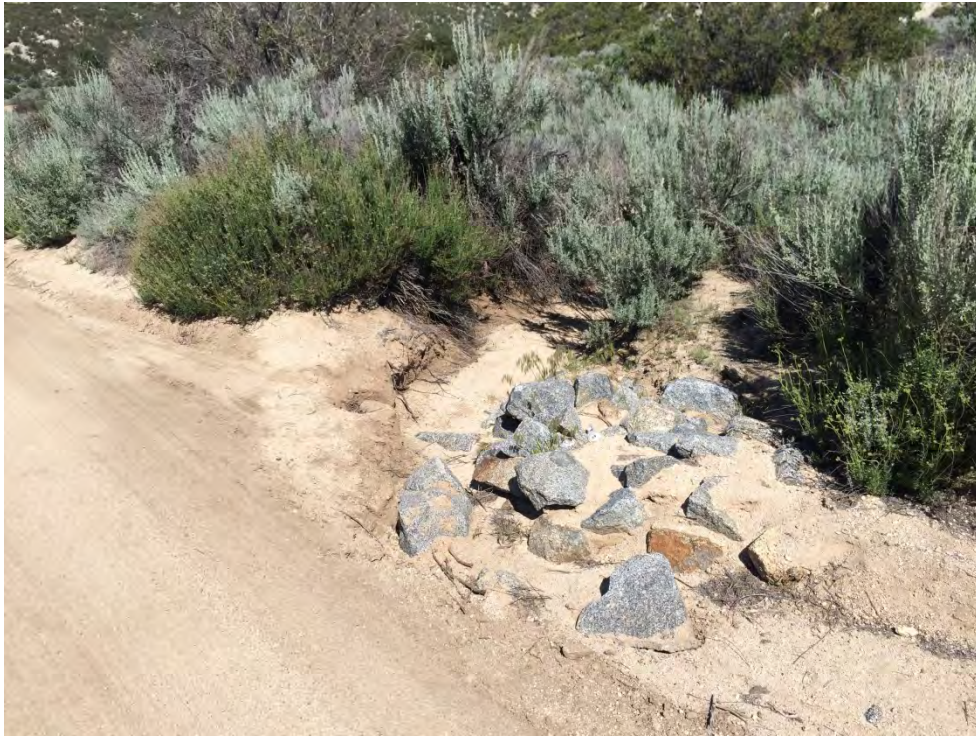
TL629E-09c – 60 feet west of Pole Z44184, rilling at outlet from riprap

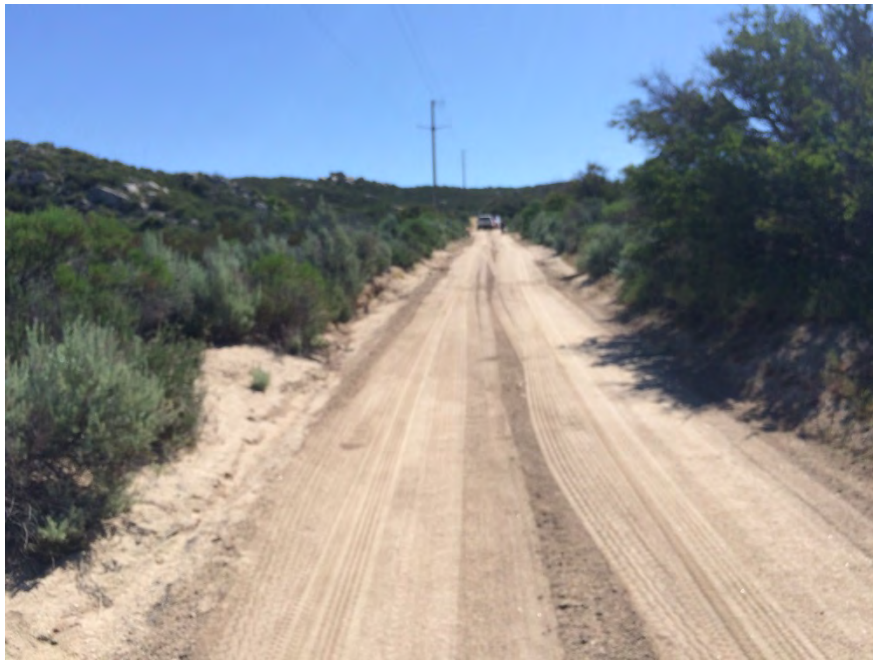
TL629E-09d – 100 feet east of Pole Z44184 looking east

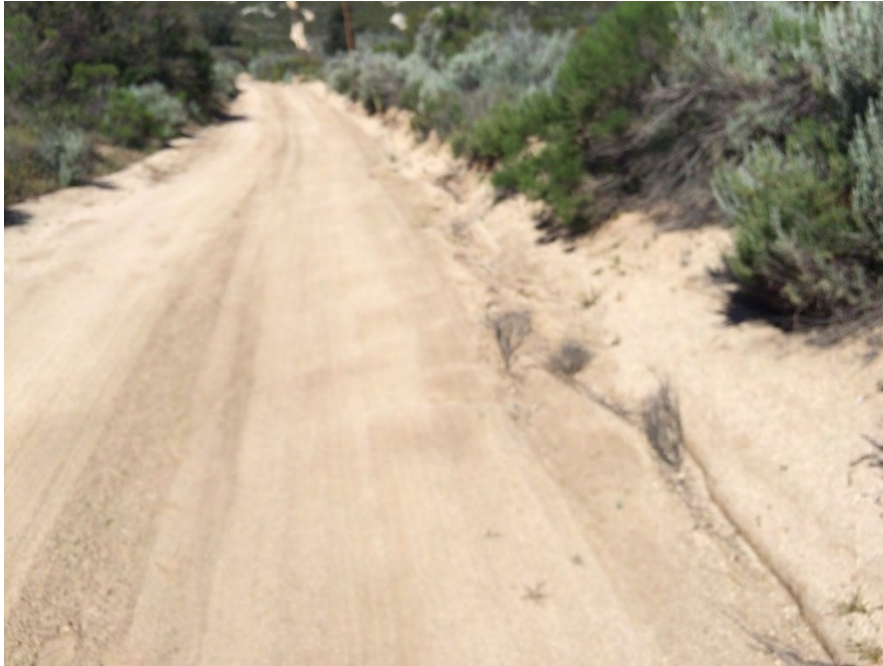
TL629E-09e - 200 feet east of Pole Z44184 looking west, minor rilling along north side of the road

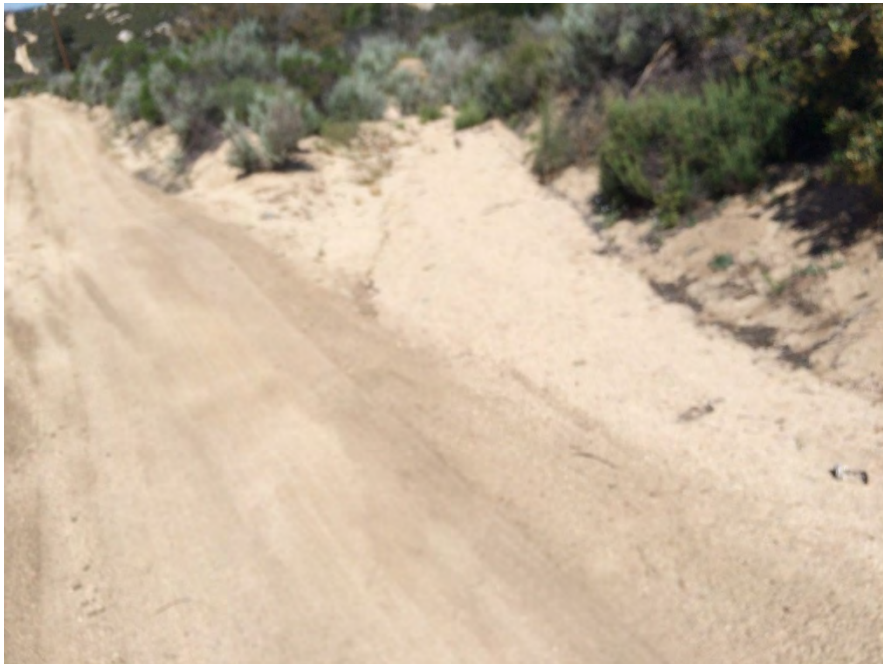
TL629E-09f - 50 feet east of Pole Z44185 looking west, sediment accumulation at outlet point from road

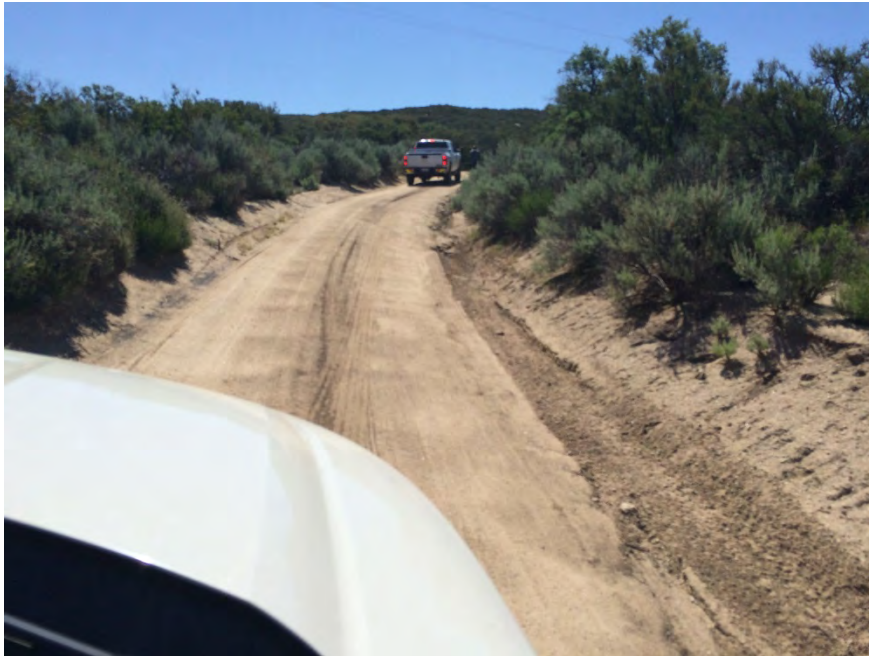
TL629E-09g - 280 feet east of Pole Z44185 looking east

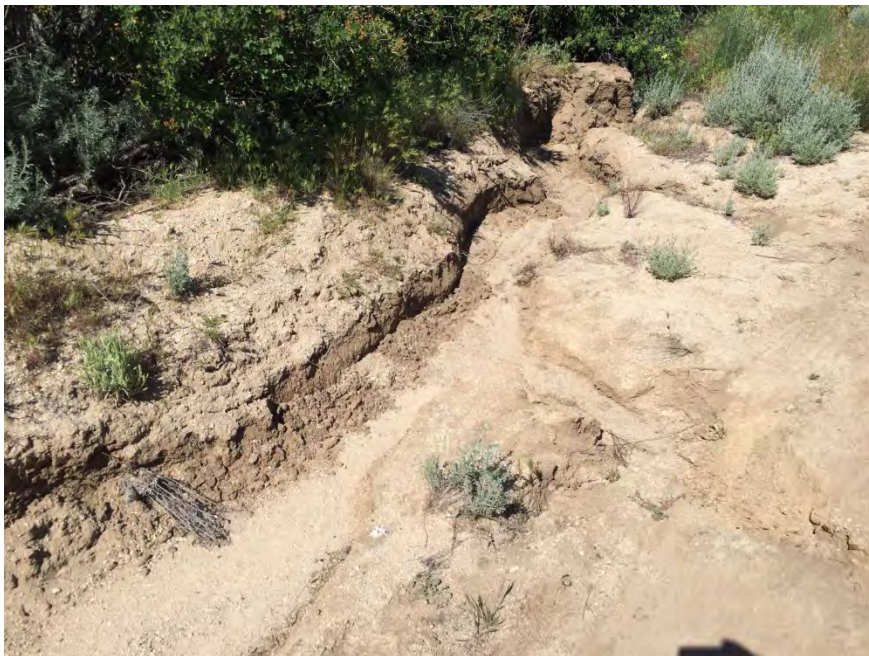
TL629E-09h - 420 feet southeast of Pole Z44186 looking west, incised area at intersection with dirt road, riprap to be added

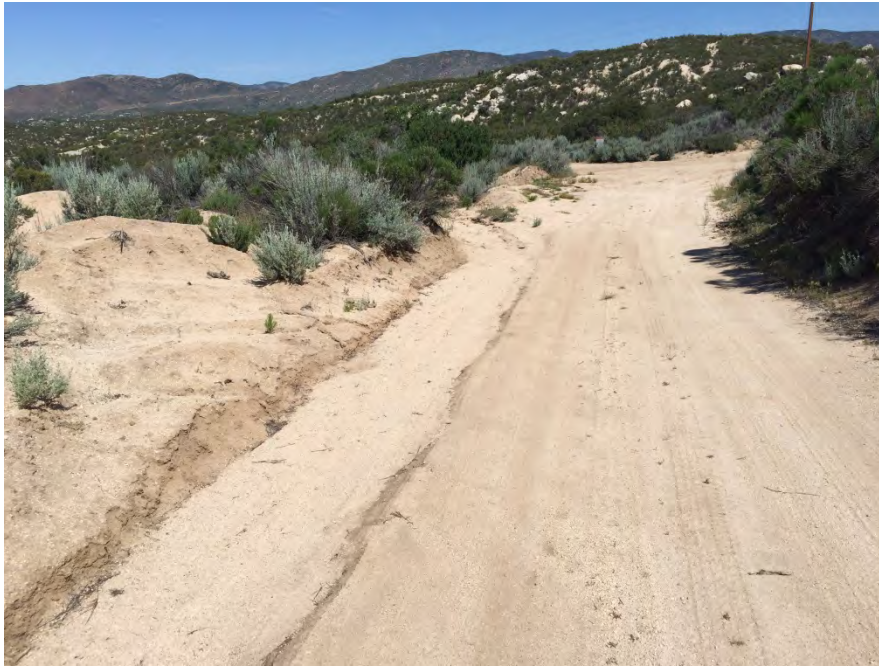
32°42'50.90"N, 116°24'50.11"W	At intersection with non-SDG&E dirt road	32°42'42.18"N, 116°24'46.82"W	75 feet south of Pole Z44188	No	Yes	N/A	No	TL629E-10a- TL629E-10g	N/A	Rilling was noted along the west side of road, approximately 18 inches wide by 4 inches deep for approximately 200’, and rilled area has accumulated with sediment. Sediment should be cleaned out during construction and velocity check dams should be installed within rilled area prior to heavy rain events during construction. 140 feet north of Pole Z44187, runoff crosses roadway, causing an approximate 8” wide by 4” deep rill. Surface runoff and associated rilling can be alleviated by reconstructing waterbar located near Pole Z44187. Waterbars should be maintained under SDG&E’s O&M program.

TL629E-10a - 130 feet south of intersection with non-SDG&E dirt road looking north, sediment accumulation within rilled area at west side of road. Sediment to be cleaned out, velocity check dams to be added

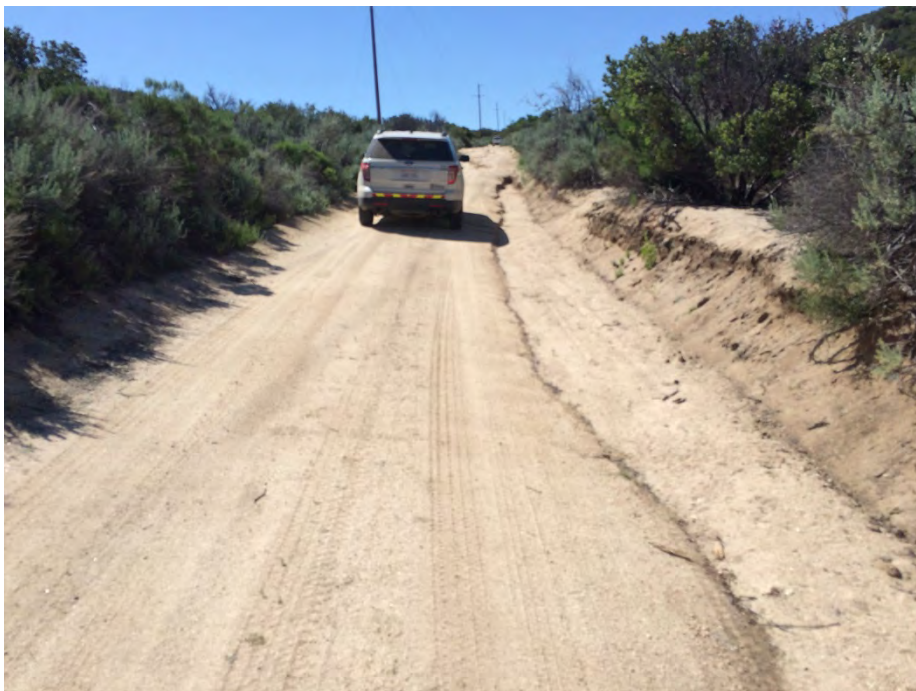
TL629E-10b - 130 feet south of intersection with non-SDG&E dirt road looking south

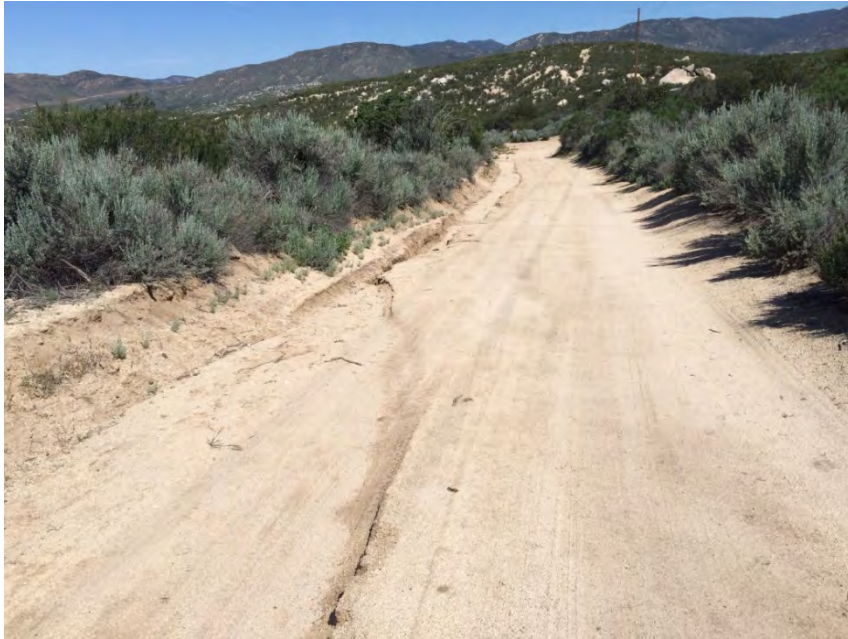
TL629E-10c - 140 feet north of Pole Z44187 looking north

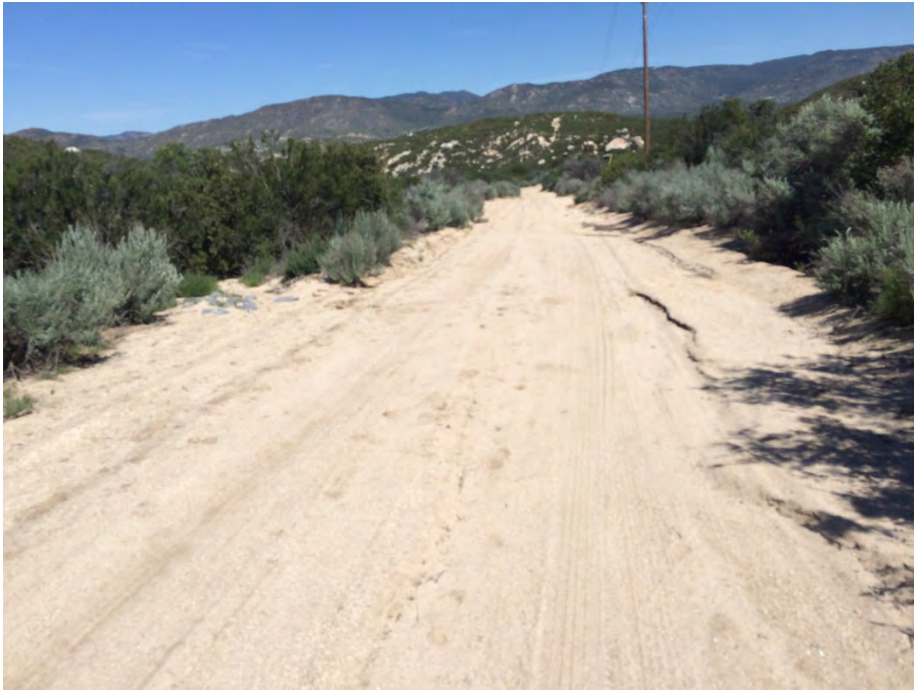
TL629E-10e - 195 feet south of Pole Z44187 looking north

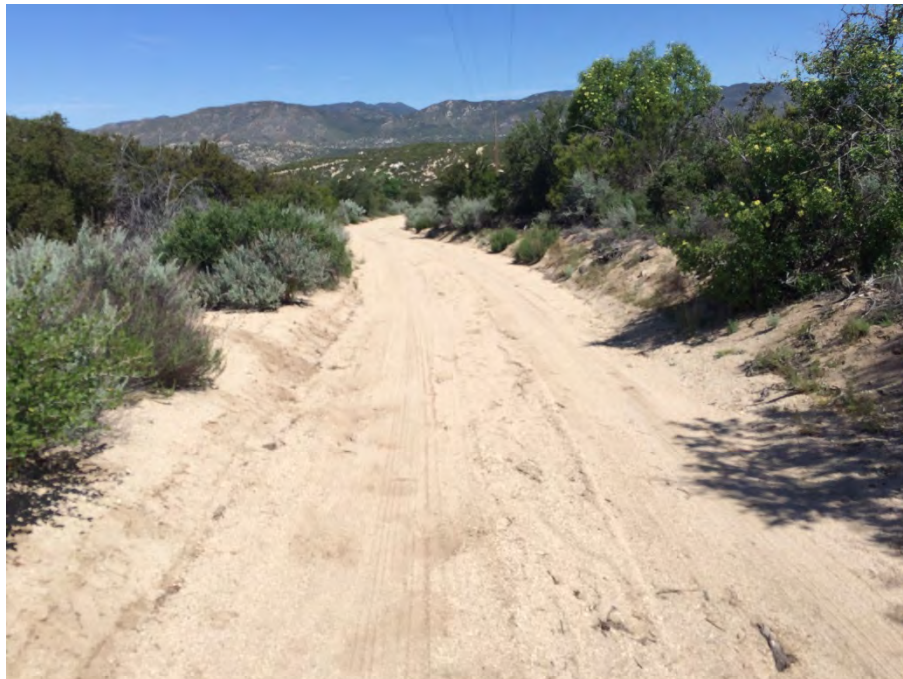
TL629E-10f - 55 feet north of Pole Z44188 looking north

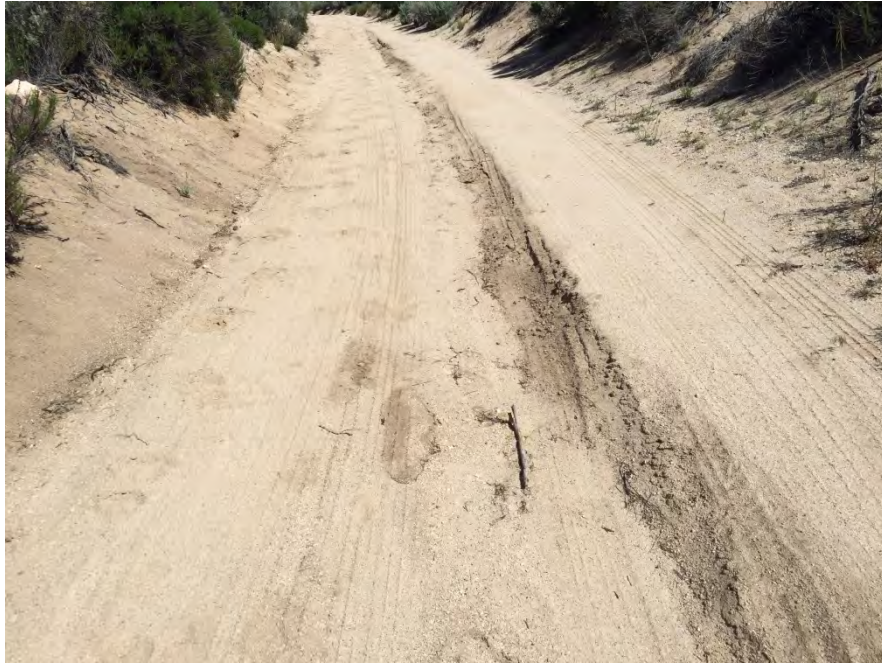
TL629E-10g - 80 feet south of Pole Z44188 looking north

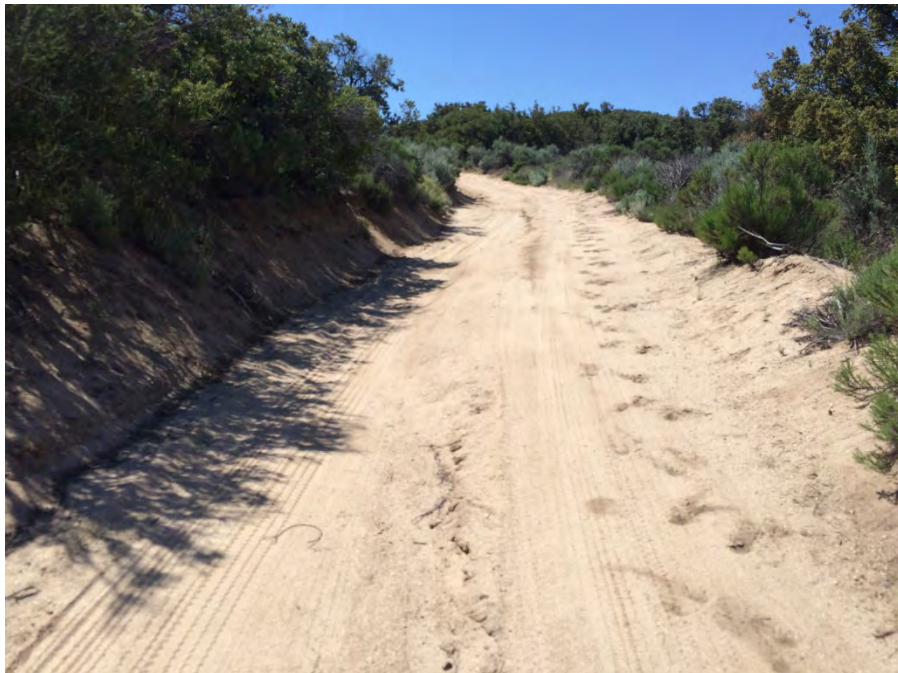
TL629E-11a - 80 feet south of Pole Z44188 looking south

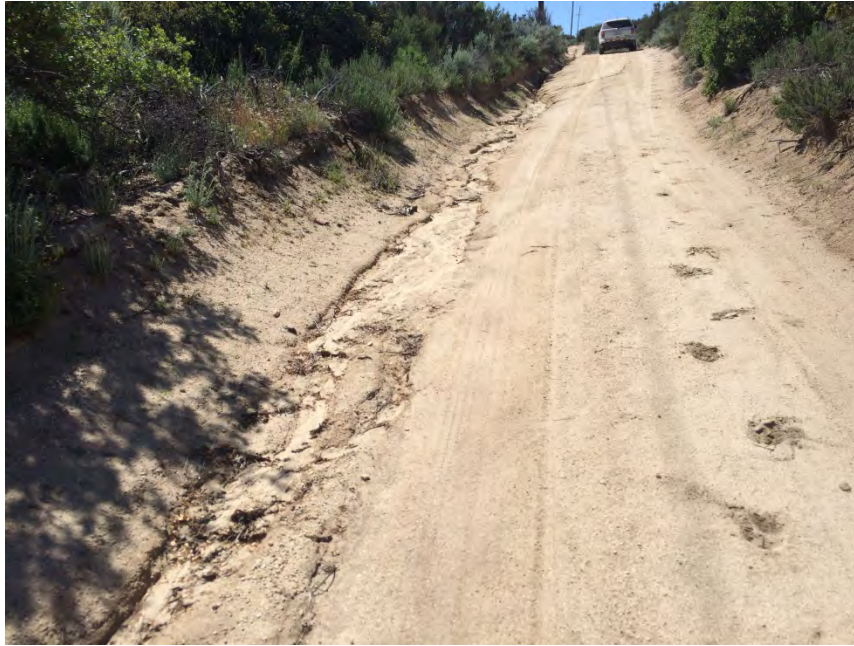
TL629E-11b - 220 feet north of Pole Z44189 looking south

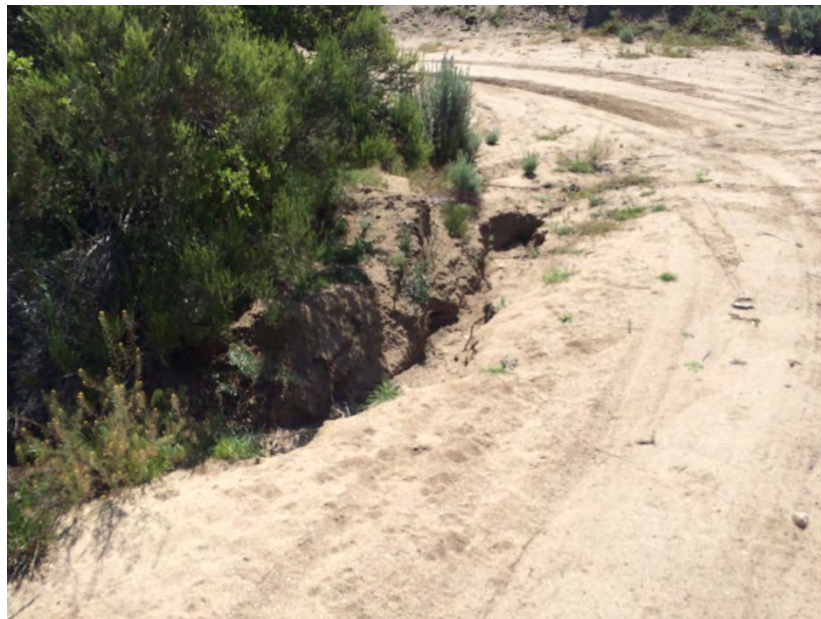
TL629E-11c – Incised area near intersection with dirt road 75' south of Pole Z442189, riprap to be added to incised area

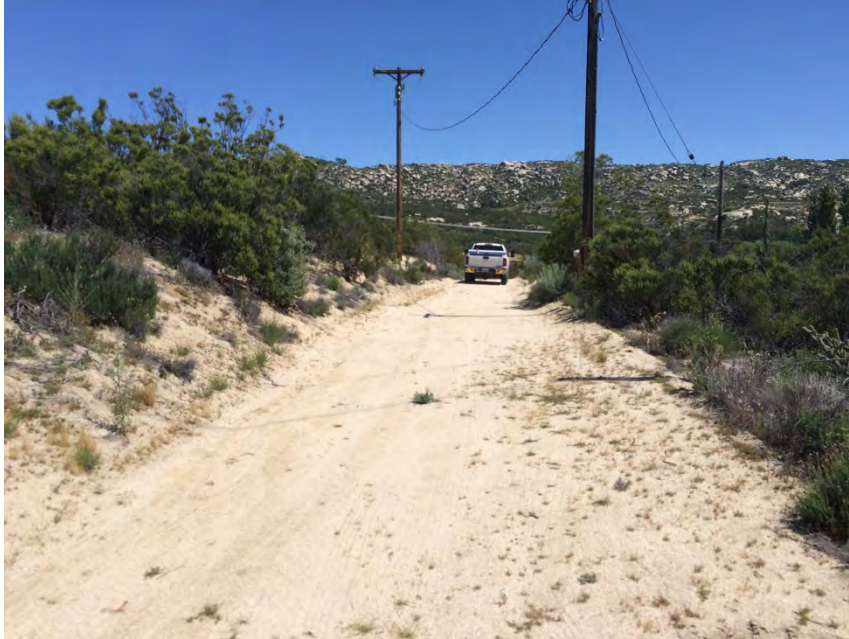
32°42'10.03"N, 116°23'55.65"W	Pole Z44209	32°42'9.97"N, 116°23'53.56"W	140 feet southeast of Pole Z44210-11	No	Yes	N/A	No	TL629E-12a- TL629E-12d	N/A	Erosion along the road was not noted within this road reach. However, at the waterbar located approximately 365’ northeast of Pole Z44209, erosion was noted at the waterbar riprap in the form of minor rilling, approximately 2” deep, in the approach to the riprap and bank incision approximately 12” deep immediately downstream of the riprap. Additional riprap shall be added at the waterbar during construction and maintained under SDG&E’s O&M program.
32° 42' 05.27"N, 116° 22' 21.95"W	Z44220	32° 42' 04.58"N, 116° 22' 21.15"W	Through gully toward Pole Z44221-22	No	No	Yes	No	TL629E-13a- TL629E-13c	17	Although the access road is quite steep in this road reach, road is comprised of rockier material which is preventing the occurrence of erosion.
32° 41' 55.90"N, 116° 21' 24.87"W	East limit of pad for Z44232	32° 41' 55.51"N, 116° 21' 23.08"W	West limit of pad for Z100145	No	No	Yes	No	TL629E-14a- TL629E-14d	21	Multiple rills noted along center of road, up to 18 inches wide by 8 inches deep. This section of roadway is slated to be removed from service and restored through implementation of the Habitat Restoration Plan.

TL629E-12a - Near Pole Z44209 looking northeast

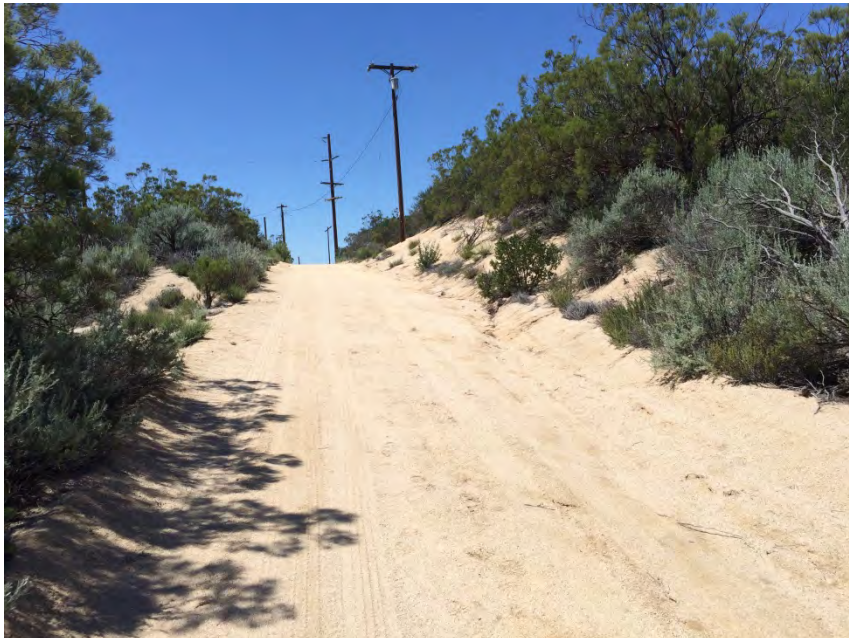
TL629E-12b – 330 feet northeast of Pole Z44209 looking southwest

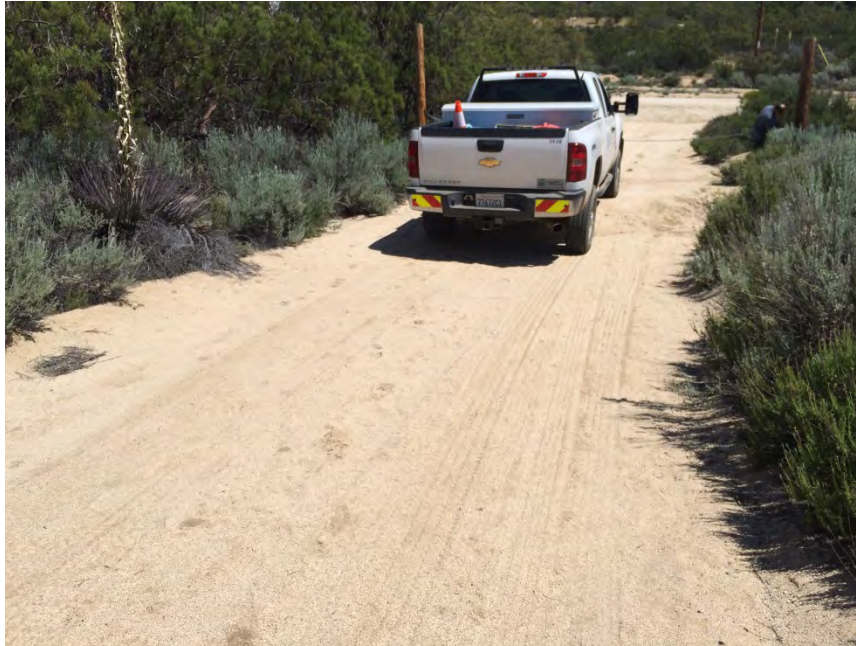
TL629E-12c – 330 feet northeast of Pole Z44209 looking northeast

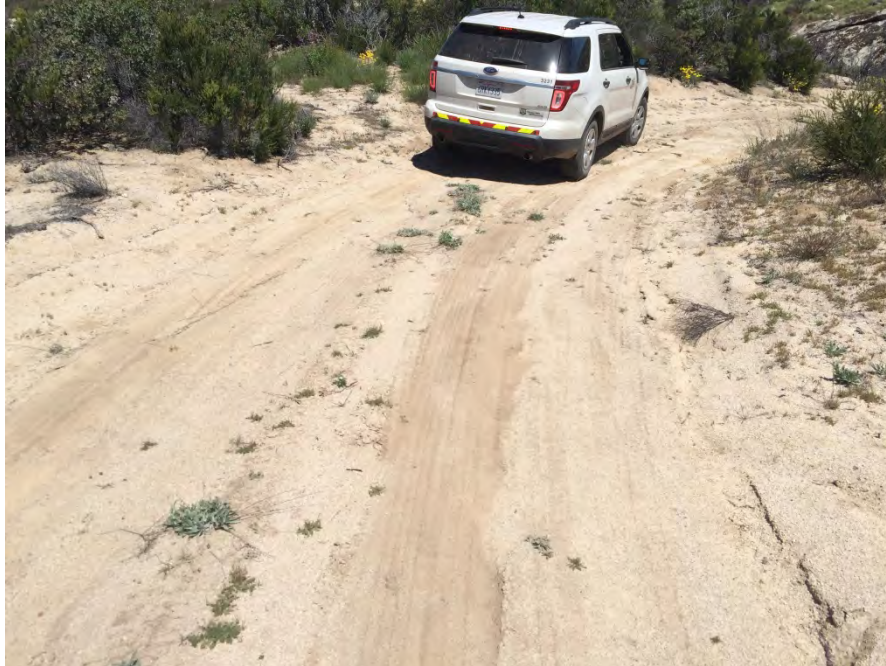
TL629E-13a – 60 feet north of Pole Z44220 looking east at entrance toward gully

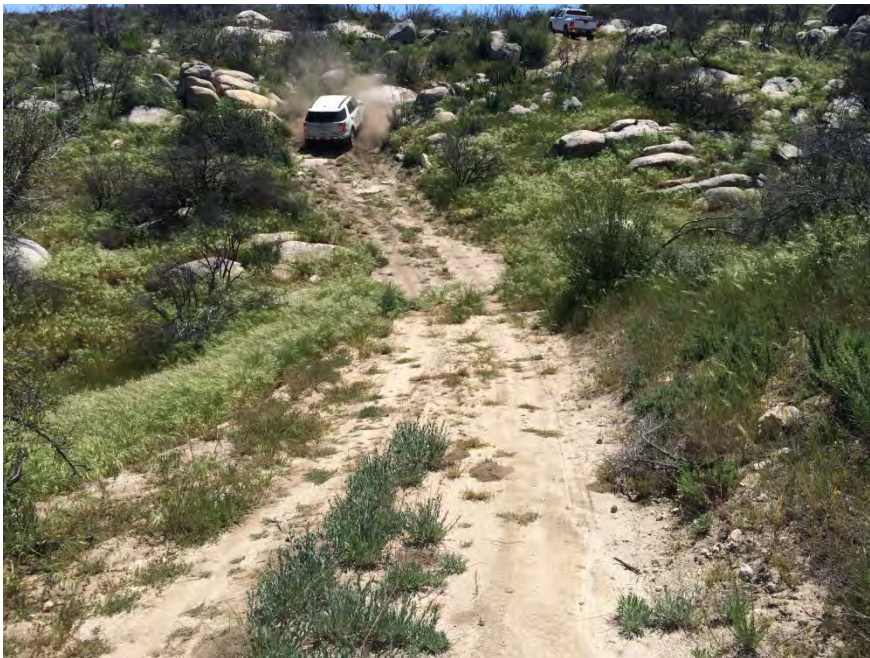
TL629E-13b – 130 feet east of Pole Z44220 looking southeast into gully

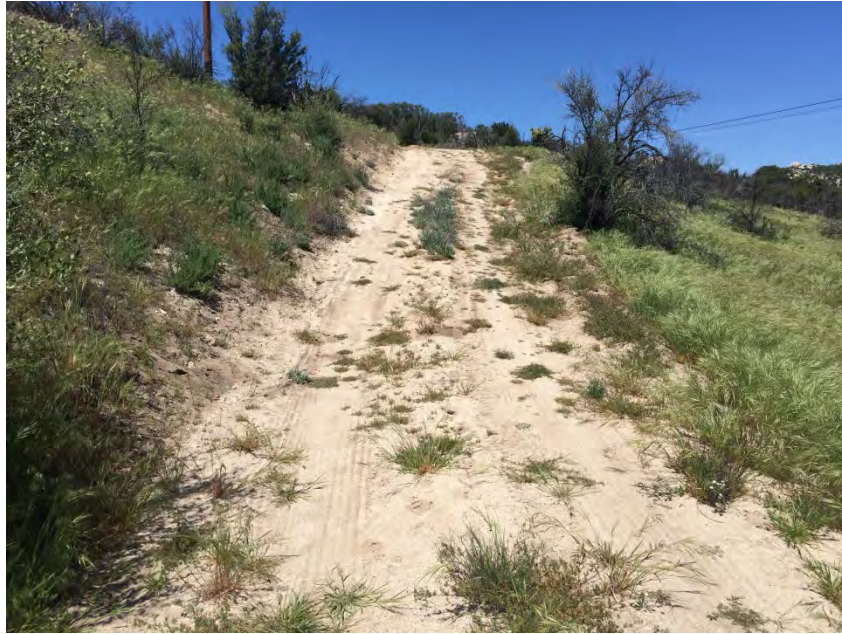
TL629E-13c – 180 feet east of Pole Z44220 looking southeast up from gully

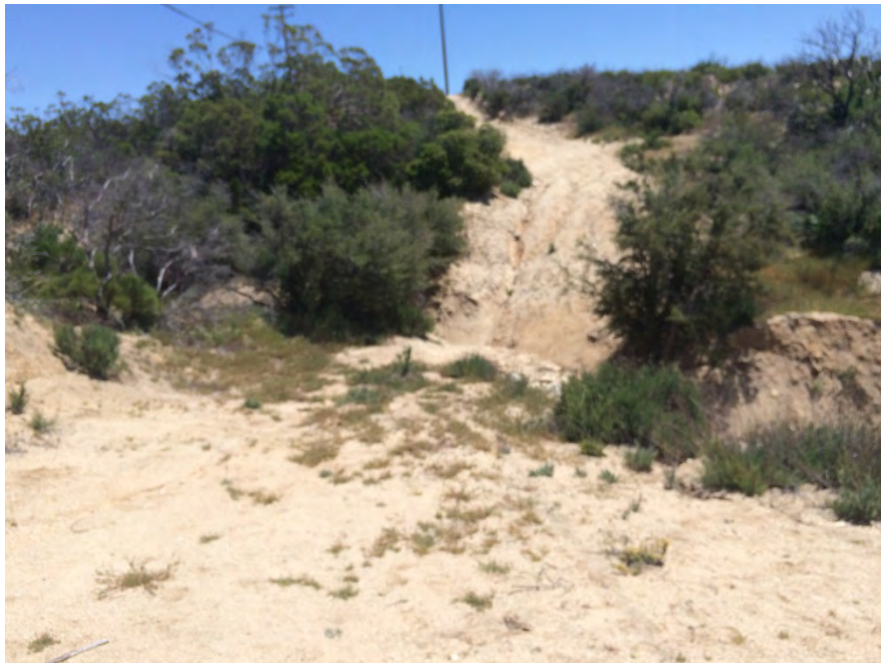
TL629E-14a – East limit of pad for Pole Z44232 looking east into gully
