**SAN DIEGO GAS & ELECTRIC COMPANY  
CLEVELAND NATIONAL FOREST  
POWER LINE REPLACEMENT PROJECTS  
ACCESS ROAD CONDITION EVALUATION AND  
REPAIR DESIGN REPORT**

**DECEMBER 2016**

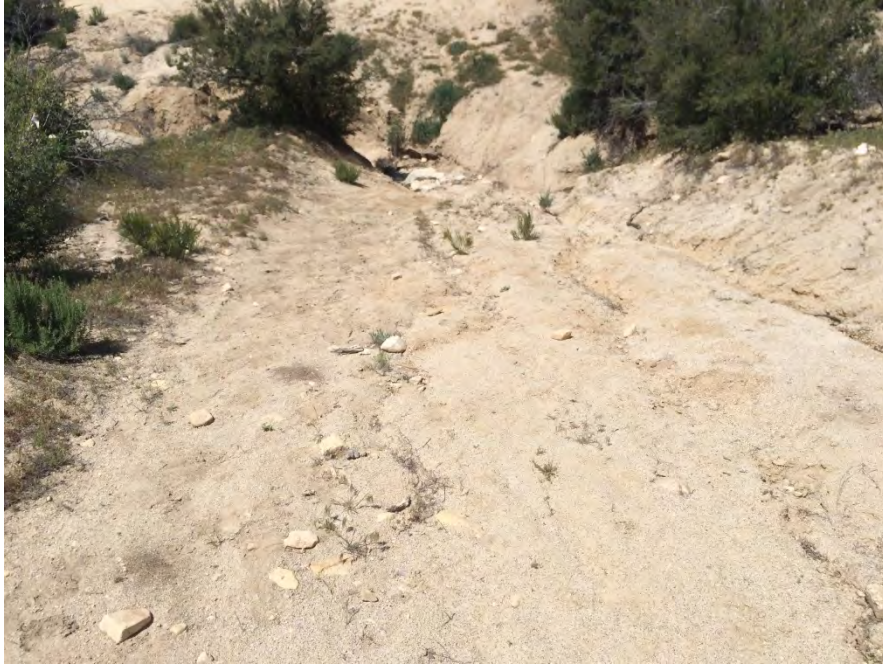
TL629E-14b – 115 feet east of Pole Z44232 looking west into gully

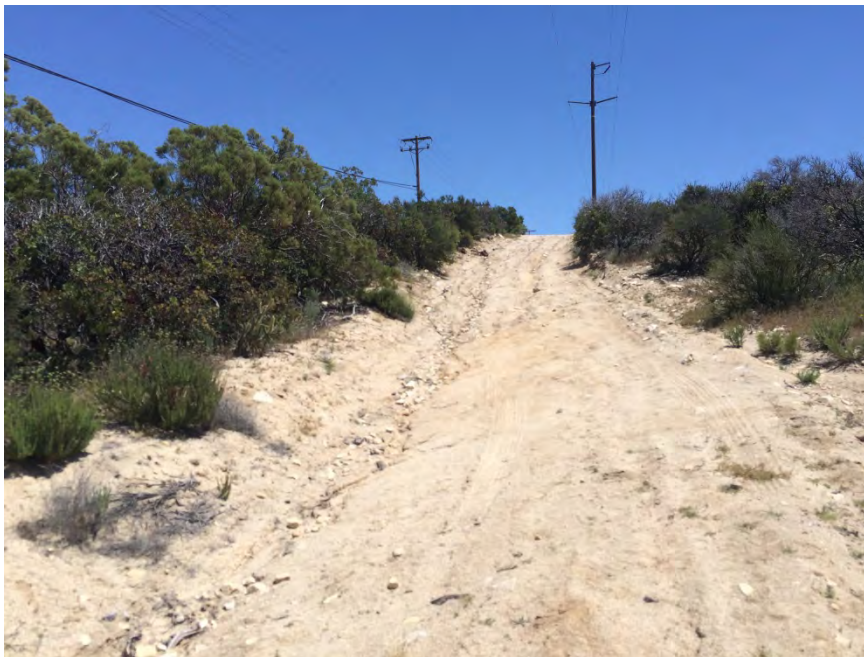
TL629E-14c – 115 feet east of Pole Z44232 looking east

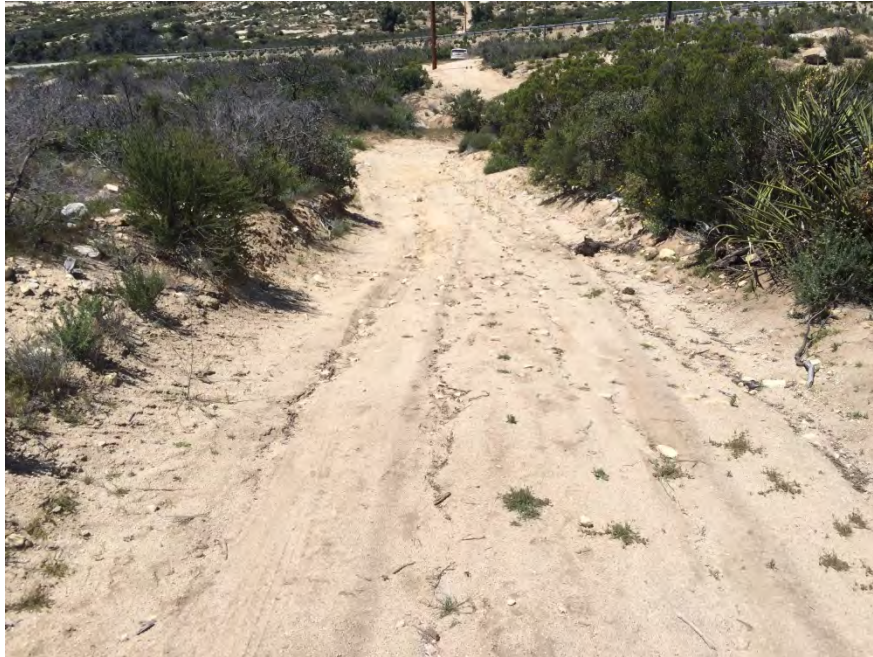
TL629E-14d – 70 feet west of Pole Z100145 looking west

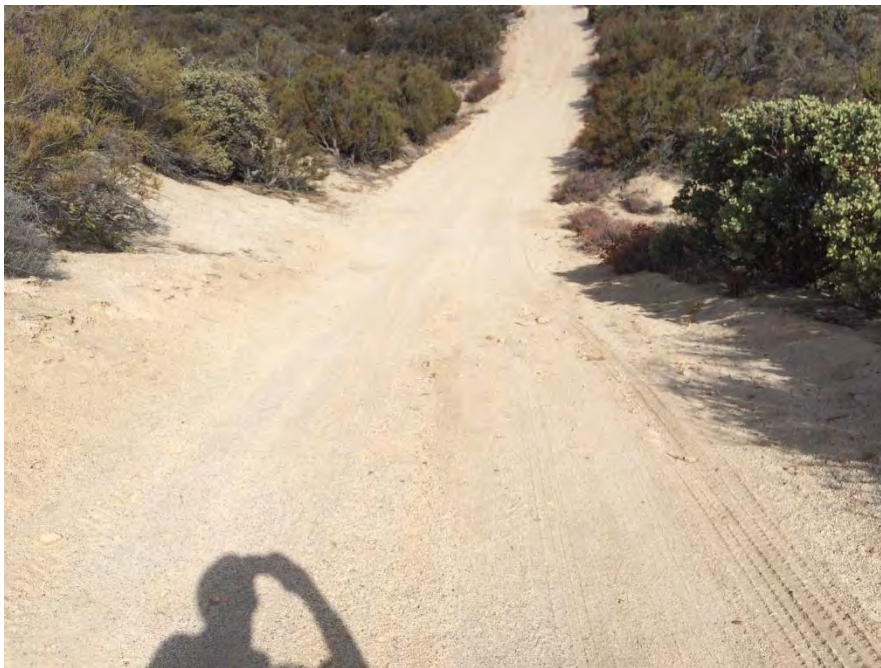
TL6931-02b - 170 feet northwest of Pole Z44243 looking northwest

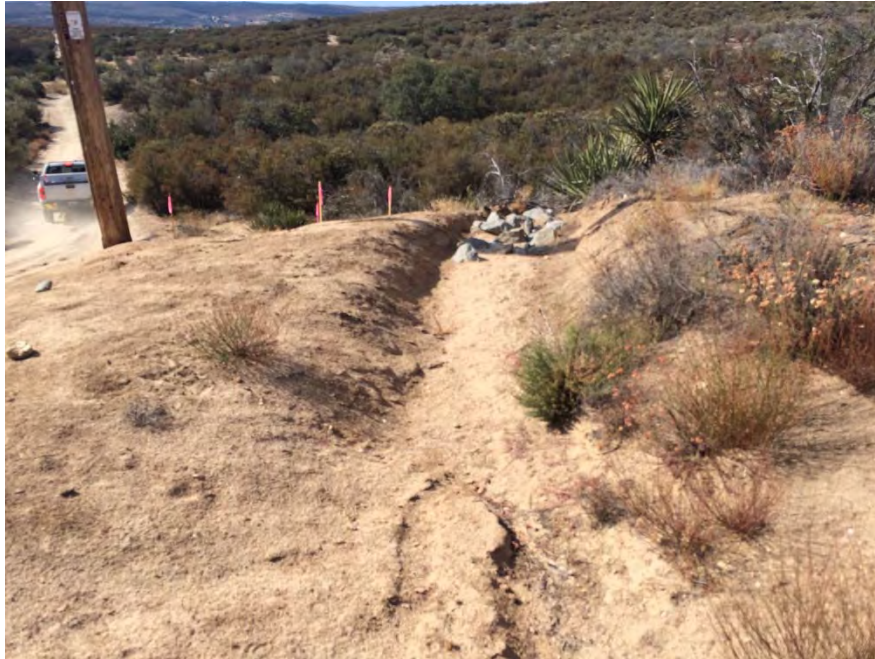
32° 41' 26.14"N 116° 20' 39.43"W	30' North West of Z44244	32° 41' 25.43"N 116° 20' 38.92"W	40' South West of Z44244	No	No	Yes	No	TL6931-03a, TL6931-03b	7	Minor rilling noted, approximately 4” deep and 6” wide. The waterbar and rip rap installed at the top of the slope are functional and in good condition.
32° 41' 06.19"N 116° 20' 35.65"W	Approximately 1,000' West Z44248, near point where road turns south	32° 41' 05.21"N 116° 20' 35.33"W	105' South of start point	No	No	Yes	No	TL6931-04a, TL6931-04b	10	Minor rilling noted, approximately 6” deep and 12”-18” wide. The waterbar in advance of road reach is installed and functioning as designed.
32° 41' 07.72"N 116° 20' 24.79"W	85' South of Z44248	32° 41' 05.58"N 116° 20' 23.79"W	320' South Z44248, 40' North of Dirt Road intersection	No	No	Yes	No	TL6931-05a, TL6931-05b	11	Minor rilling, approximately 2” deep and 6” wide was noted on the east side of the road. Waterbars installed at the top and bottom of the slope are in good condition and functional. Sediment accumulation is occurring at the lower waterbar and should be removed during construction and maintained under SDG&E’s O&M program.

TL6931-03a – Near Pole Z44244 looking southeast, waterbar at top of hill upstream of evaluated area in good condition

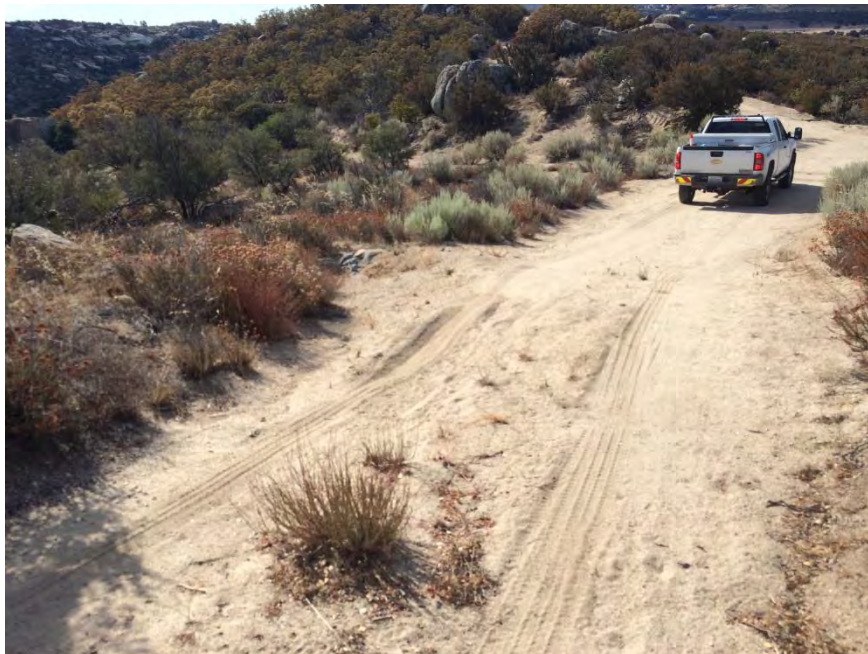
TL6931-05b - 310 feet south of Pole Z44248 looking south, functioning waterbar noted

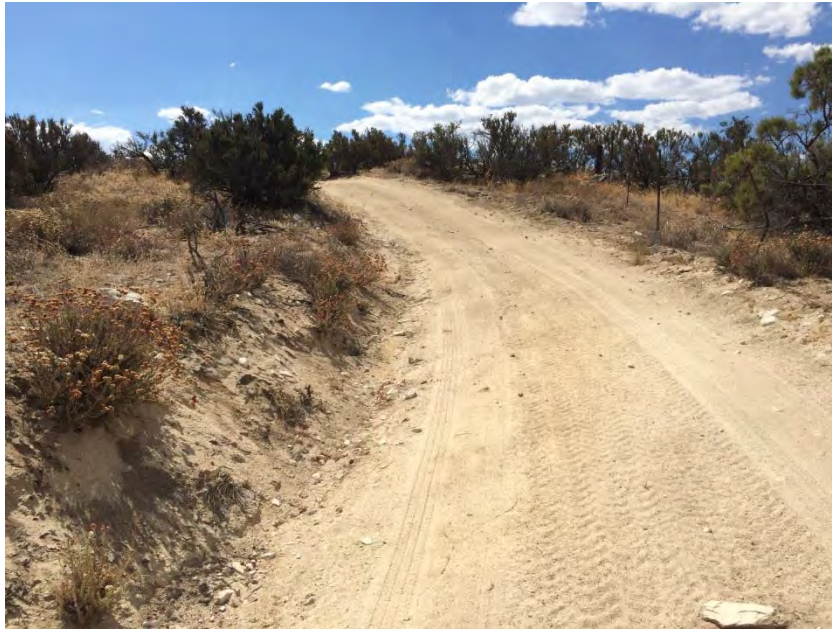
TL6931-08a - Along access road parallel to and 180 feet east of Tierra del Sola Road, 430' south of southerly turn in road, looking south, road in good condition

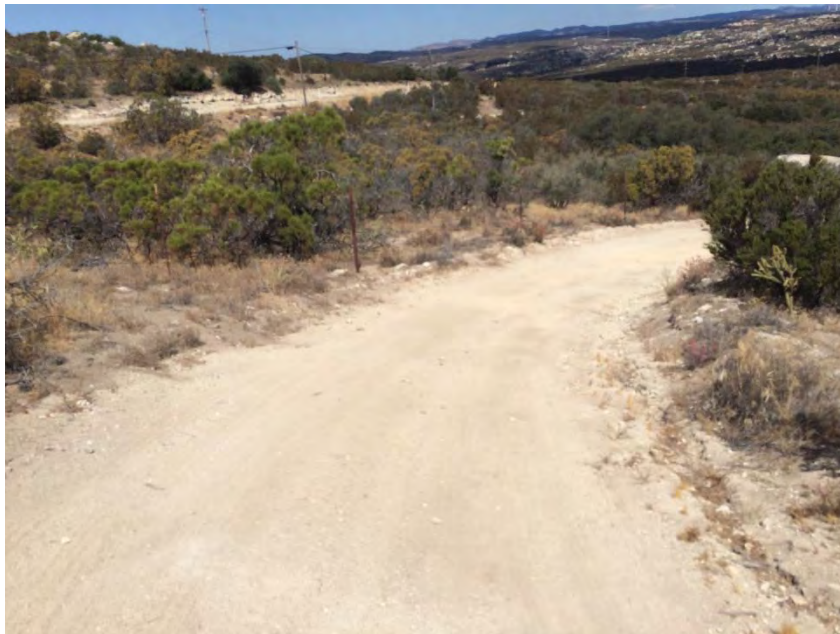
TL6931-08b - Along access road parallel to and 180 feet east of Tierra del Sola Road, 500' south of southerly turn in road, looking north, road in good condition

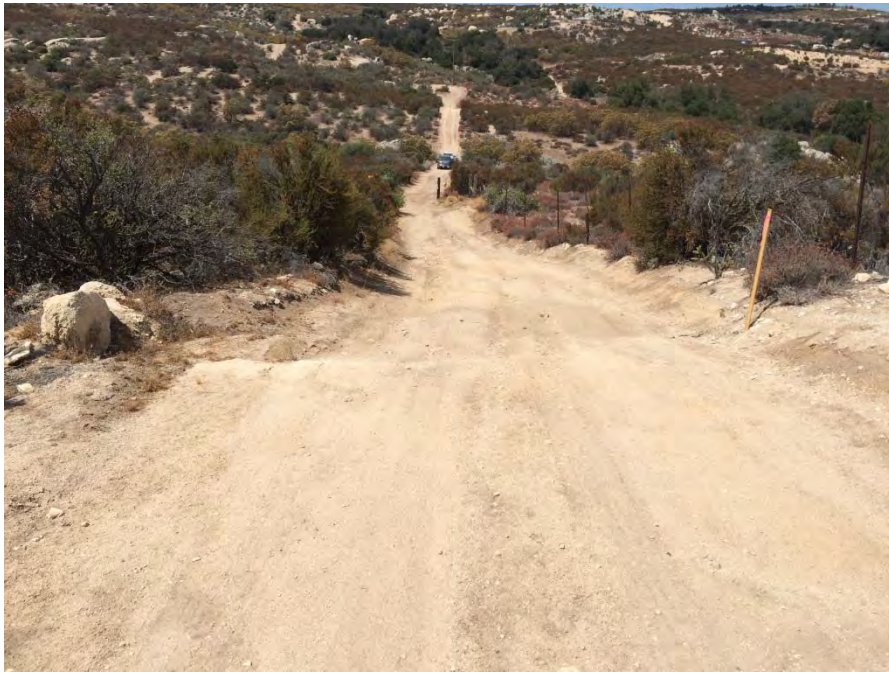
TL6931-10a - Near Pole Z44244 Z44284\_85 looking west

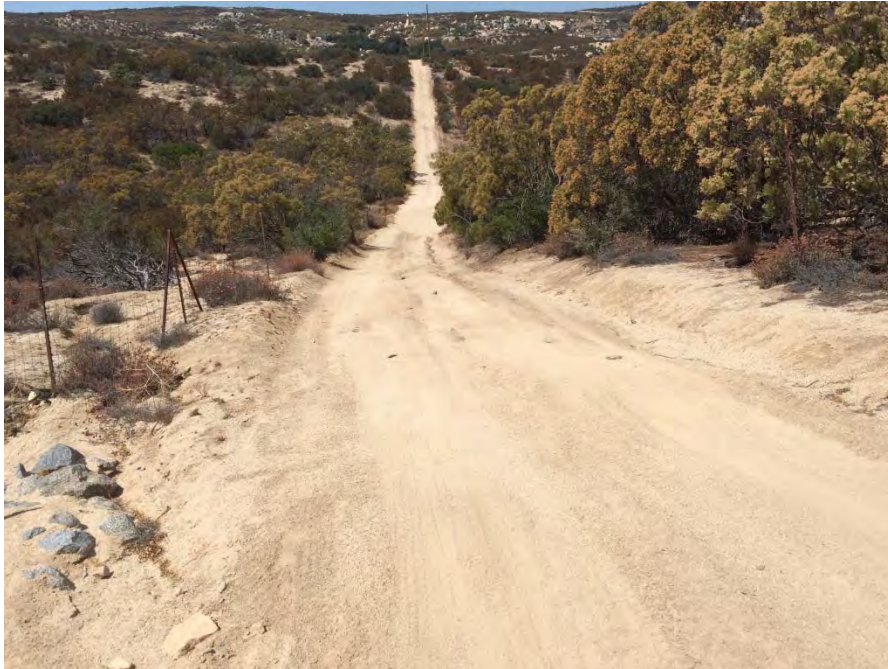
TL6931-11b - 65 feet west of Pole Z44281 looking west, minor rill along north side of road

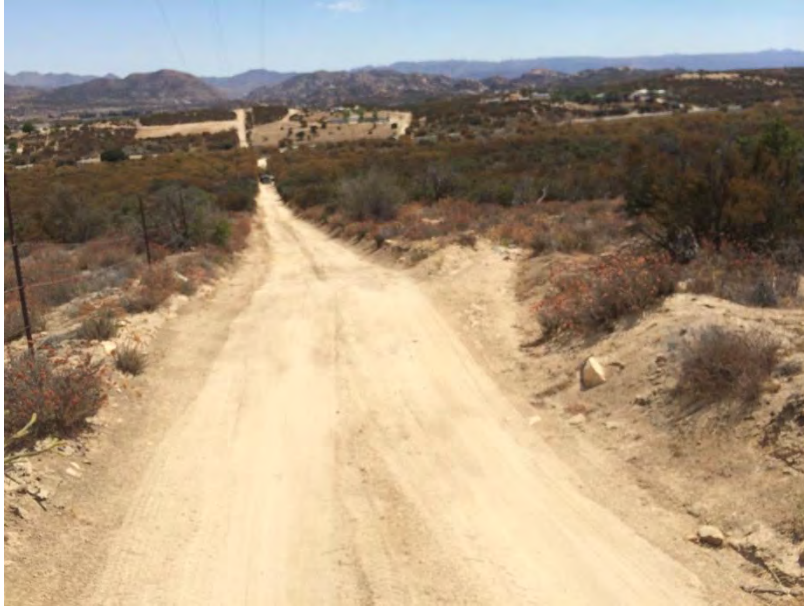
TL6931-12a - 50 feet east of Pole Z44281 looking east, road in good condition

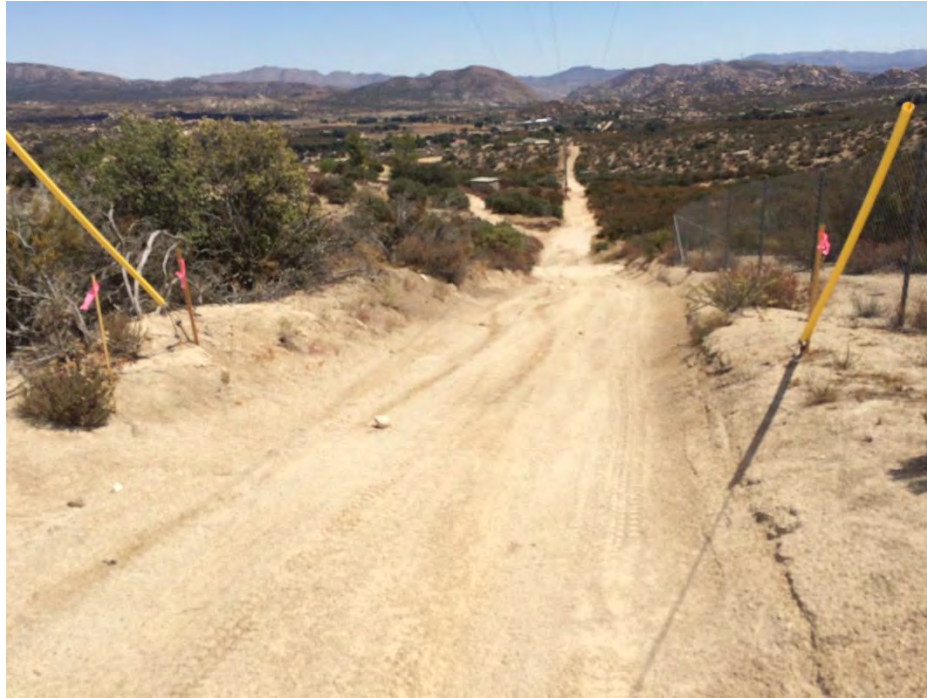
TL6931-13b - At Pole Z44284\_85 looking west, road in good condition

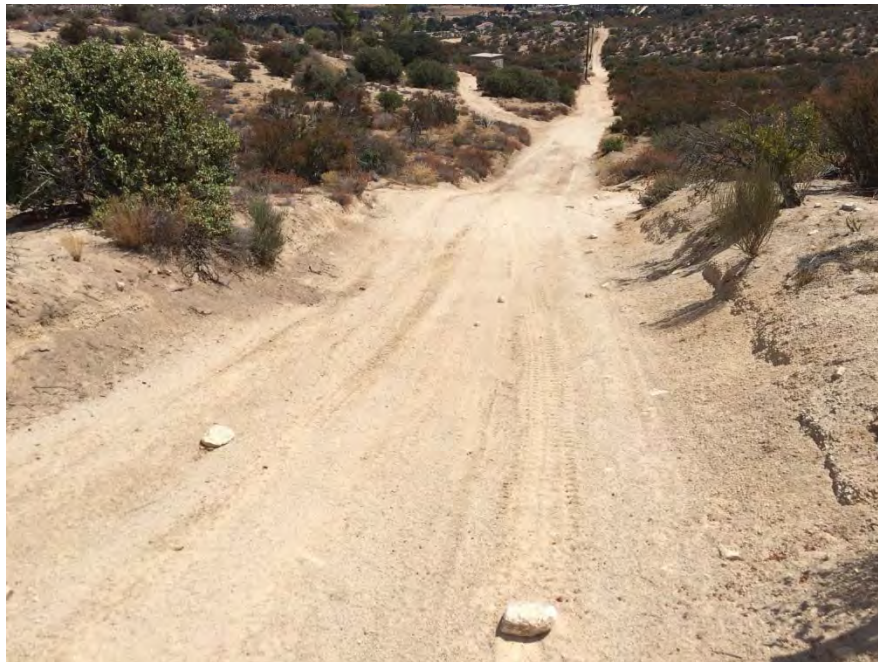
TL6931-14a – 140' east of Pole Z44284\_85 looking east, road in good condition

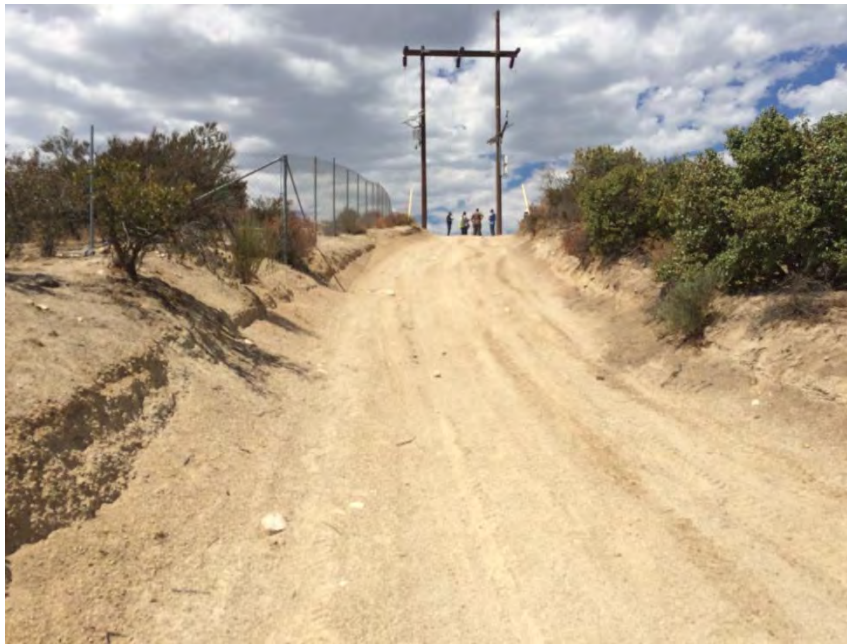
TL6931-14b – 140' east of Pole Z44284\_85 looking west, road in good condition

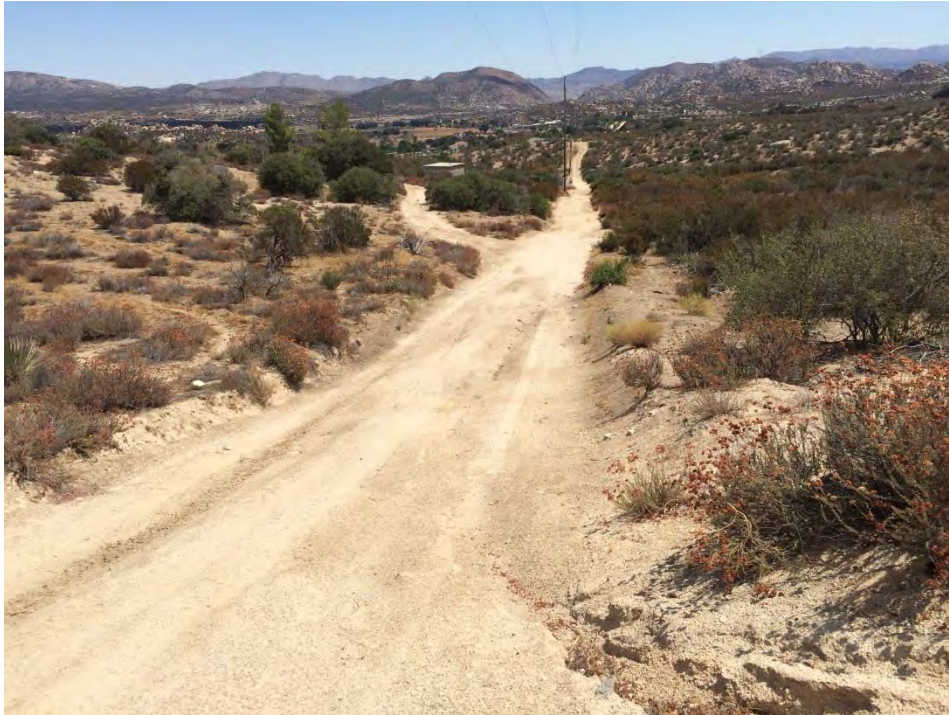
TL6931-14d – 140' east of Pole Z44284\_85 looking east beyond waterbar, road in good condition

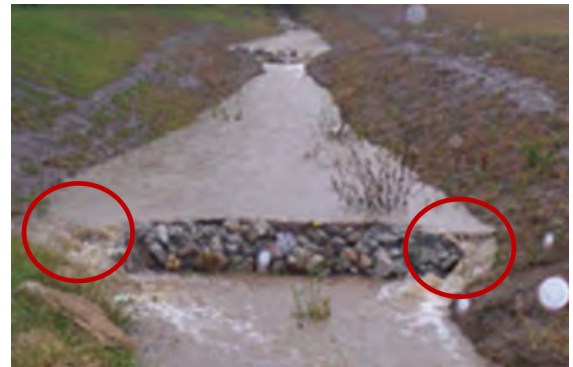
*Example of eddies causing erosion around the rock berm.*
