Re: Monthly Report Summary #22 for Aliso Canyon Turbine Replacement Project

Aliso Canyon Turbine Replacement Project CPUC Site Inspection Form

Project:	Aliso Canyon Turbine Replacement	Date:	January 7, 2016
Project Proponent:	Southern California Gas Company and Southern California Edison	Report #:	VS086
Lead Agency:	California Public Utilities Commission	Monitor(s):	Vince Semonsen
CPUC PM:	Andrew Barnsdale, Energy Division	AM/PM Weather:	Partly cloudy and cool with a slight breeze.
E & E CM:	Lara Rachowicz	Start/End time:	0800 to 1000 SCE work. 1030 to 1400 at the Aliso Storage Field.
Project NTP(s):	Guard House and Road Widening (NTP-1). The new Admin/IM Building (NTP-2) and Central Compressor Station (CCS) (NTP-3). P-41 Fill Site (NTP-2), PS-42 Fill Site, P-32 Fill Site (NTP-3), and the Natural Substation (NTP-3, NTP-A). TSPs 2 through 42 (NTPs A, C, and D) and the SCE 210 Freeway Yard. Telecommunications Route 2 (NTP-E).

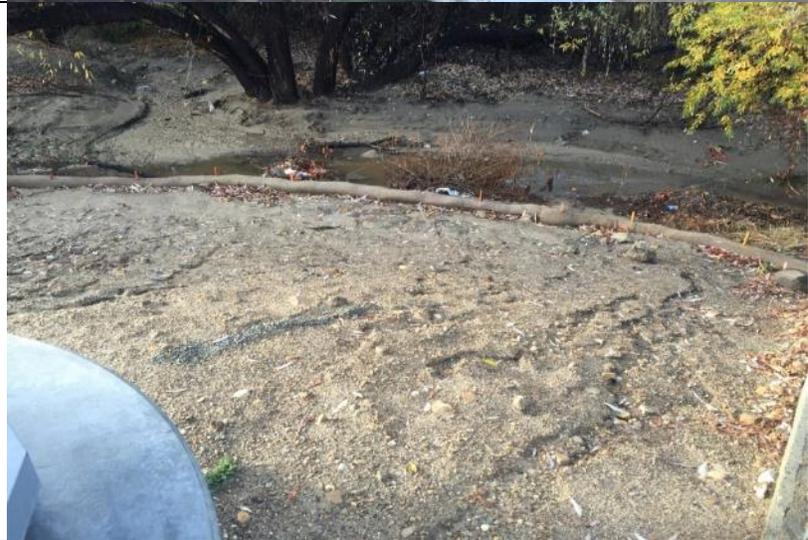
Site restoration between the pole and the small creek.

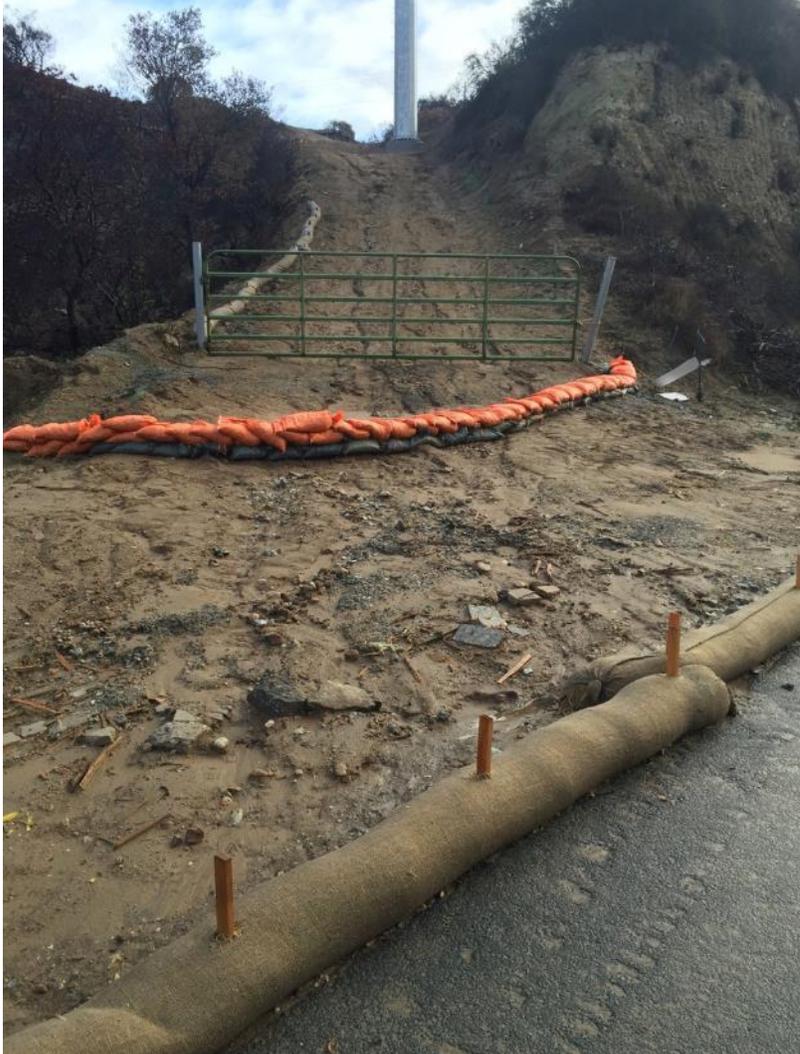
Looking up the TSP 26 access road from the frontage road.
1/07/16	TSP 26

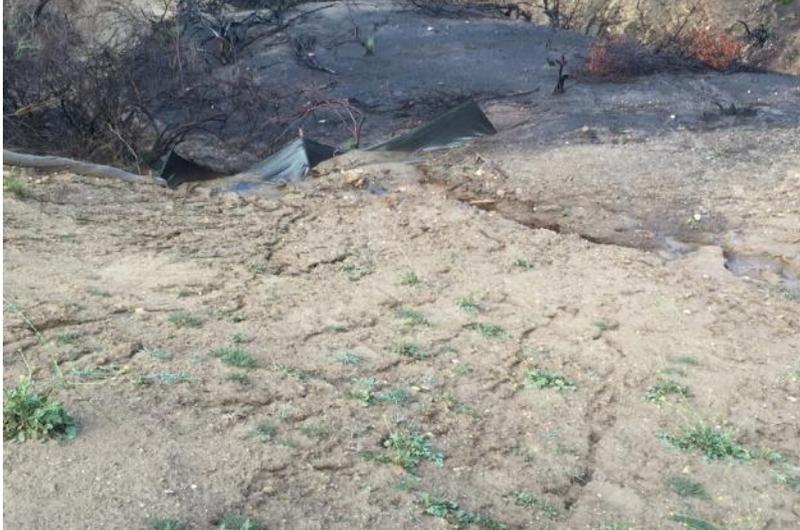
Silt fencing below the pole site.

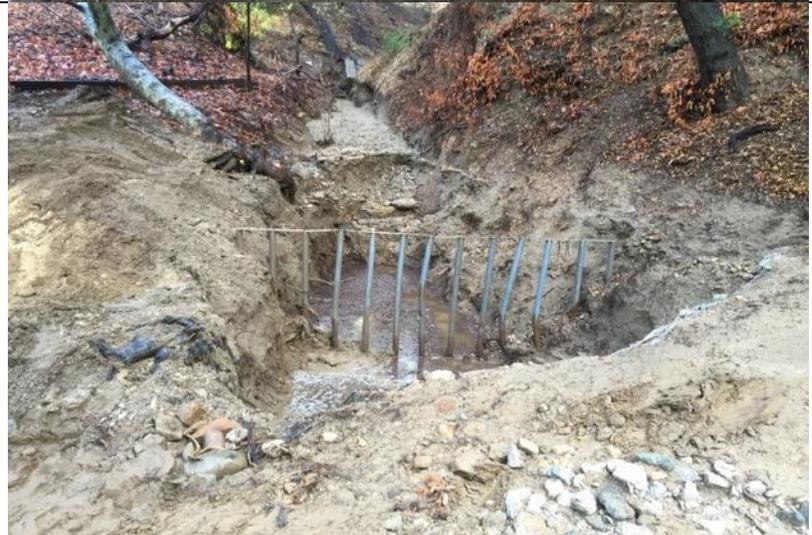
Debris cage near the road entrance; it has been partially cleared by LA County crews.
1/07/16	Access road for TSPs 12 through 22

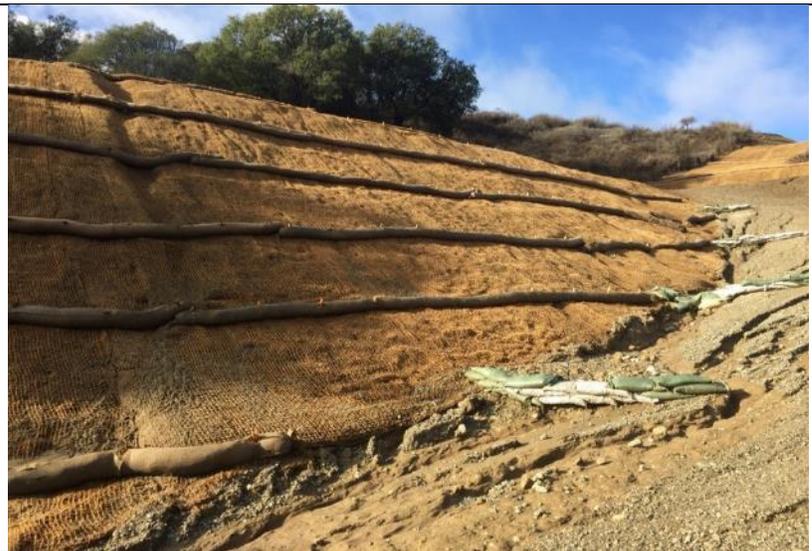
TSP 21-22 Pull Site showing the restored fill slope.
1/07/16	Access road for TSPs 12 through 22

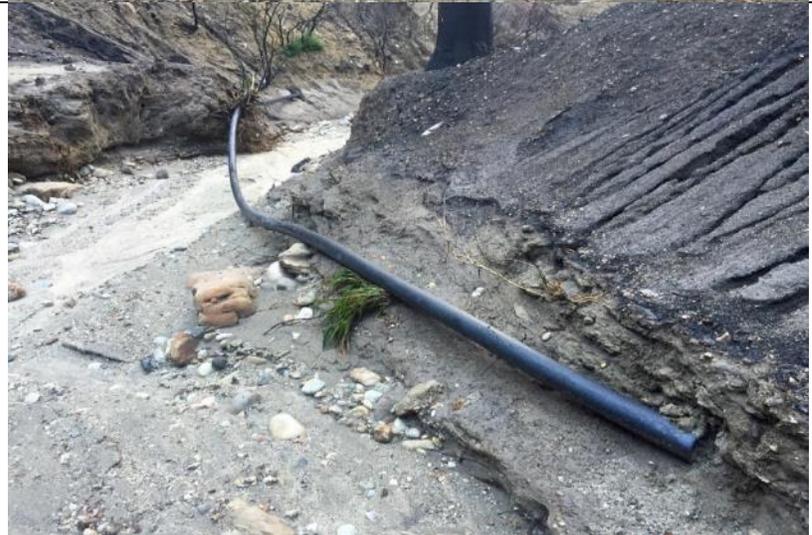
Plastic water pipe downstream of the project site.
1/07/16	Drainage #4 TSP 24/25 access road

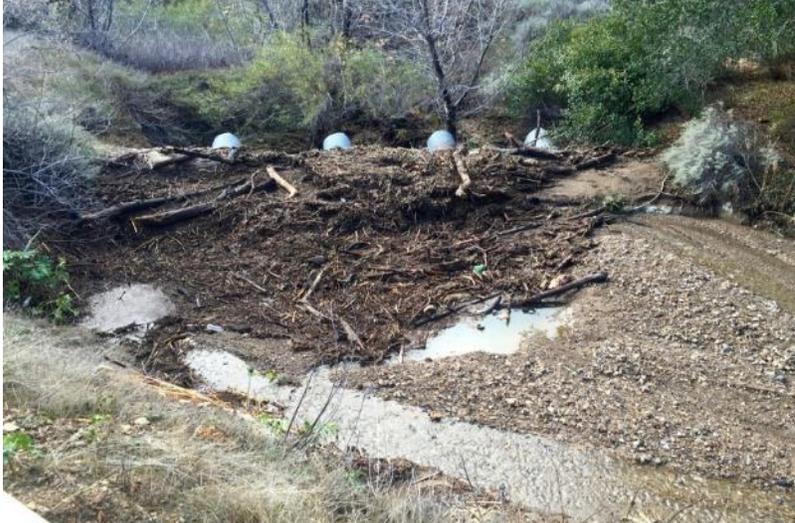
Lower sedimentation basin/newt pond filled with sediment and debris.

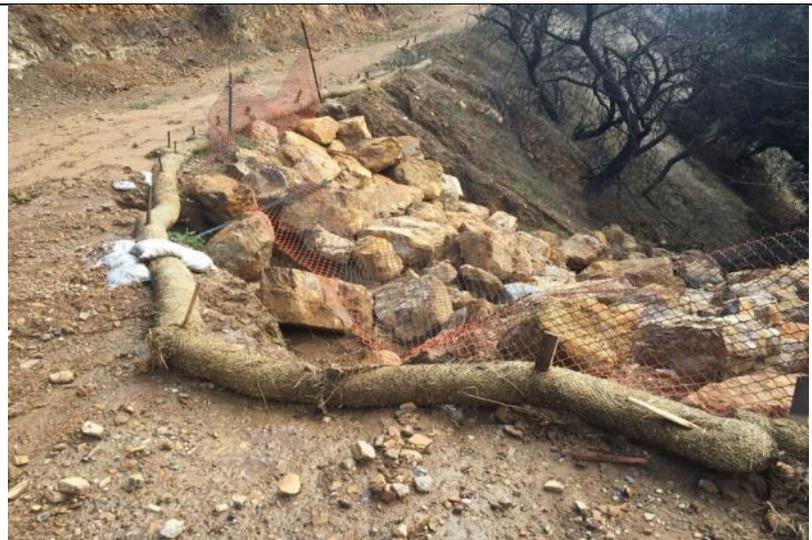
BMPs around the rip rap below the PS-42 Fill Site.
1/07/16	Well pad above the PS-42 Fill Site

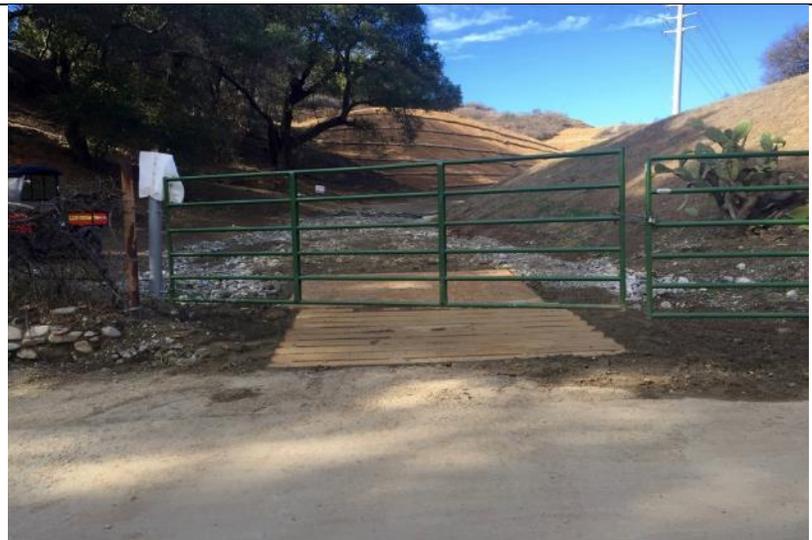
Entrance to the access road has been cleaned.
1/13/16	Limekiln Creek near the Guard House

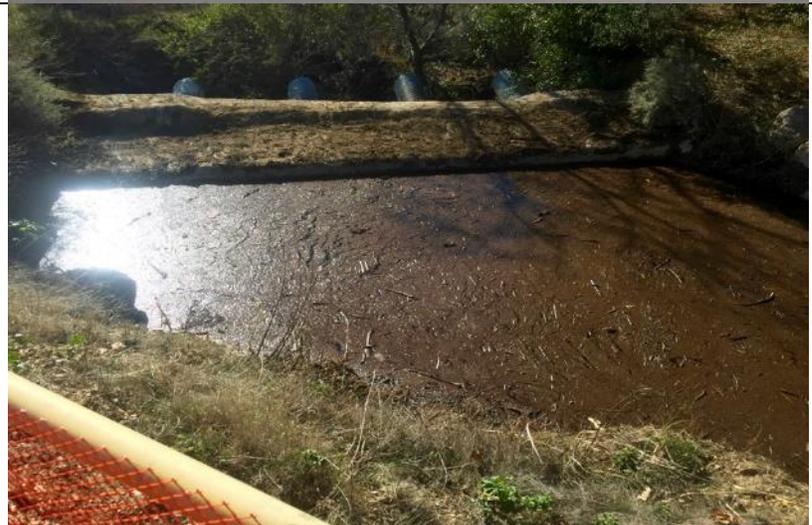
Lower sedimentation basin/newt pond recently cleared out of sediment and debris.
1/13/16	Limekiln Creek near the Guard House

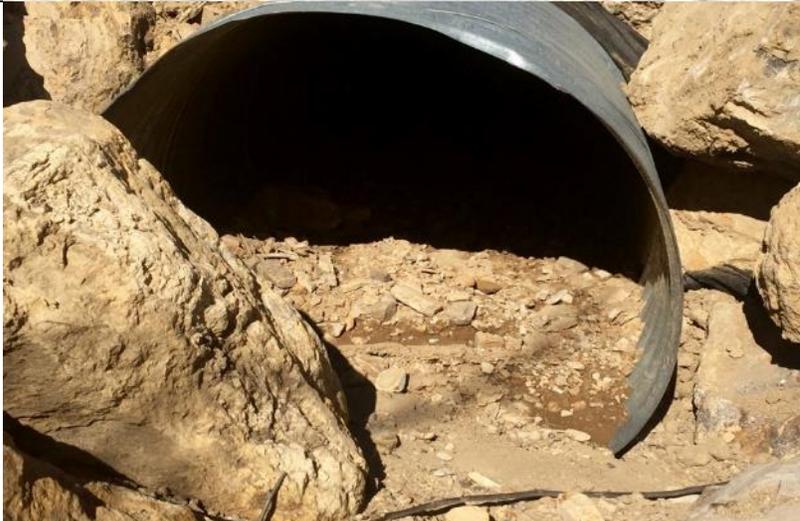
Sediment in the roadway culvert.
1/13/16	CCS

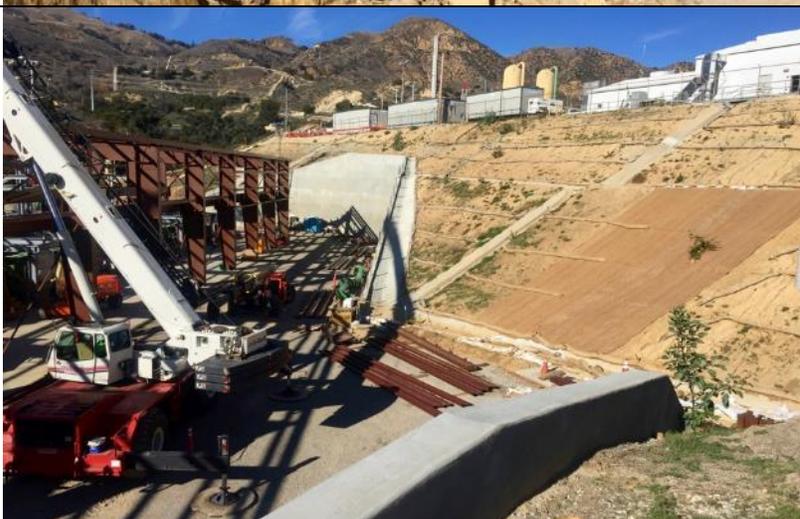
At the CCS, maintenance work had been completed on the slopes above the site – see photo. I checked the upper sedimentation basin/newt pond below the CCS and it appeared to be in good condition (fairly clear of debris and sediment).

Slopes above the CCS with BMP repairs.

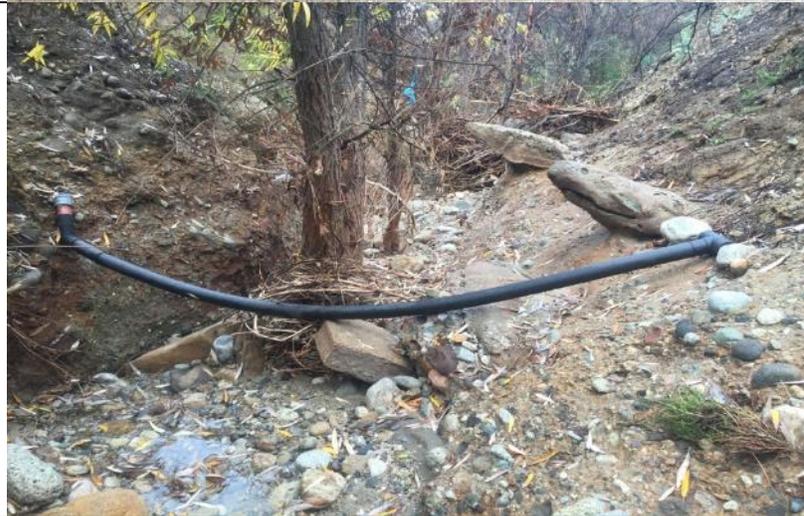
I walked up Drainage #4 to check the TSP 24/25 access road stabilization work and noted that a short piece of old water piping was lodged in the creek near the frontage road – see photo. The culverts have been cleaned out – see photo – but the accumulated sediment was just smoothed out in the drainage. This material was essentially left in the drainage and will flow downstream with the next storm. Ideally, trapped sediment should be removed so that it does not immediately return to the drainage or become trapped behind the BMPs.

<p>Assumed piece of the water piping lodged downstream of the project site near the frontage road.</p>

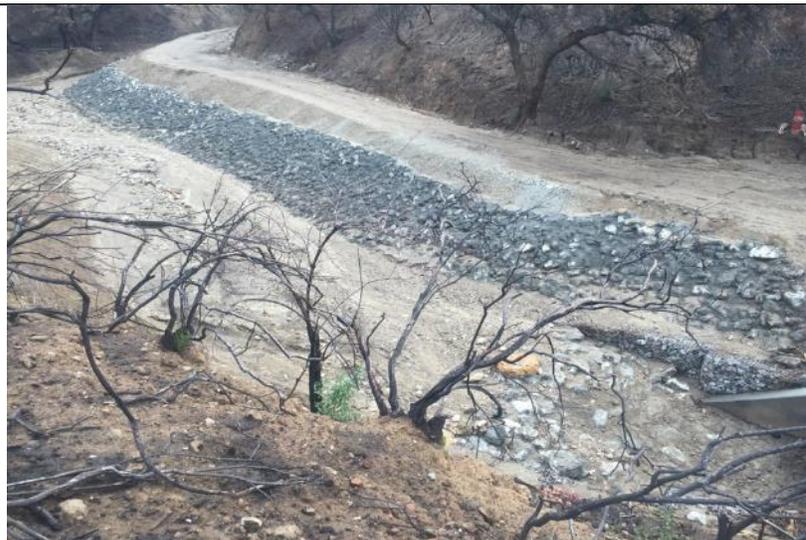
The protected access road is in good condition.
1/20/16	TSP 2

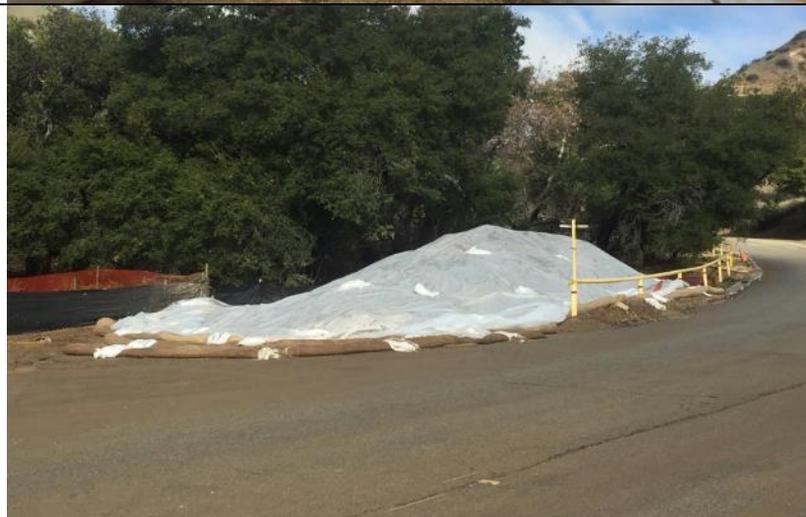
Mud and debris from the lower sedimentation basin/newt pond has been covered with plastic.

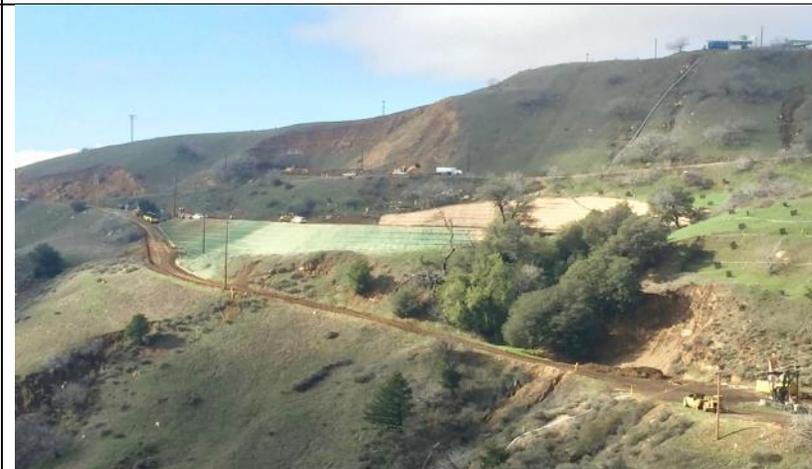
Overview showing the bank stabilization measures.
1/20/16	First relief well site

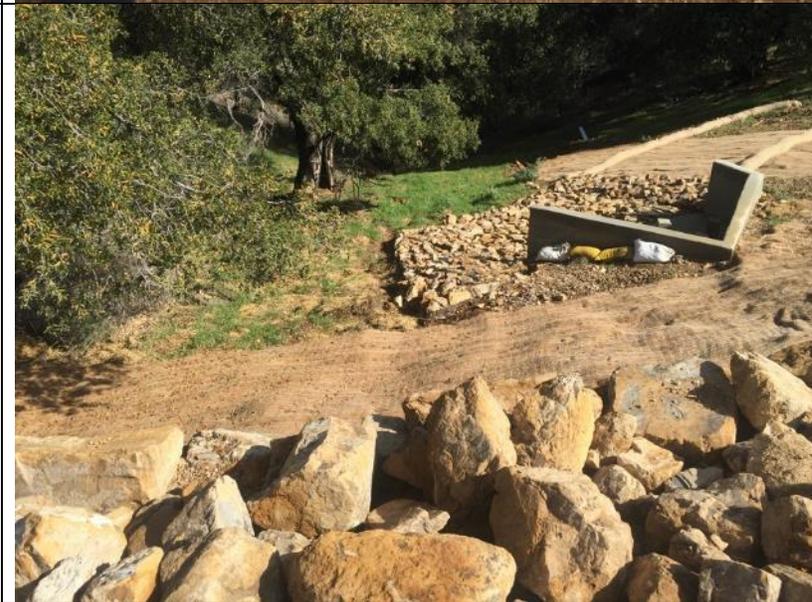
<p>BMPs below the access road have been repaired.</p>

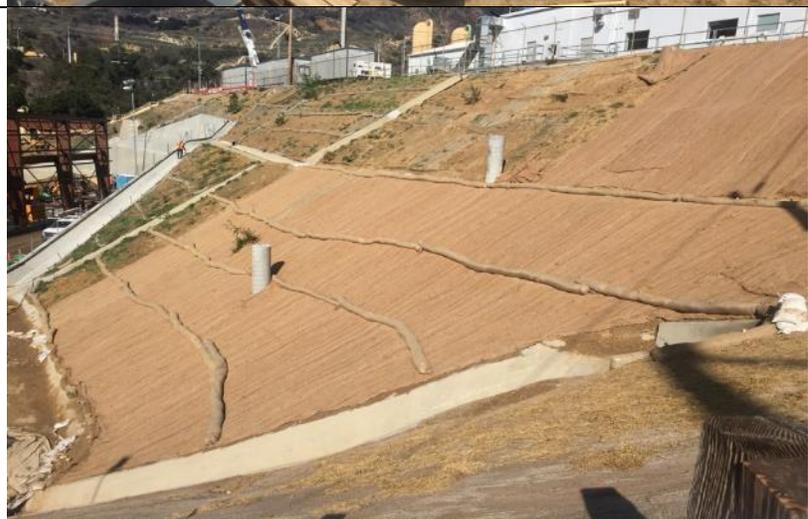
Slopes above the CCS with BMP repairs ongoing.

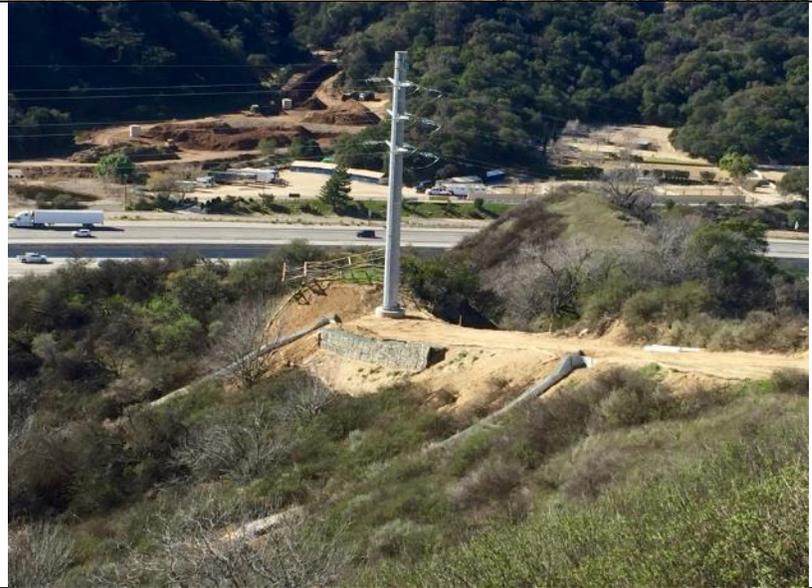
McCarthy drains have been installed at TSP 28.

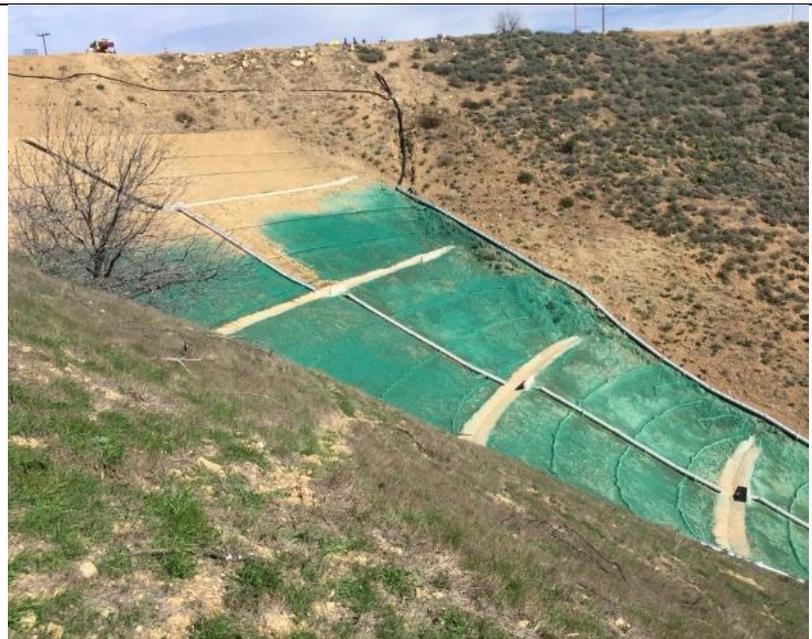
Date	Location	Photo	Description
1/29/16	PS-42 Fill Site

The fill slopes are being hydroseeded.
1/29/16	PS-42 Fill Site

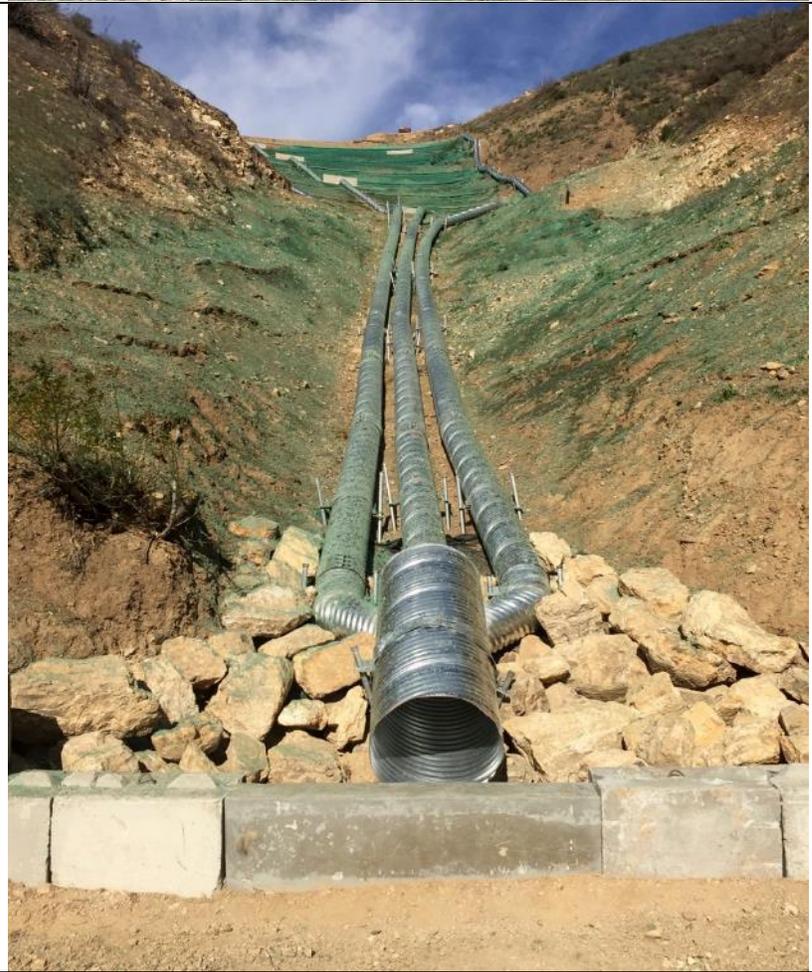
Diversion piping has been completed, with the outflow directed into the new box culvert.

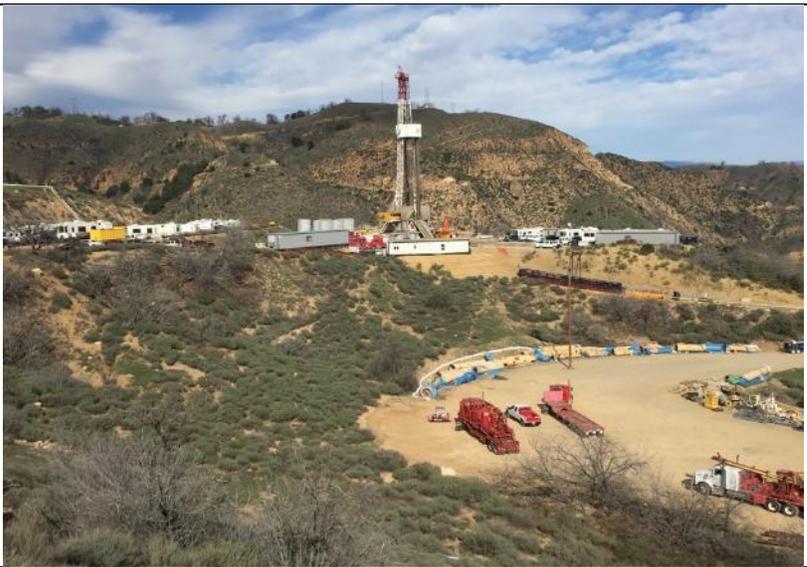
Date	Location	Photo	Description
1/29/16	First relief well site (associated with the ongoing well leak at the Aliso Storage Field)

Overview from west of the well site.
1/29/16	New Admin/IM Building

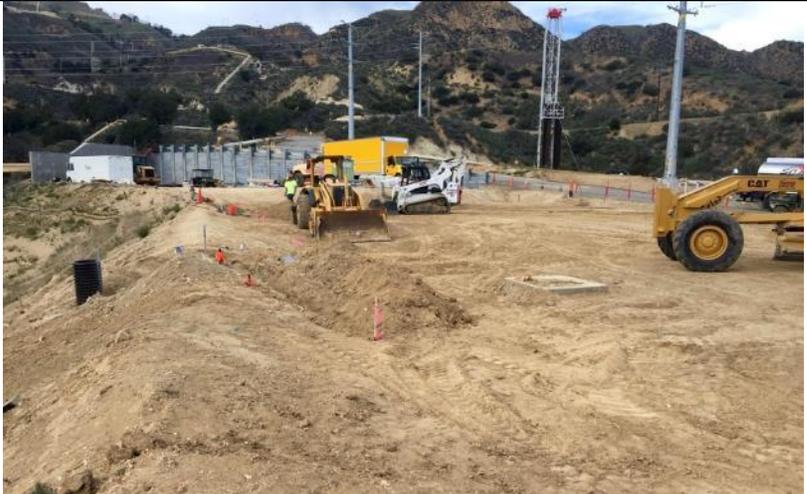
Backfilling work and final grading.
1/29/16	CCS

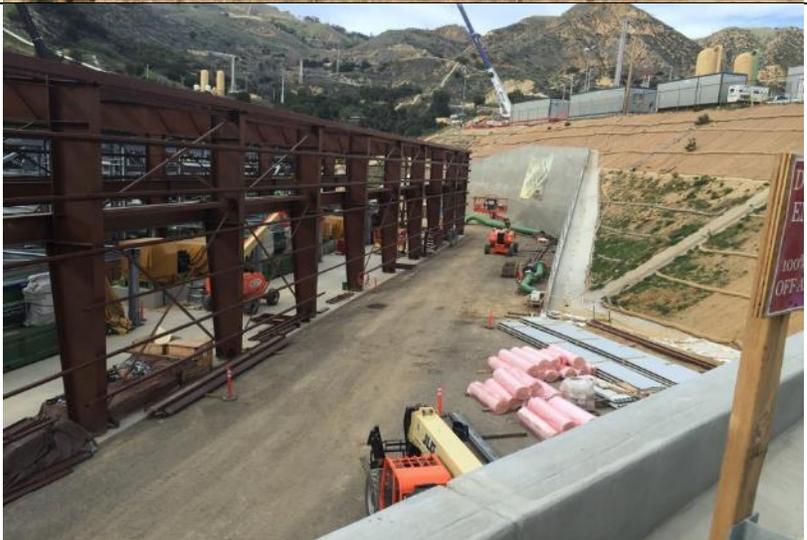
Buildings are being constructed.

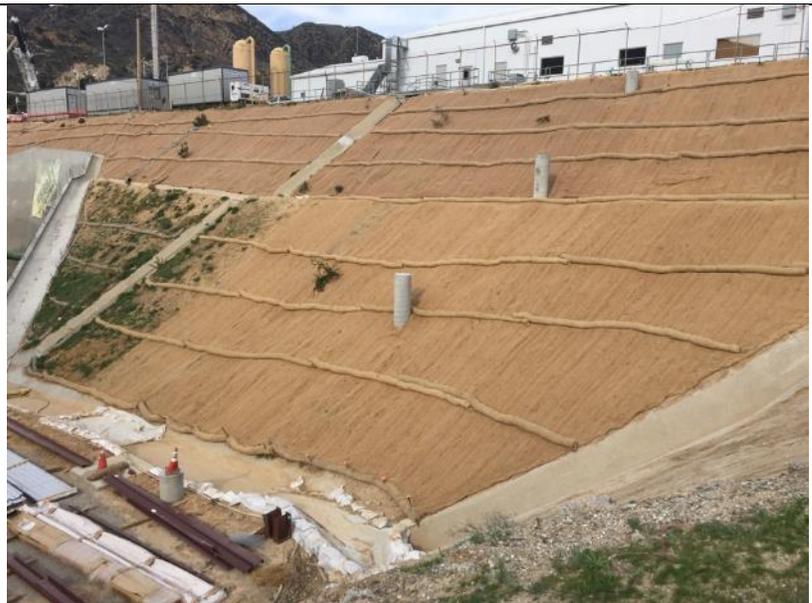
REPRESENTATIVE SITE PHOTOGRAPHS			
Date	Location	Photo	Description
1/29/16	CCS

Slopes around the CCS are now mostly covered with coconut erosion blanket.
